**REPORT ON THE  
SITE EXAMINATION TESTING  
AND MONITORING OF THE RECONSTRUCTION  
OF THE ACTON STONE CHAMBER,  
ACTON, MASSACHUSETTS**

Town of Acton  
and  
New England Antiquities Research Association  
(NEARA)

Craig S. Chartier  
Plymouth Archaeological Rediscovery Project

September 2007

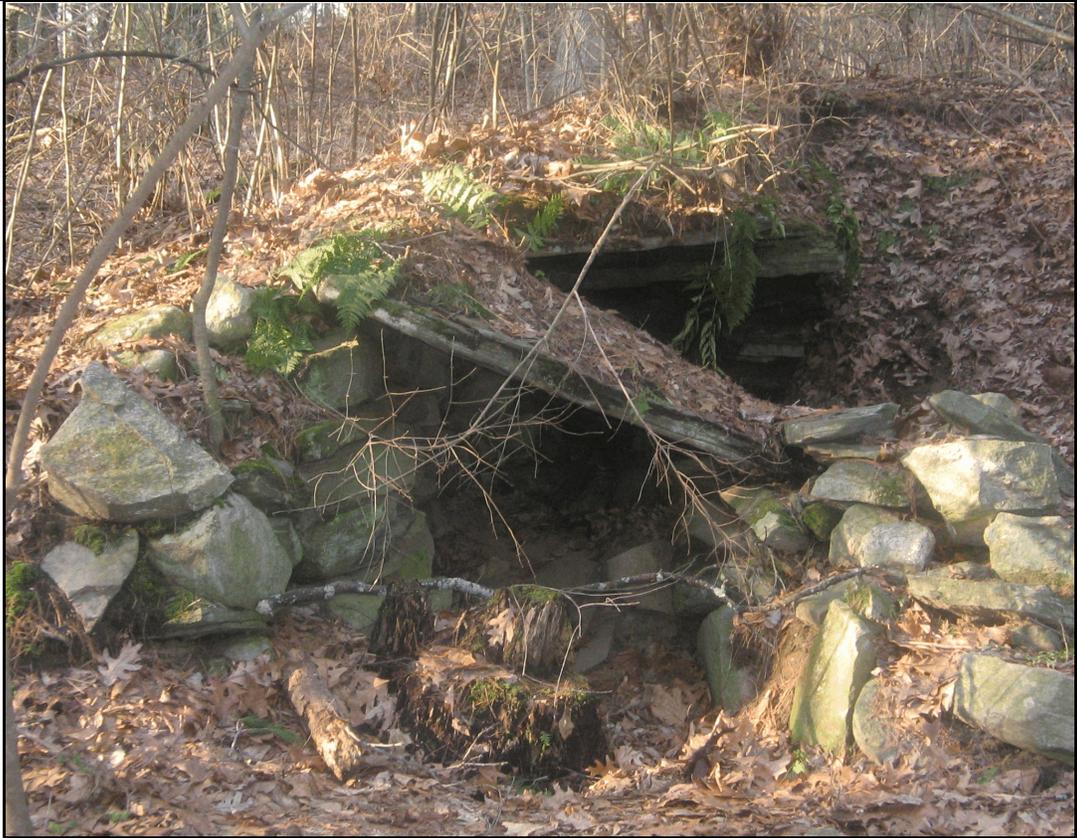
Figure 3. Exterior of stone chamber prior to reconstruction

The Town of Acton Board of Selectmen, as overseen by the Acton Historical Commission, and in collaboration with the New England Antiquities Research Association (NEARA), was awarded a Community Preservation Act (CPA) grant for the restoration and stabilization of the Historic Stone Chamber on the Nashoba Brook Conservation Land in Acton, Massachusetts (Figures 1 and 2). The aim of the restoration project was to restore the stone chamber to a condition that both resolves the present safety hazards (danger of collapse), and to re-establish certain architectural principles applied during its period of original construction. The Acton chamber has been known about for many years, but it has been within the last 40 years that, due to both human and environmental factors, it has suffered its most severe deterioration. The deterioration has now reached the stage where it has been determined that, due to its location on public land with open access and the fact that it now possesses a serious danger of collapse with potential serious injury to whomever happens to be present, that it must either be rebuilt or demolished (Figures 3 and 4).

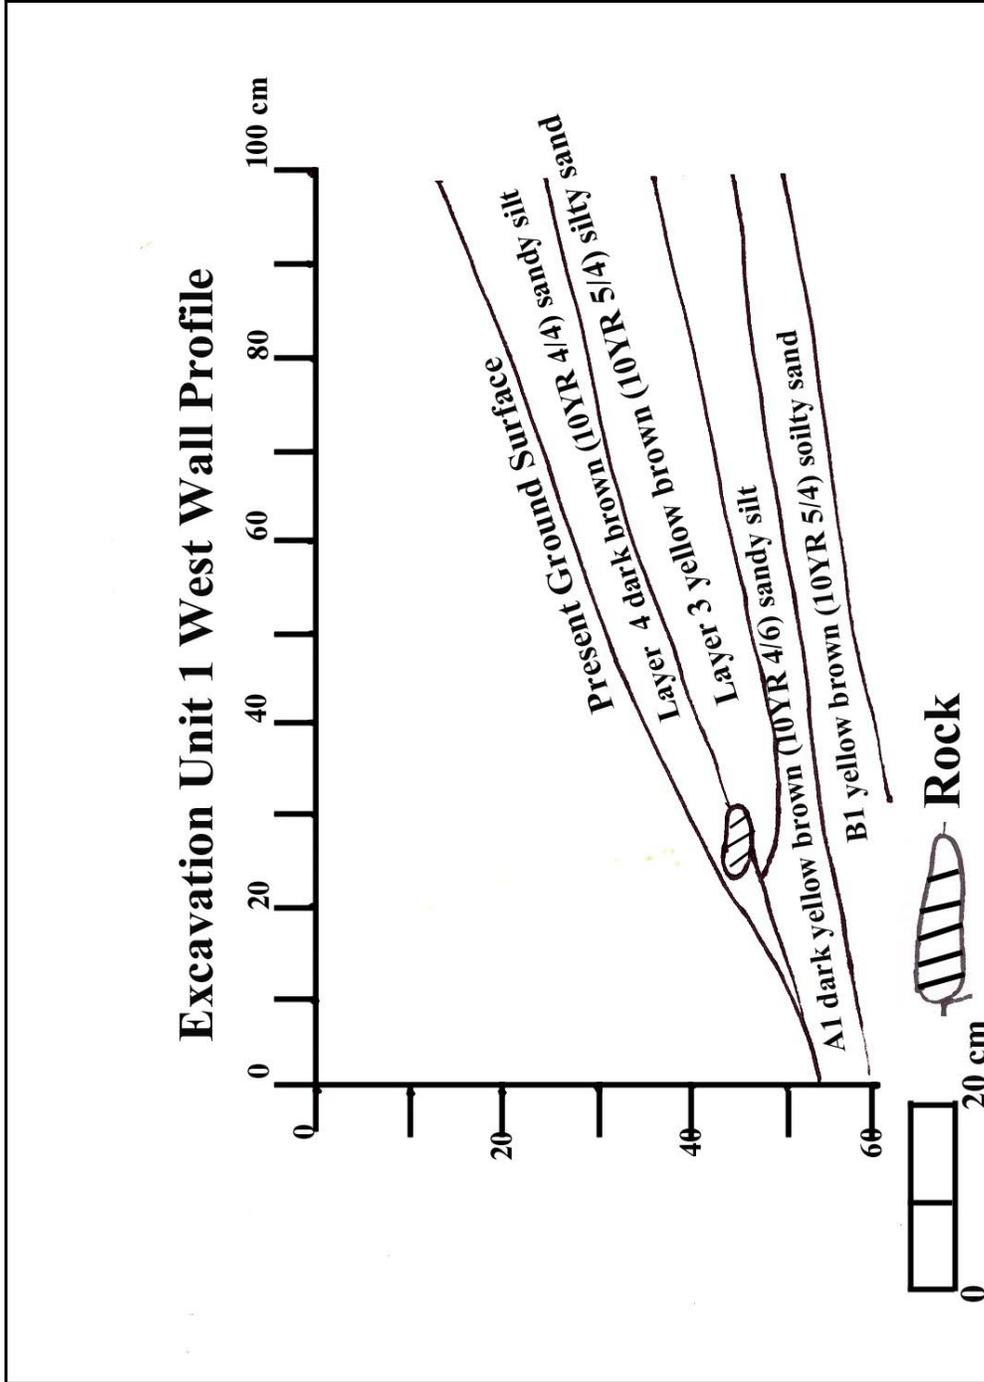
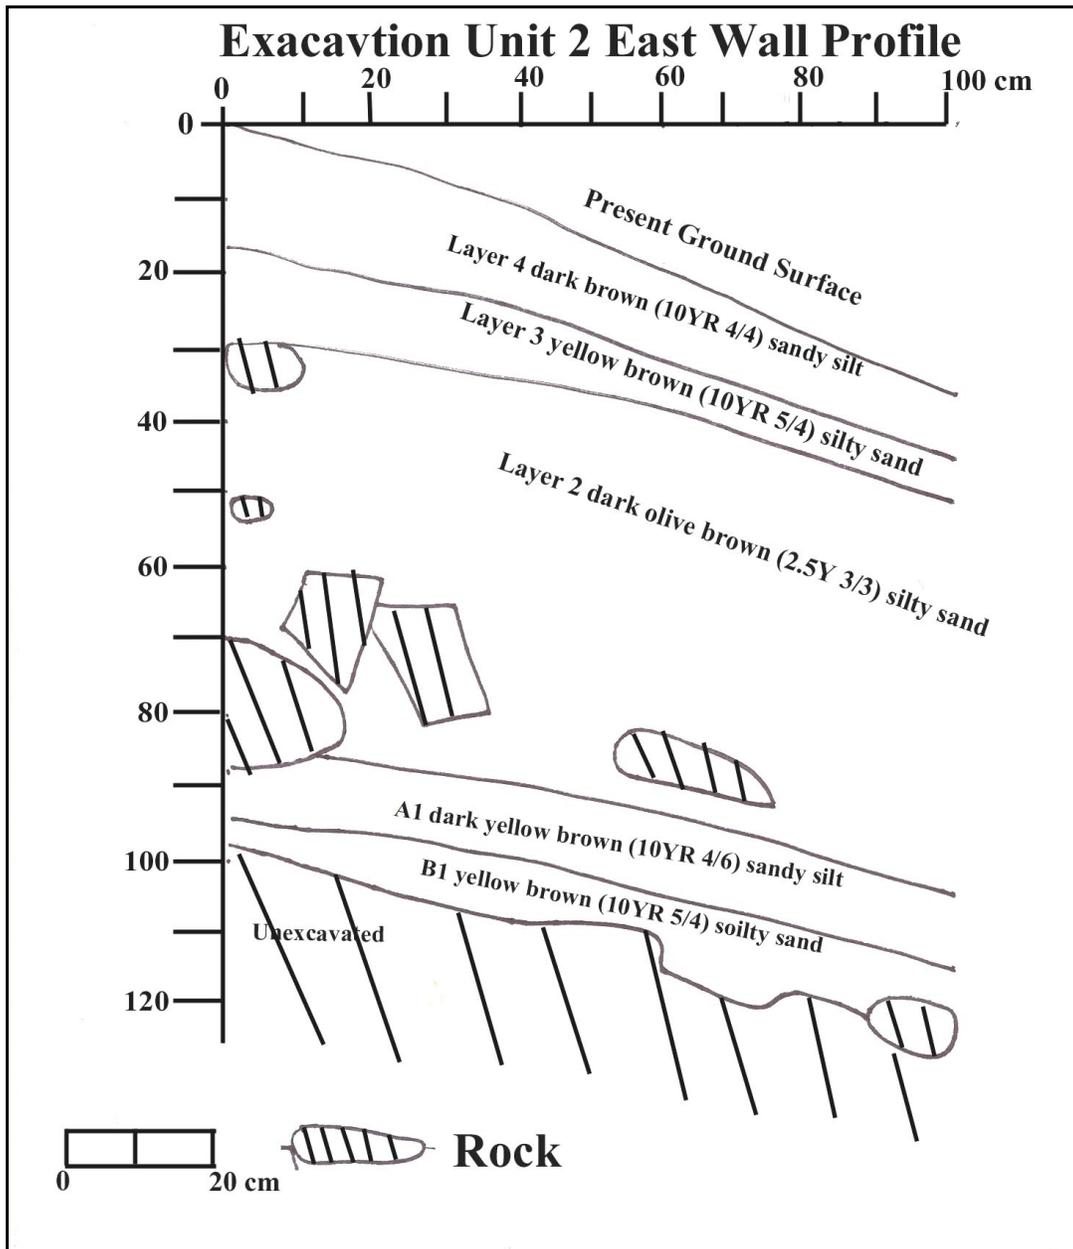
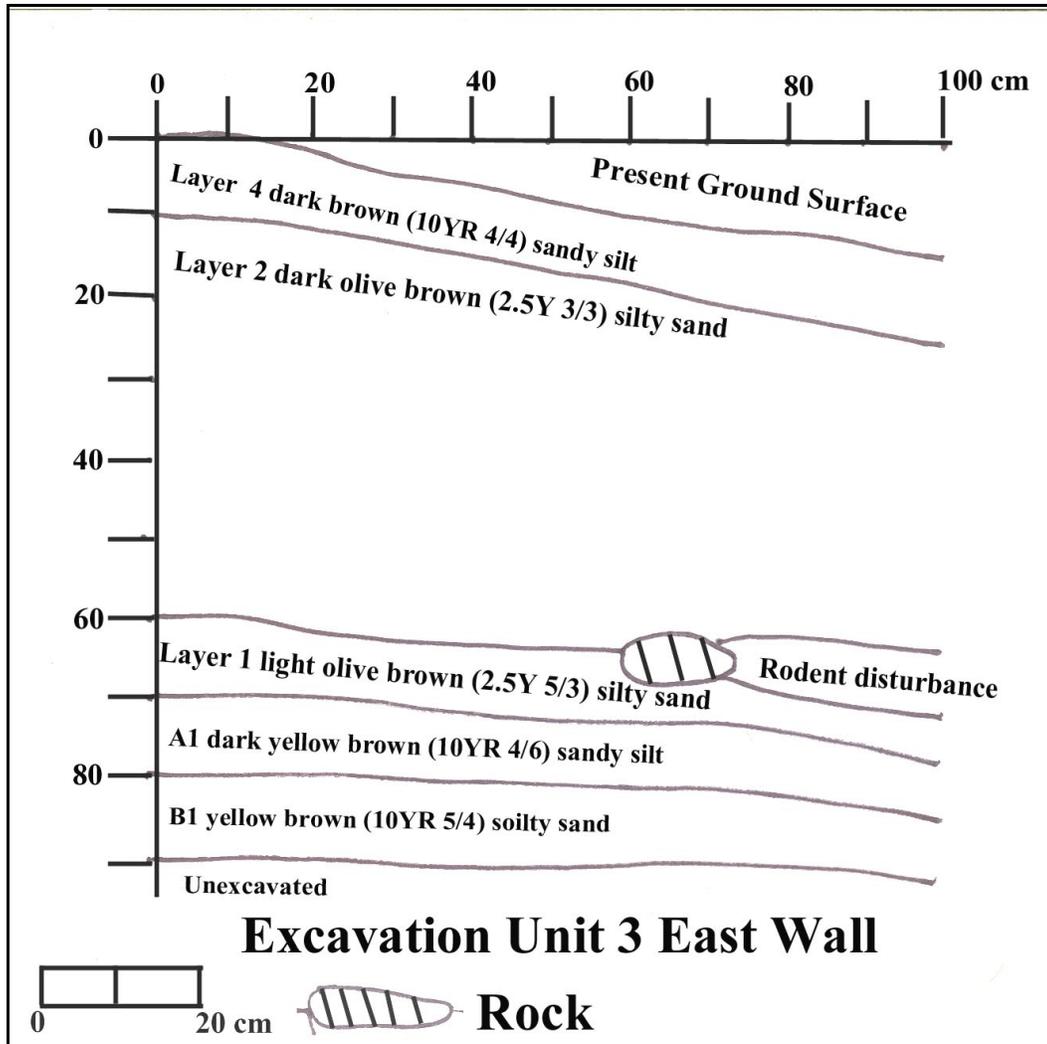
A dark brown (10YR 3/3) sandy silt Layer 4 was encountered in all three units averaging 5 to 10 cm thick in EU 1, 10 to 20 cm thick in EU 2 with the thickest portion being in the northern half, and 10 cm thick in EU 3. Layer 4 overlaid Fill layer 3 which was a yellow brown (10YR 5/4) silty sand layer that was found to be five to 10 cm thick in EU 1, five to 15 cm thick in EU 2 and not present in EU 3. Layer 3 overlaid Layer 2, a dark olive brown (2.5Y 3/3) silty sand with rocks and gravel, which was not present in EU 1 but which averaged 50 to 55 cm thick in EU 2 and 35 to 55 cm thick in EU 3. Layer 1 was encountered only in EU 3 where it took the form of a light olive brown (2.5Y 5/3) seven centimeter thick layer of fine sand. A rodent burrow was also encountered in EU 1 in the NE corner at 40-70 cmbs. Soils were loose with hickory nutshells being recovered. The original ground surface was encountered below Layer 1 in EU 2 and 3 and below Layer 2 in EU 1. This layer consisted of an unplowed A1 horizon, dark yellow brown in color (10YR 4/6) that averaged 10 cm thick. The A1 horizon overlaid a yellow brown (10YR 5/4) B1 horizon, 10 cm of which was excavated. A large erratic or portion of the underlying bedrock was encountered at the bottom of EU 2, eventually covering the entire floor of the unit (Figure 10, 11, and 12).

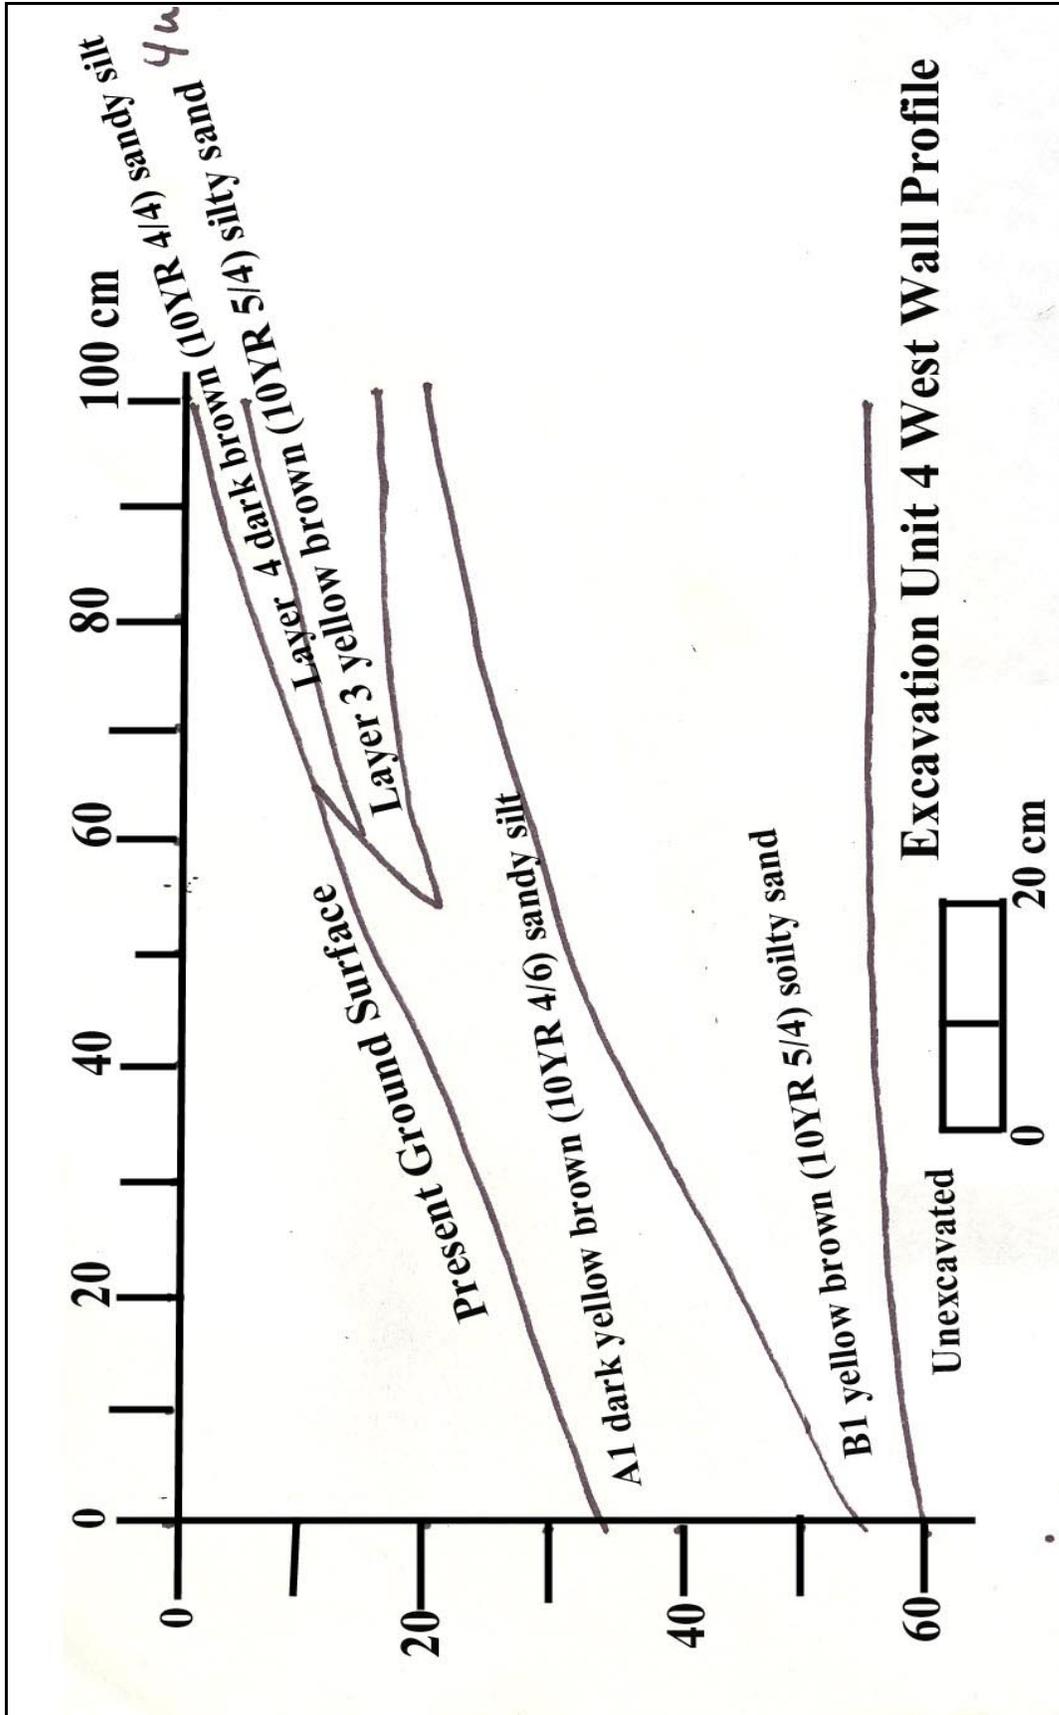
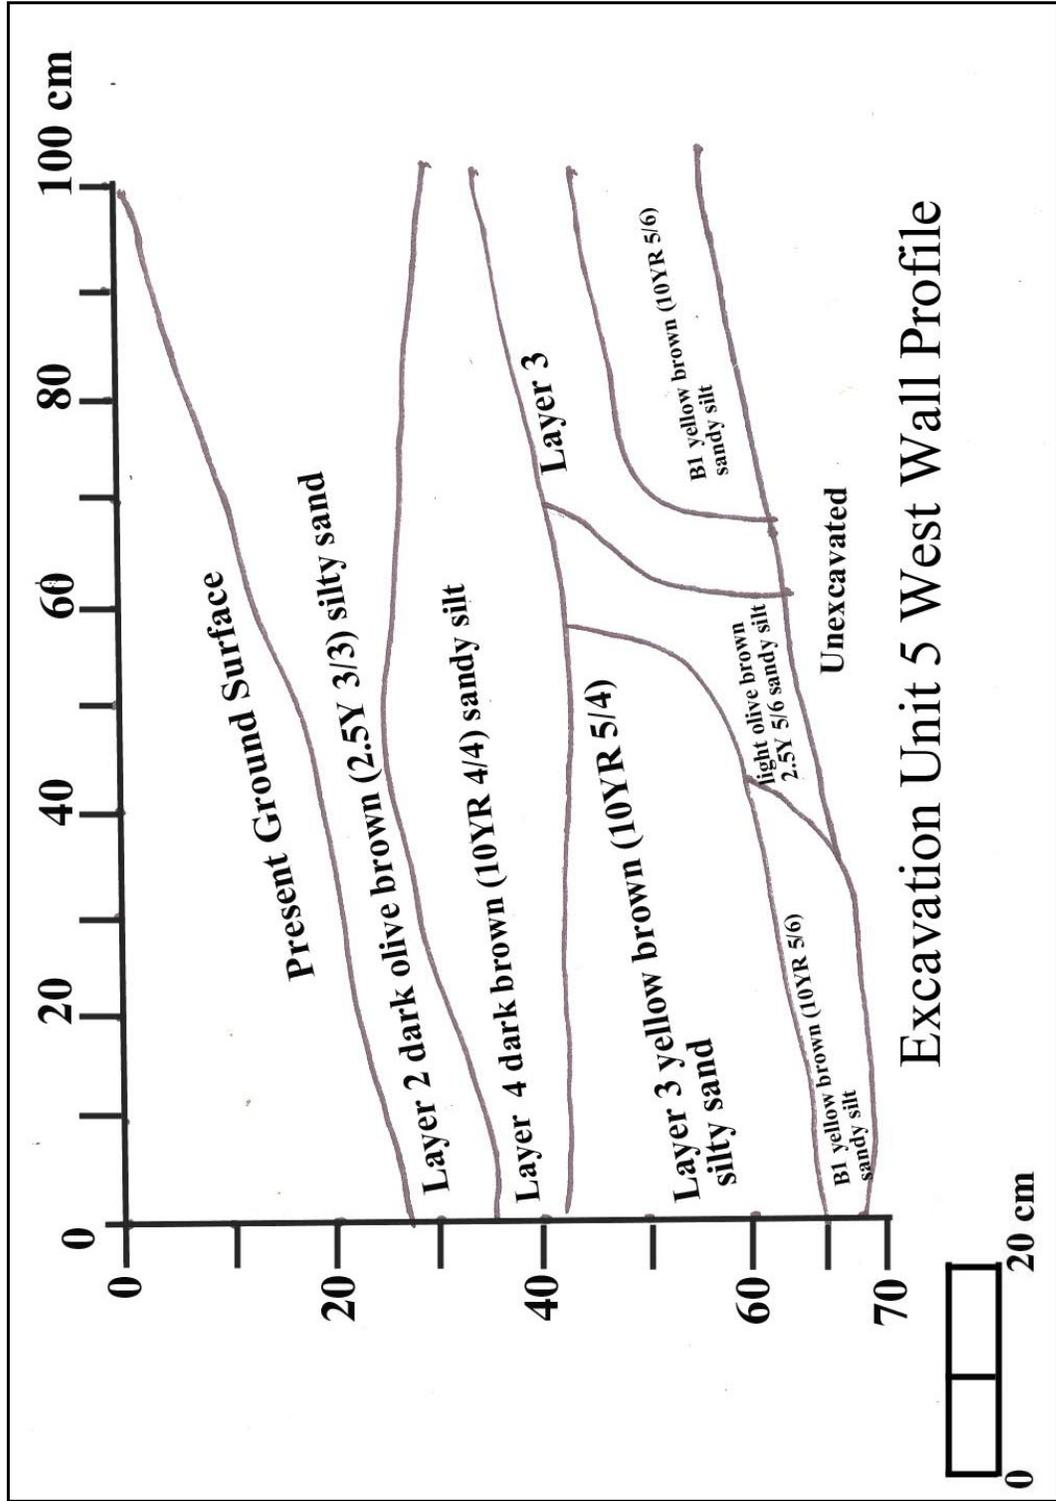
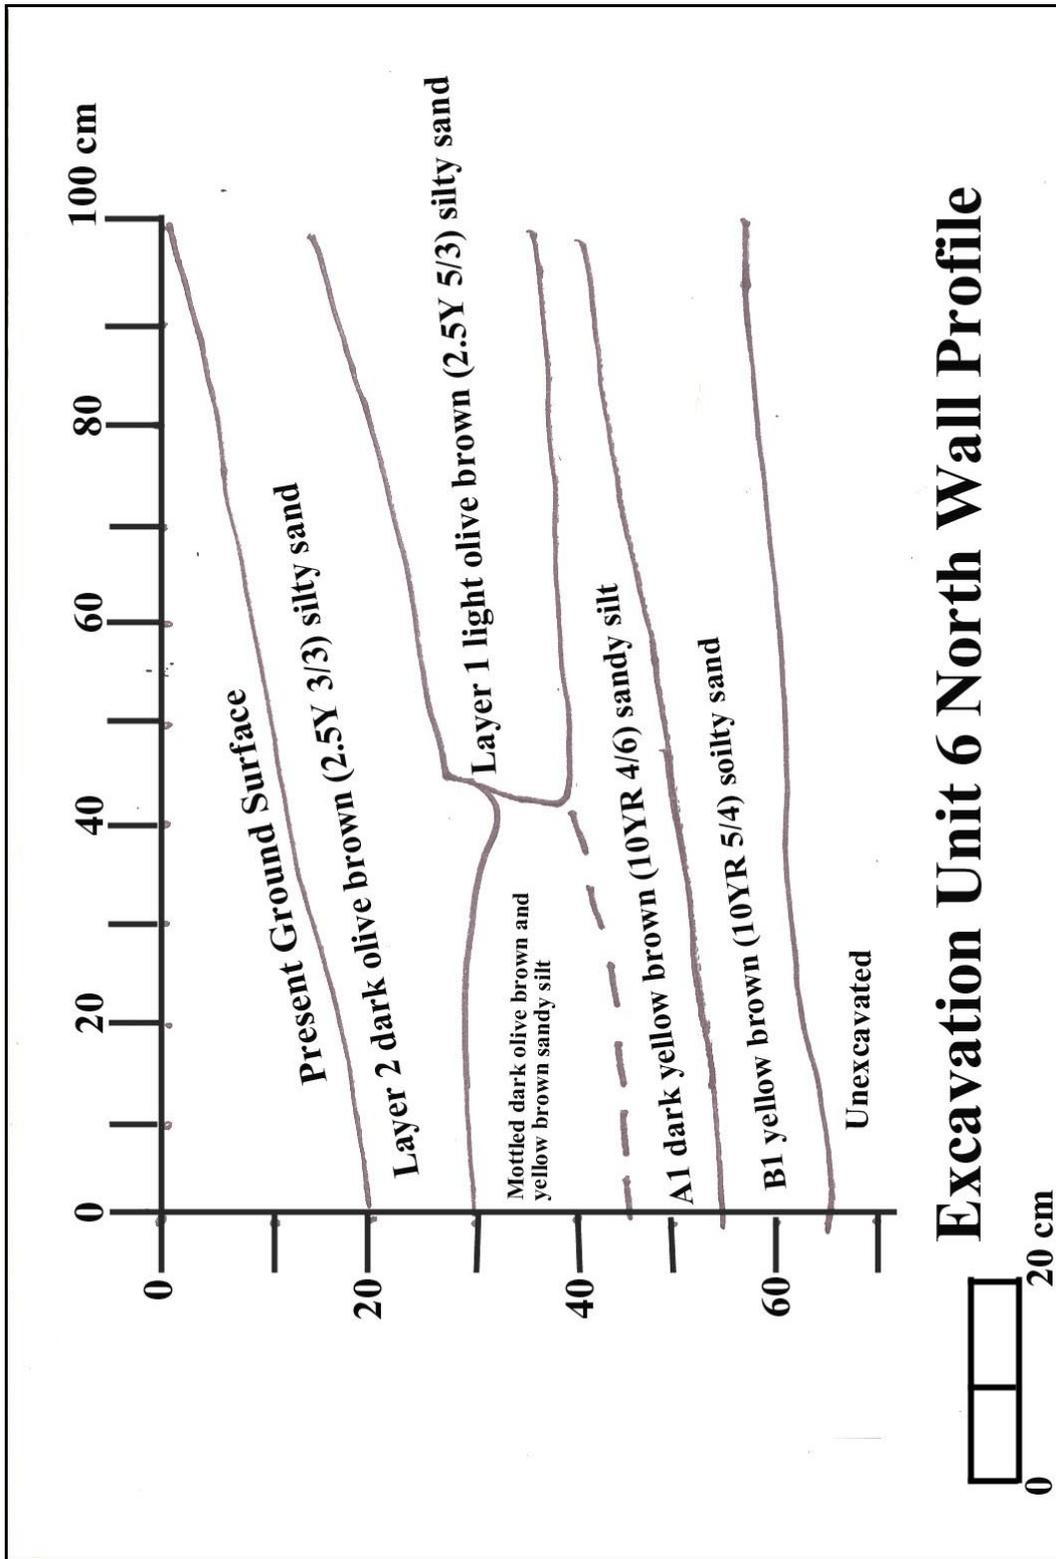
A dark olive brown (2.5Y 6/4) sandy silt, corresponding to Layer 2 in EU s 1-3, was encountered in all three units averaging 15 cm thick in EUs 4 and 6 and 30 cm thick in EU 5 with the thickest portion being in the northern half. Layer 2 overlaid Layer 1 which was a light olive brown (2.5Y 5/4) silty sand layer that was encountered in EU 6 where it was found to be 10 to 25cm thick. This layer was not present in EUs 4 and 5. In EU 5, Layer 2 overlaid a soil horizon that was identified as Layer 4 in EUs 1-3, a 10YR 5/6 sandy silt that averaged 10 to 30 cm thick with the thickest portion in the southern half. This in turn overlaid Layer 3, the 10YR 3/2 horizon encountered in EUs 1-3. Layer 3 overlaid the A1 horizon in EU 5 while Layer 2 overlaid the A1 in EU 4, located at the bottom of the slope. An area of root disturbance was encountered in EU 5 in the western half, extending into the B1 horizon. It appears that EU 4 encountered the southern terminal edge of the overburden deposited during the mounding phase of construction. The southern portion of EU 6 encountered A1 horizon soils on top of a very rocky B1 (Figures 13, 14, and 15).

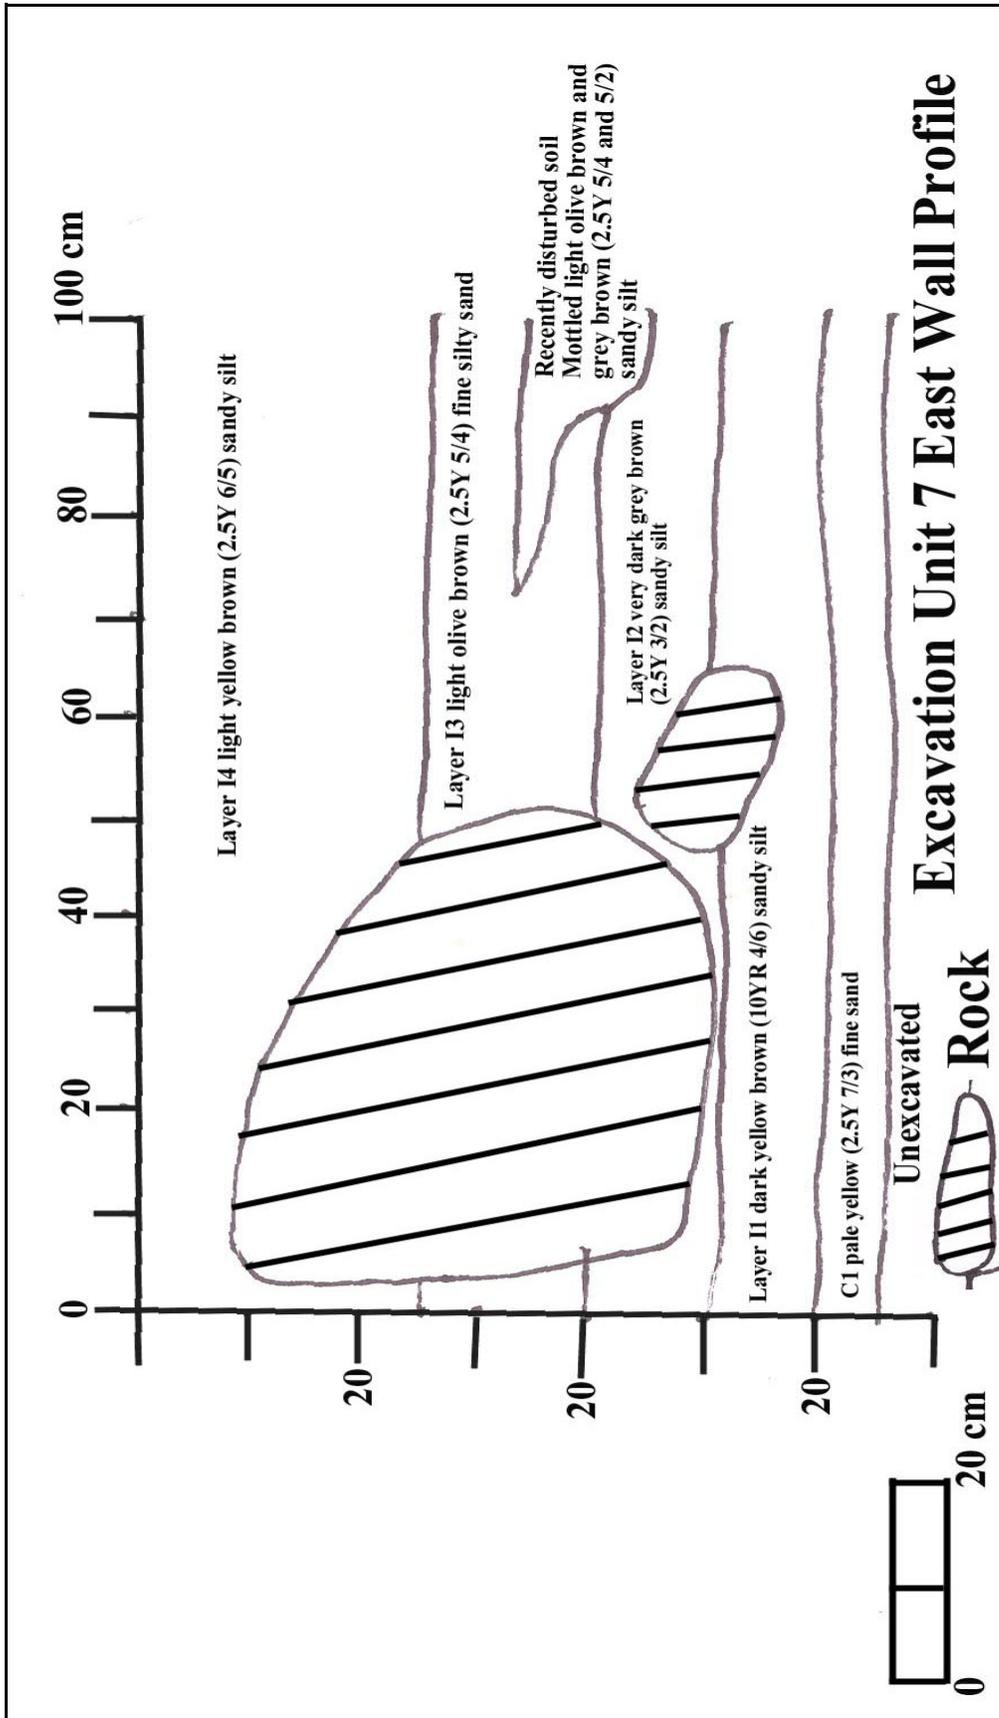
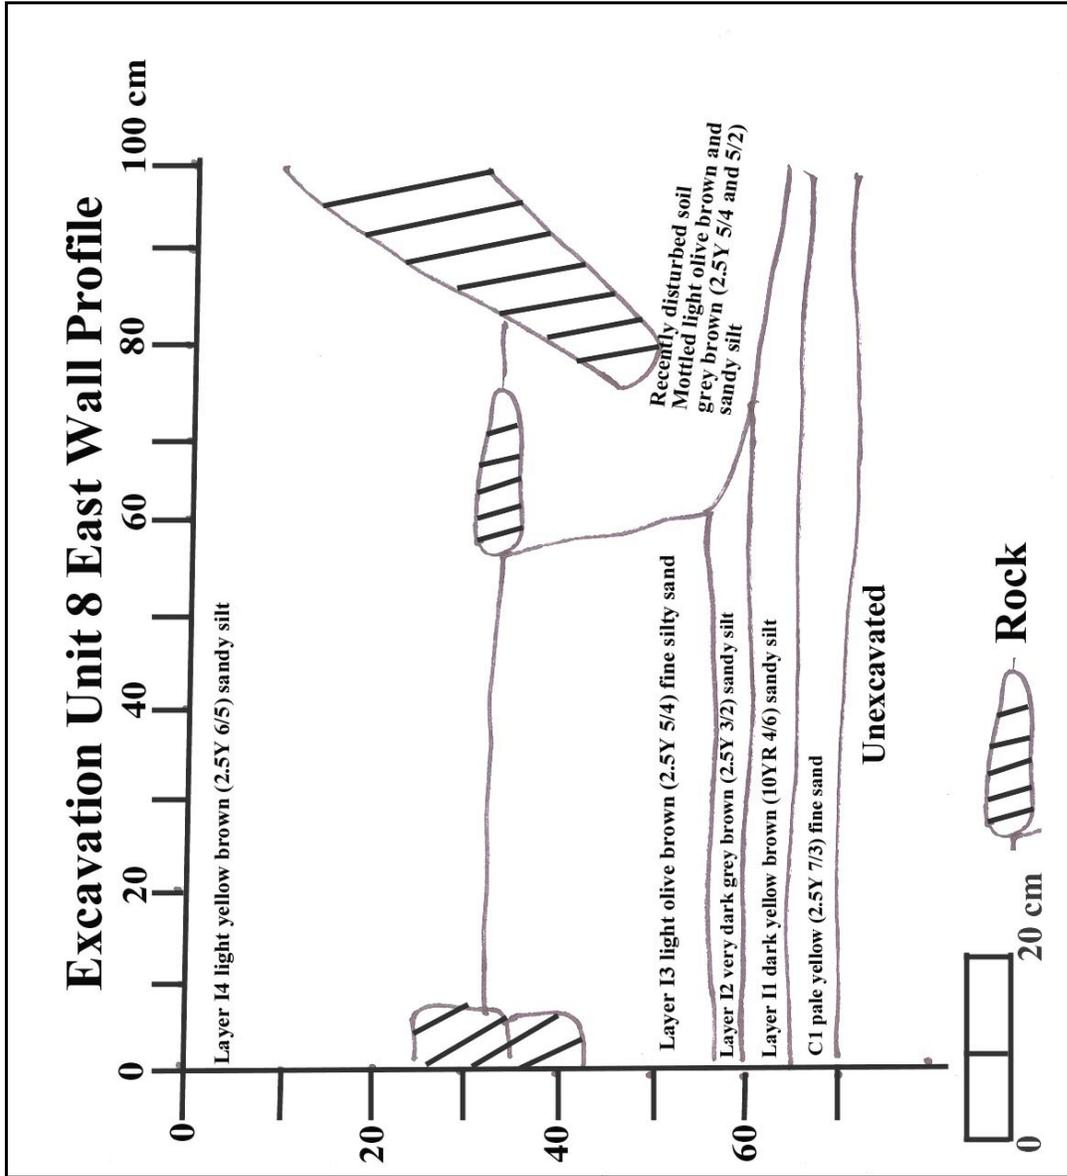
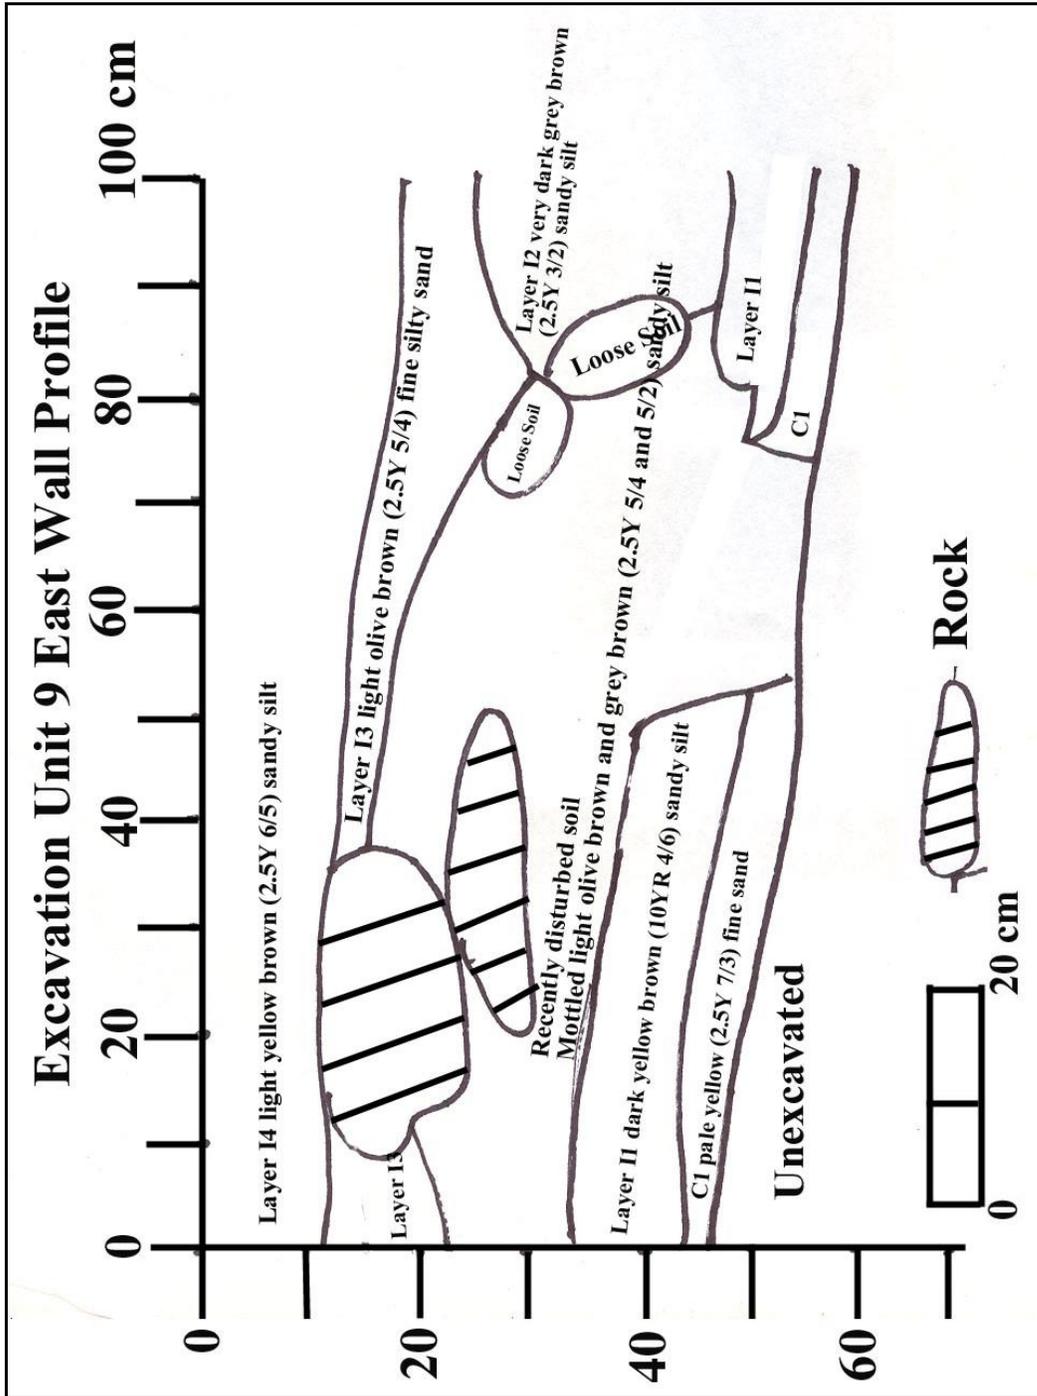
washed in layer that appears to date primarily to the late nineteenth century. Included within this layer were many pieces of roof spall and cobbles and boulders associated with the passage foundation walls. Layer I3 overlaid Layer I2, a very dark grey brown (2.5Y 3/2) sandy silt that is interpreted as representing a buildup and decomposition of organic material on original chamber floor. This layer had a uniform thickness between and across all units of five centimeters. In EU 9, Layer I2 consisted of only a small portion in the southern half. The northern half of the unit contained a soft mixture of light olive brown and grey brown (2.5Y 5/4 and 5/2) sandy silt, interpreted as a recent feature created by an individual or individuals using the chamber as a recreational location. Associated with this disturbed soil was a large amount of charcoal and numerous brown, green and clear bottle glass fragments. This feature measured 80 cm north to south and was 25 cm deep. Layer I1 was encountered below Layer I2. Layer I1, which was dark yellow brown (10YR 4/6), is believed to be a combination of the original floor and some organic decomposition. This layer was also uniformly five centimeters thick. A pale yellow (2.5Y 7/3) fine sand C1 horizon was encountered below Layer I1 (Figures 17, 18, and 19).

Apparently, after the abandonment of the chamber, the location was used by individuals as a possible camp or habitation site in the late nineteenth century and also in the late twentieth century. At some point soon after its abandonment and continuing into recent times, some factor in the local environment changed, likely development at the top of the hill and clearing of vegetation on summit and hill side associated with the chamber, that caused dramatic increased erosion resulting in the deposition of layers I3 and I4. By the time that the chamber passage began filling with wind and waterborne silt, stones had collapsed from the sides of the passage and were quickly buried with Layer I3.
