**Preliminary Report  
on the  
Architectural Survey  
of the  
Old Court House  
Barnstable, MA**

Prepared for  
Tales of Cape Cod

Prepared by  
Craig Chartier  
Plymouth Archaeological Rediscovery Project

December 2014

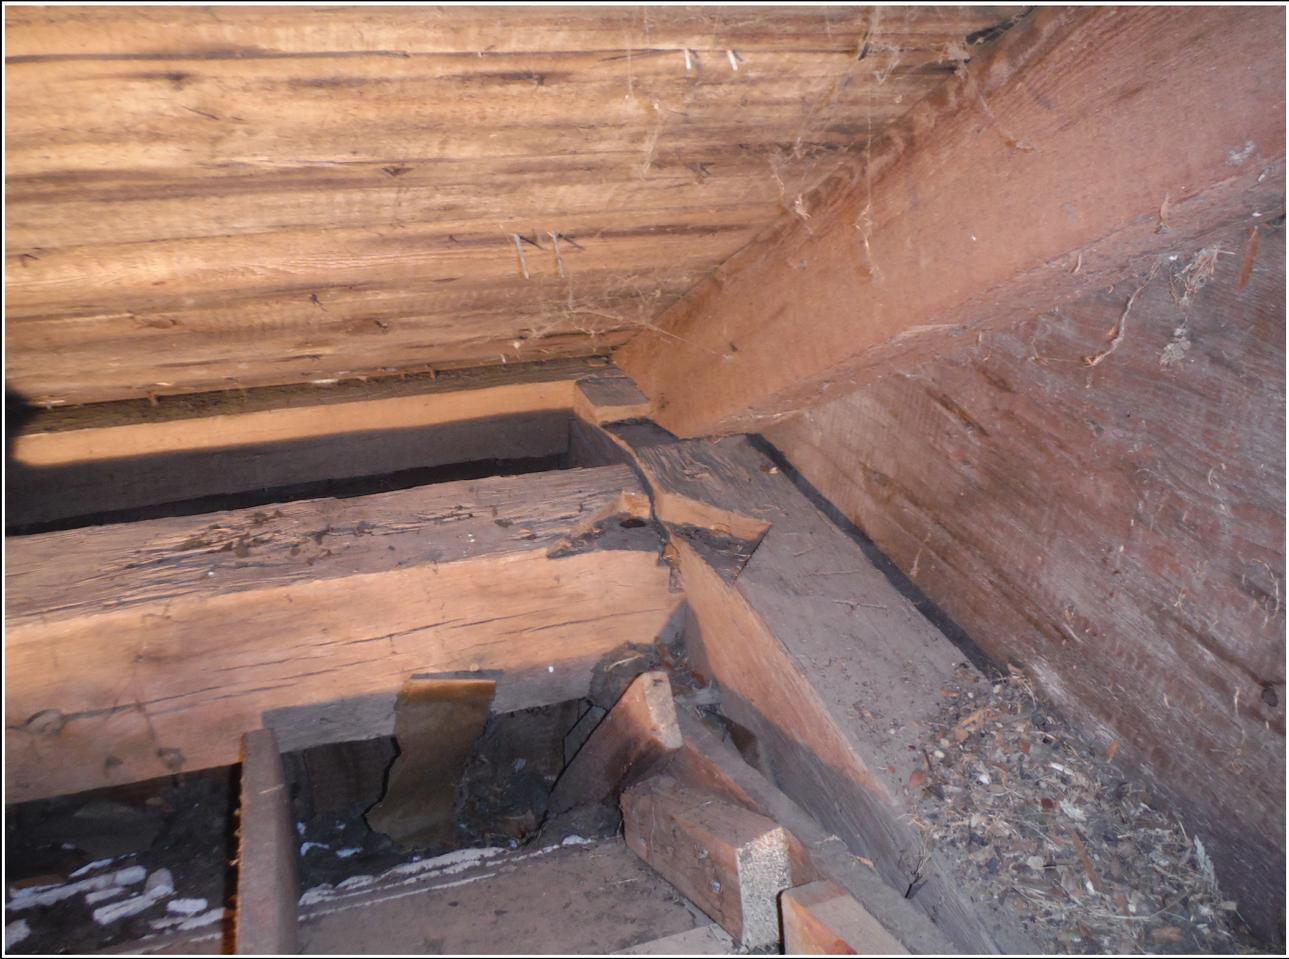
Clues to the original roof shape were present at the corners where the footings for corner rafters, consistent with those used for a hipped or gabled roof, were found (**Figure 1**). The installation of the original roof apparently began at the northwest corner where a drawing was found that represented the original carpenter's calculations of the angles needed for these corner rafters was found (**Figure 2**). Once the carpenter had calculated at this corner the correct angle needed, he then transferred that angle to the other corners. As a result, we did not find similar evidence of calculations at the other corners. Along the south and north sides of the top plate, what may be the footings for the original common rafters were found to have been reused in the 19<sup>th</sup> century as the footings for the present rafter system. We did not think of it at the time, but one of things that needs to be checked is to see if rafter pockets exist on the east and west sides. The framing system for a modern hipped roof includes rafters on all four sides. The original roof may have been of a lighter frame than the present one and could have consisted of only four corner rafters that were strengthened by the roof boards joining them, but some rafters would have needed to be present on at least the north and south sides.

Figure 1. Pocket for original hip roof corner rafter

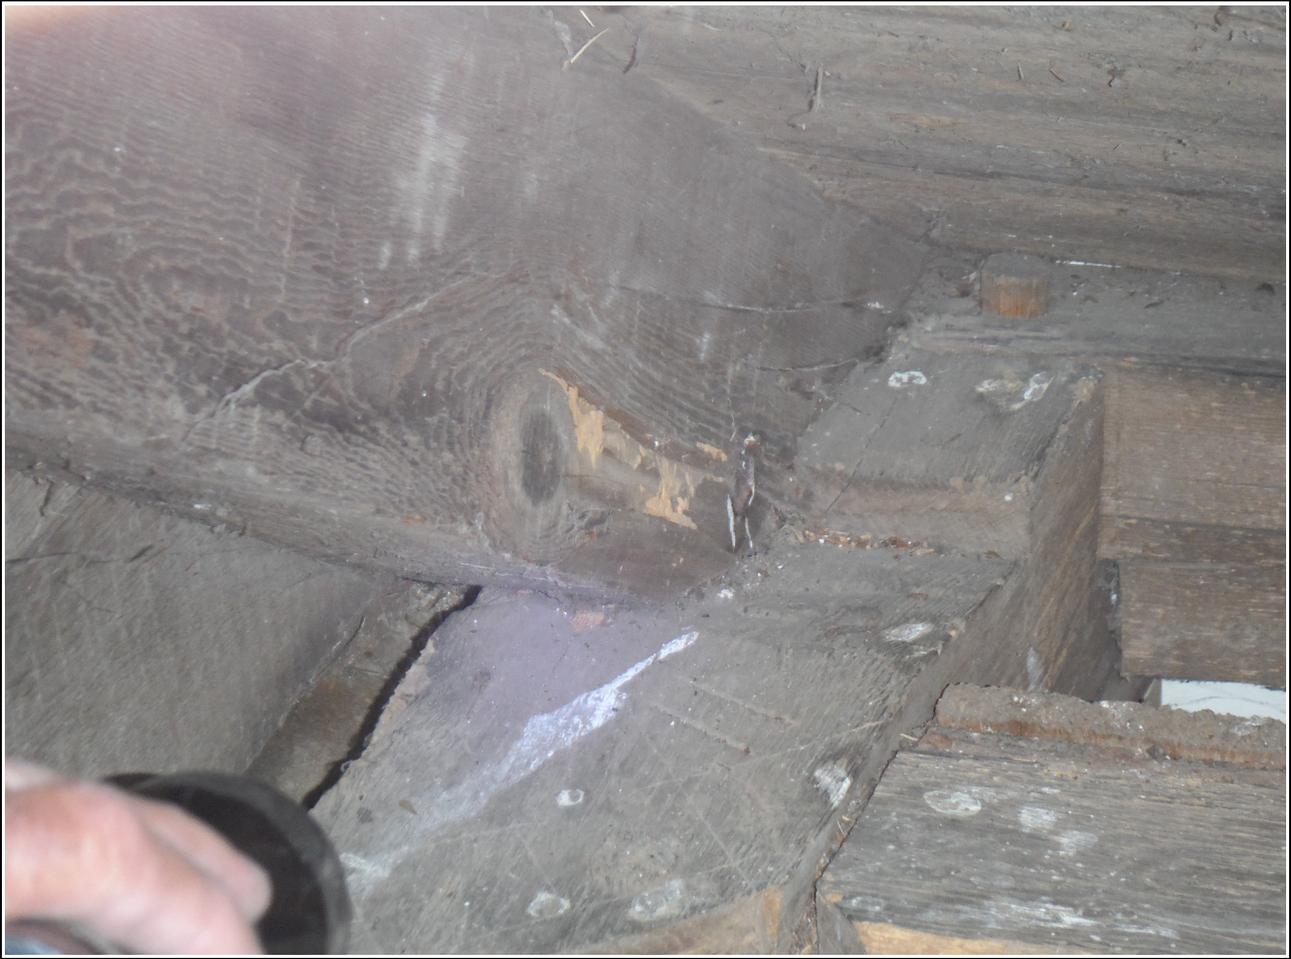
Figure 2. Carpenter drawing in attic at NW corner

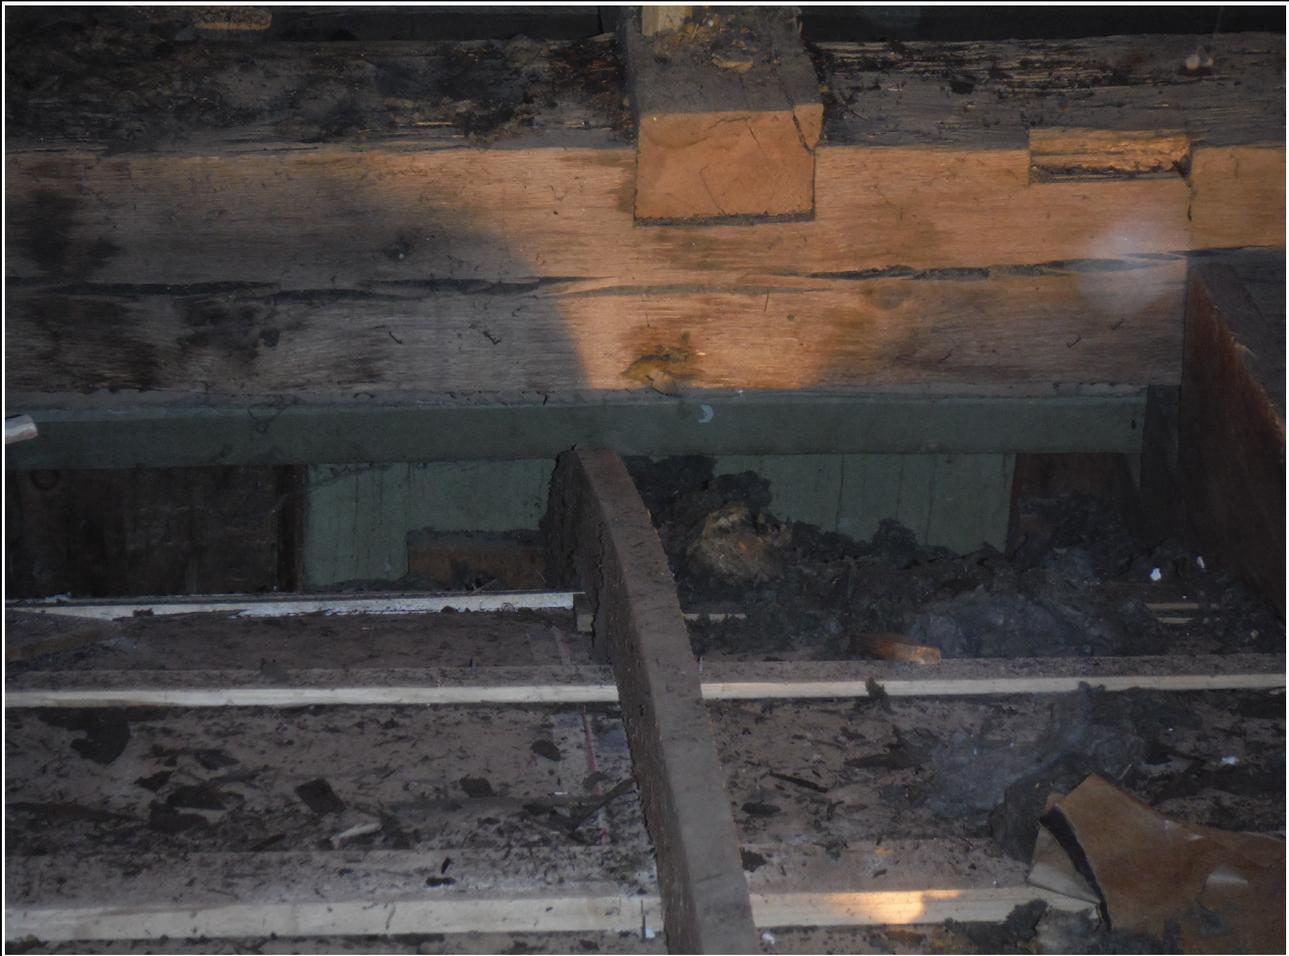
Evidence of what looks like a classic 18<sup>th</sup> century soffit, the projecting cornice of the original building, were found on the north and south sides and it is hypothesized that it once encircled the roof. The original water sawn external sheathing of the building was visible along the north and south walls. The original plate appears to be white oak and is hewn while all of the 19<sup>th</sup> century rafters are water sawn. Some of the most interesting findings were pieces of what are interpreted as original interior paneling that had been reused as scantling to help support the 19<sup>th</sup> century vaulted ceiling and as patches along the south wall. The paneling appears to be 18<sup>th</sup> century in date and was put together with mortise and tenon construction. It bears traces of what may be the original paint, a light gray green, and originally was probably affixed around the interior of the court house to chair rail height, although it could have extended right up the walls (**Figure 3**). Some pieces may have been used for the court bench and docket.

Figure 3. 18<sup>th</sup> century paneling on south wall

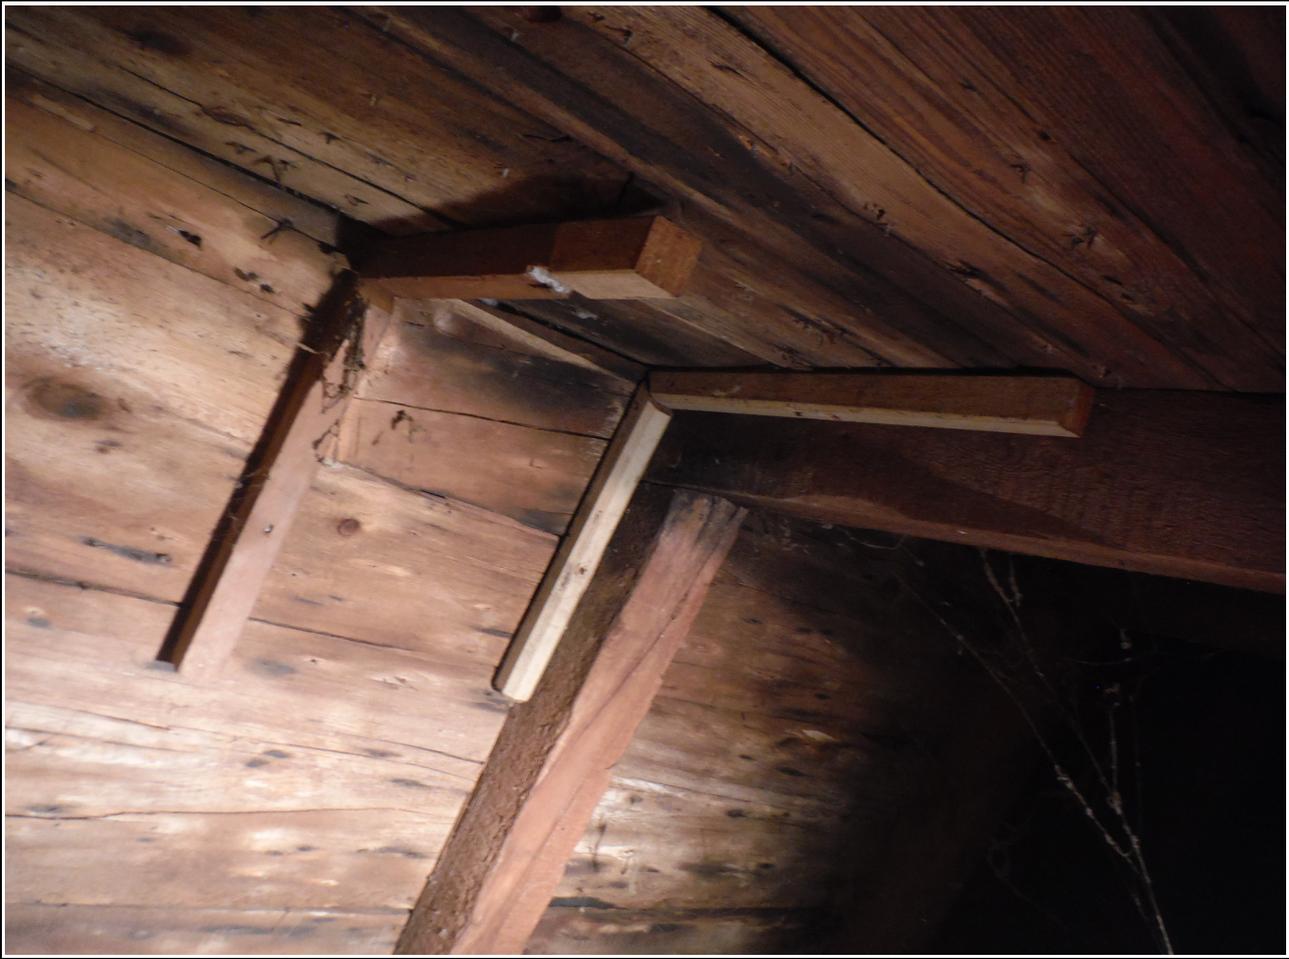
Close to the center of the building, between the two large 19<sup>th</sup> century trusses associated with the vaulted ceiling, is what appears to be a covered hole in the roof (**Figure 4**). A platform had been built beneath the hole using what appear to be reused stair risers (**Figure 5**). The roof hole and platform are conjectured to have been related either to a flagpole located at this point or simply to gain access to the roof for some other purpose.

Figure 4. Roof hole

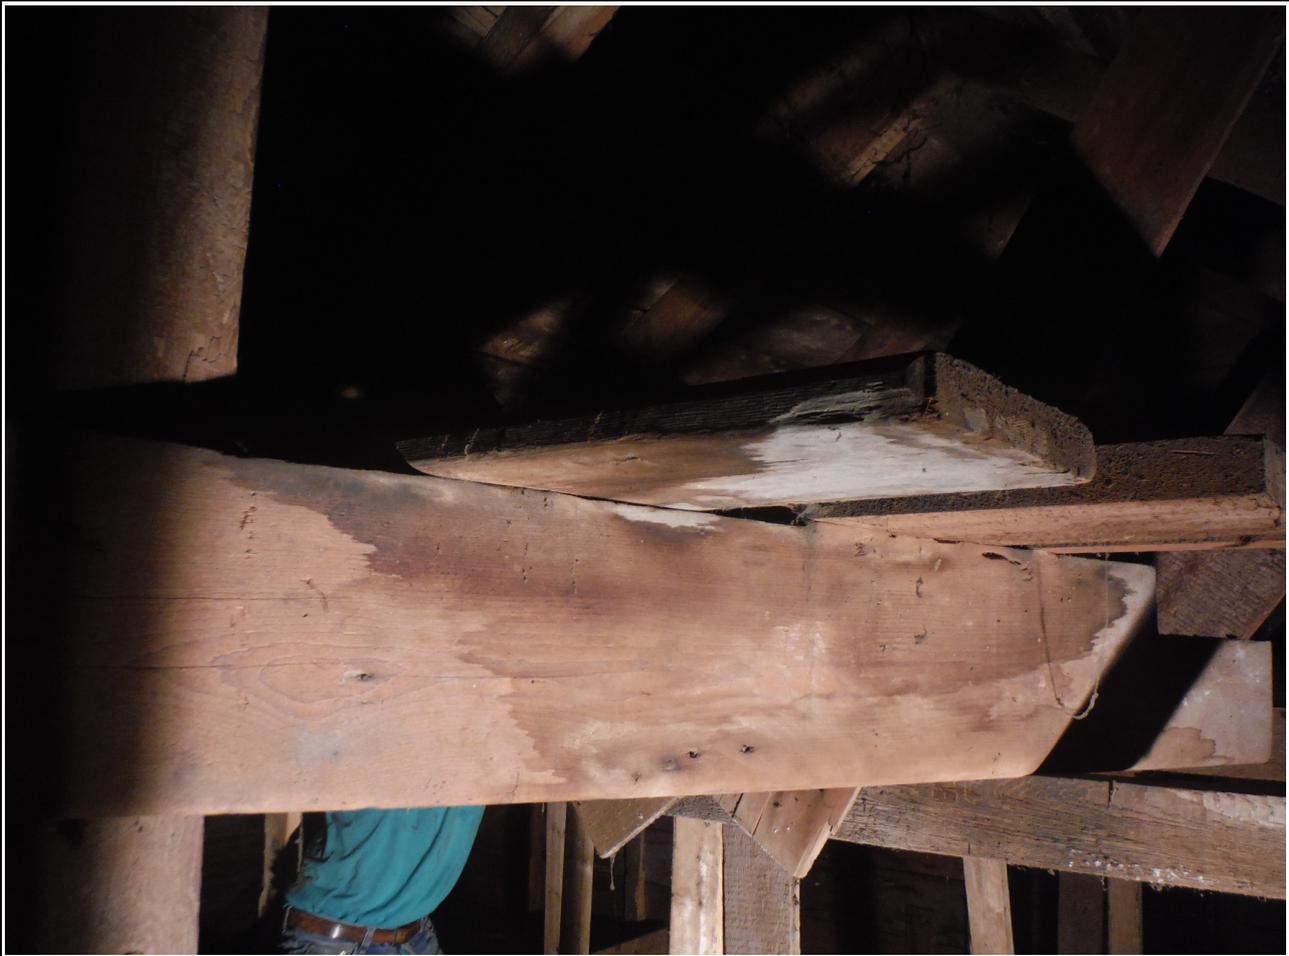
Figure 5. Platform made with reused risers beneath hole in roof

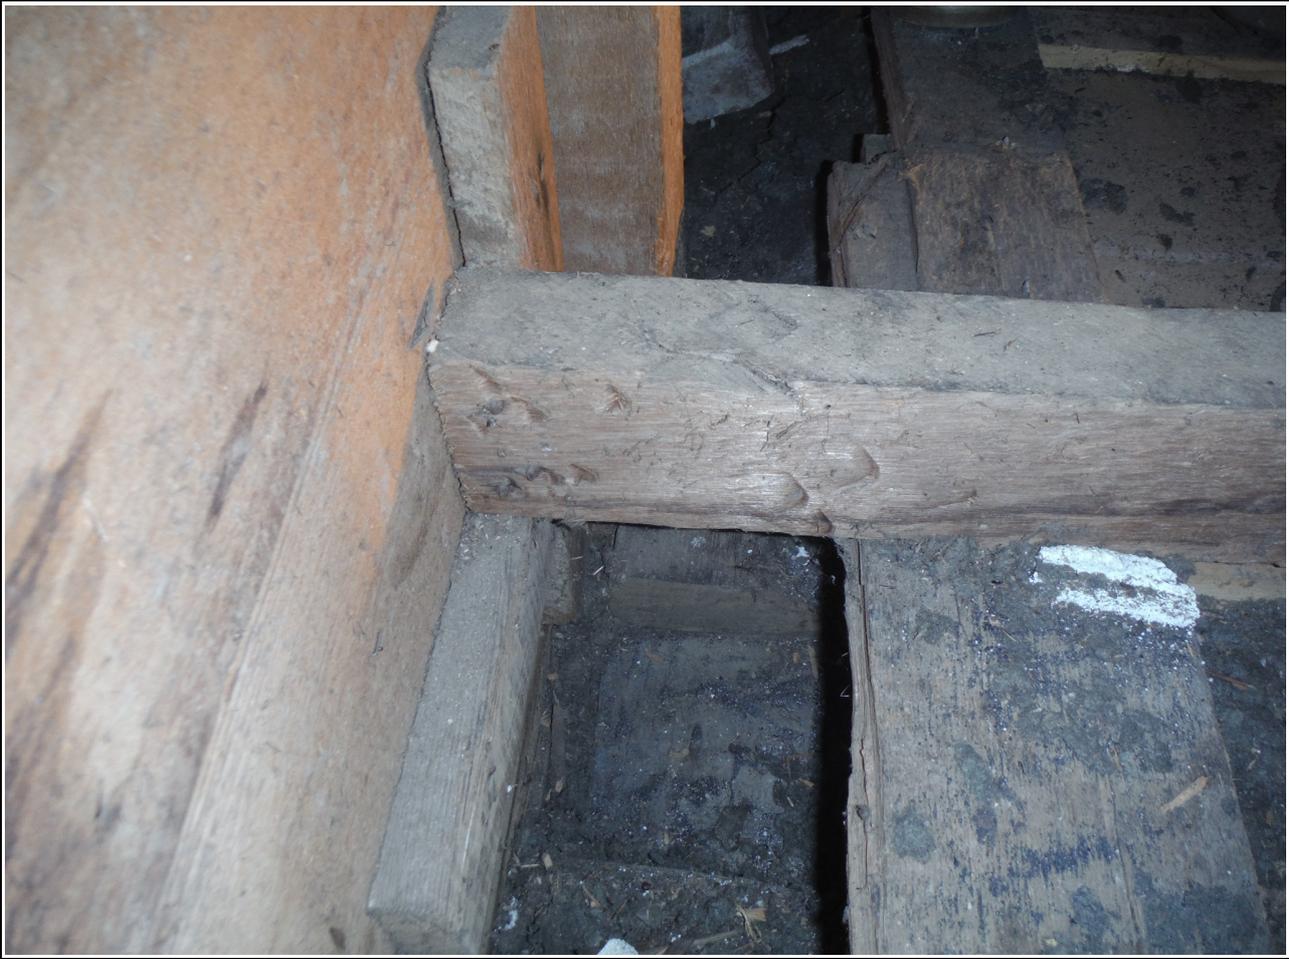
Large mortises for an east to west running girt were found at the center of the east and west tie beams (**Figure 6**). This beam was probably supported by pillars extending from the beam to the floor of the courthouse. The presence of this beam may indicate that the original ceiling was flat and probably plastered.

Figure 6. Girt mortise in attic

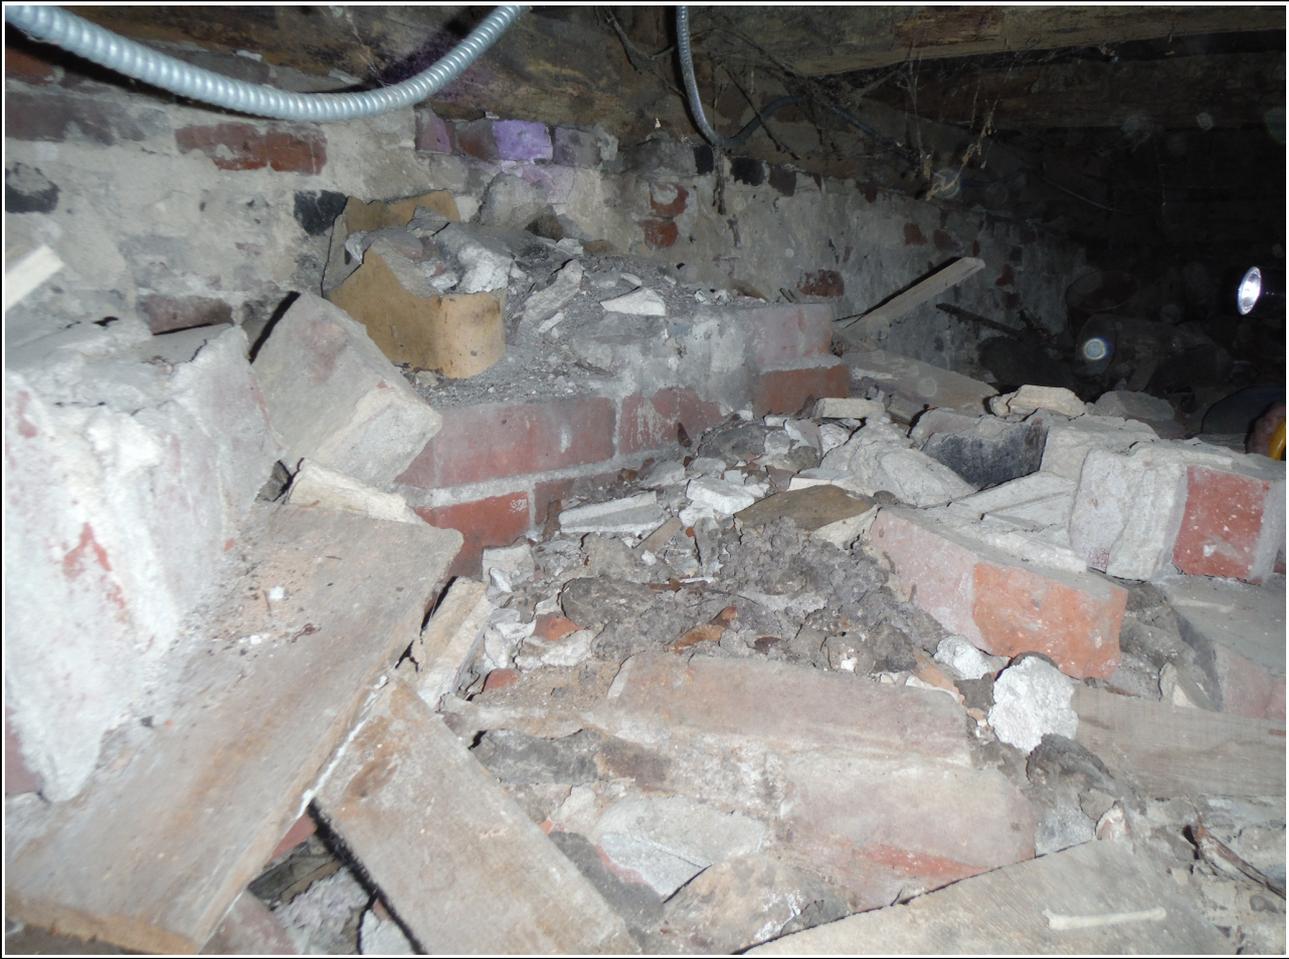
The crawlspace beneath the main portion of the building is accessed through a hole in the floor of the closet at the northwest corner of the main floor. The total depth of the crawl space was over two feet, making it very comfortable to crawl around in. The first thing noticed upon entering it was a collection of mid-19<sup>th</sup> century case bottles and pottery that is assumed to have been deposited here during the building's conversion from a court house to a Baptist church. These artifacts were just below and to the south of the access hole. The foundation for a late 19<sup>th</sup> to 20<sup>th</sup> century chimney were visible south of the entry hole along the west wall (**Figure 7**). The base of the prick post in the center of the west wall was also visible. No evidence of an 18<sup>th</sup> century chimney was found.

Figure 7. 20<sup>th</sup> century chimney base in crawlspace

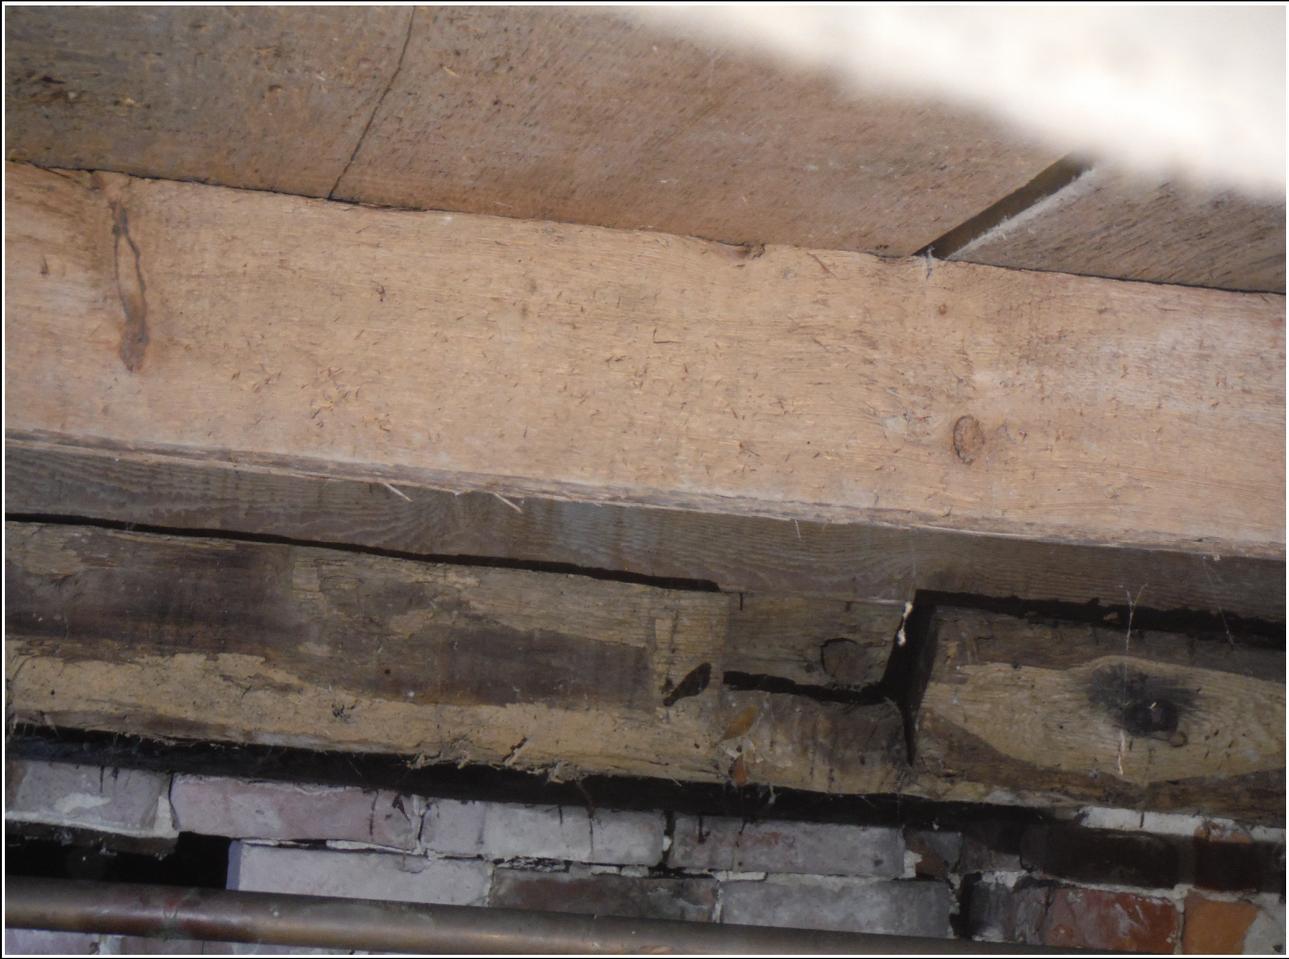
The original floor appears to have been supported by half round white oak joists that originally ran north to south, as joist pockets are present along the north and south sills (**Figure 8**). The orientation of the joists was possibly flipped in the 19<sup>th</sup> century so that it ran east to west with the joists resting on top of the east and west sills and added white pine sleepers that ran north to south. The joists rested on top of the original sill. What may be original east to west running sleepers were positioned near the 19<sup>th</sup> century joists. The sleepers had “ship knee” reinforcements that were joined to the sill along the walls (**Figure 9**). These ship knees were white oak and were secured with iron pins to the sill and the sleepers. At various points the sleepers and joists were supported by stones and vertical timbers. Ship knees were present along the south wall.

Figure 8. Original joist pocket in south sill

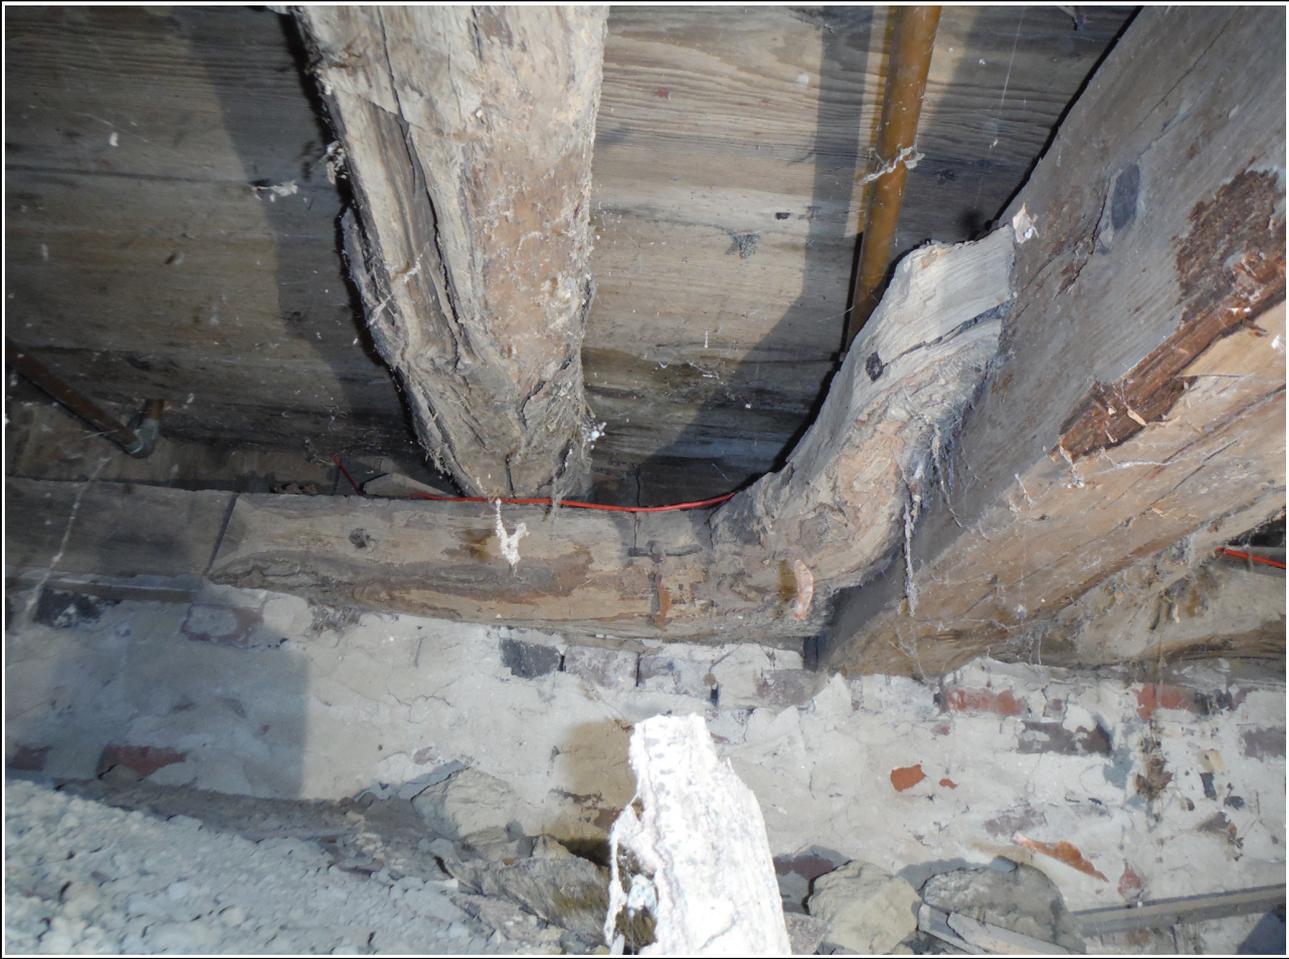
Figure 9. White oak ship's knee brace
