## Introduction

Archaeological and architectural investigations at the Sturgis Library were carried out in the spring and summer of 2014. The initial purpose of the investigation was to evaluate the potential for any archaeological remains relating to the Reverend John Lothrop occupation being present beneath or to the immediate east or north of the oldest part of the library. As a way of understanding what was being found under the house, the investigation was extended to include an architectural analysis of the substructure and the attic. Subsequent excavations were carried out on the south lawn of the library. Architectural investigations found extensive evidence of reuse of older architectural elements in renovations that had been made to the building during its life as well as the discovery of previously unknown architectural elements and details. Archaeological investigation found evidence of late seventeenth to nineteenth century refuse disposal and architectural demolition beneath the building and limited, but significant, deposits of earlier seventeenth century refuse disposal on the south lawn.

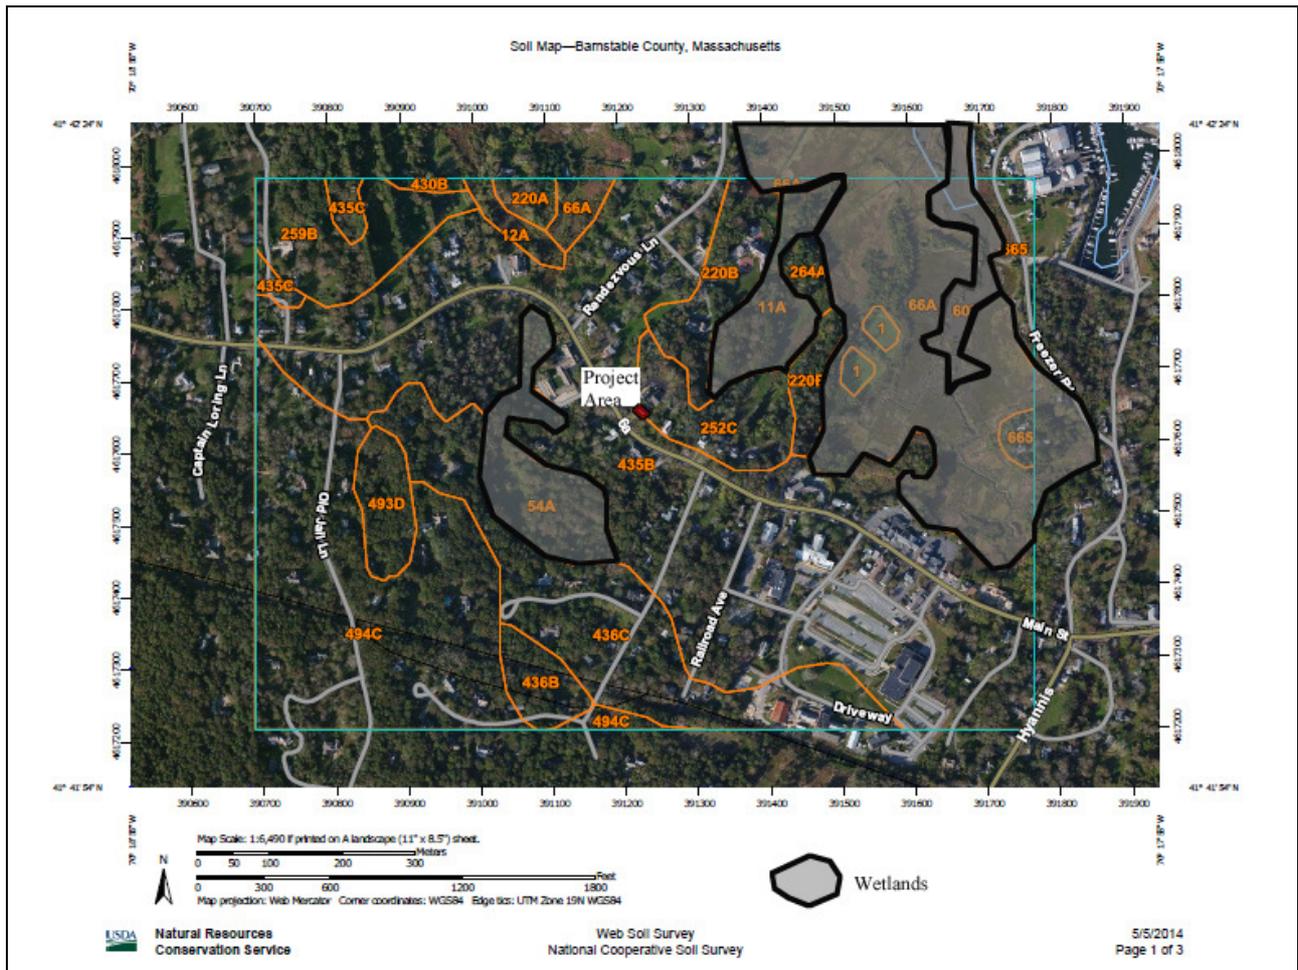
Figure 2. Soils and wetlands present in and around the project area

Initially it was believed that only two soils are present in the project area: Carver coarse sand and Plymouth loamy coarse sand (**Figure 2**). The Carver coarse sand is present in the east, west and north yards while the Plymouth loamy coarse sand is present in the south yard. Carver coarse sand is glaciofluvial (deposited by water coming off of the glaciers) and is commonly present on outwash plains and moraines. These soils are excessively well-drained and probably supported forests of white and scrub pine in the past. The soil profile is as follows:

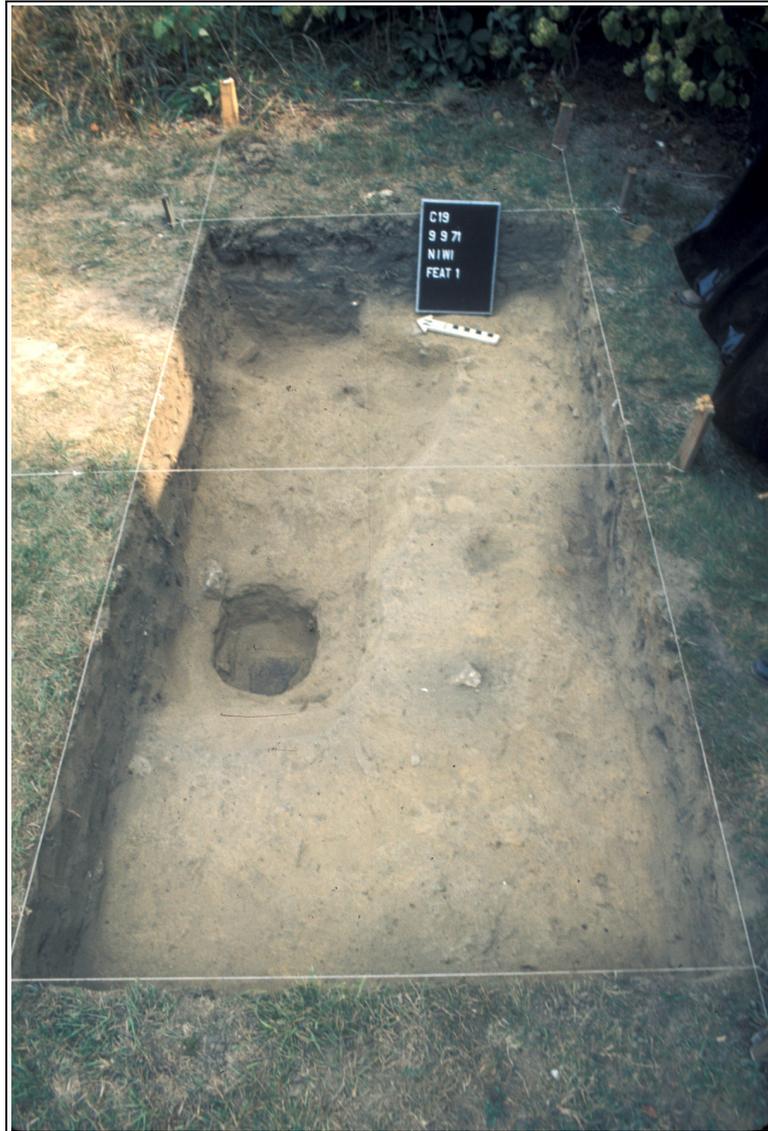
Figure 8. Plimoth Plantation 1971 testing (Test Unit 3 post hole)

Test Pit 3 (TP3) was located in the west yard adjacent to the west side of the library's northwestern extension. This unit encountered what appears to be a post hole and post mold set into the subsoil. This unit was subsequently extended by one unit to the south. No other features were encountered. TP 3 was subsequently renamed unit N1W1 and a eight square east to west by two square north to south grid was established in the area, presumably to search for other post holes. Subsequent excavations appear to have failed to encounter any other post holes. The post hole found is most probably related to either an out building or more likely a fenceline. No artifacts are on record as having been found and it is probable that nothing significant was found.

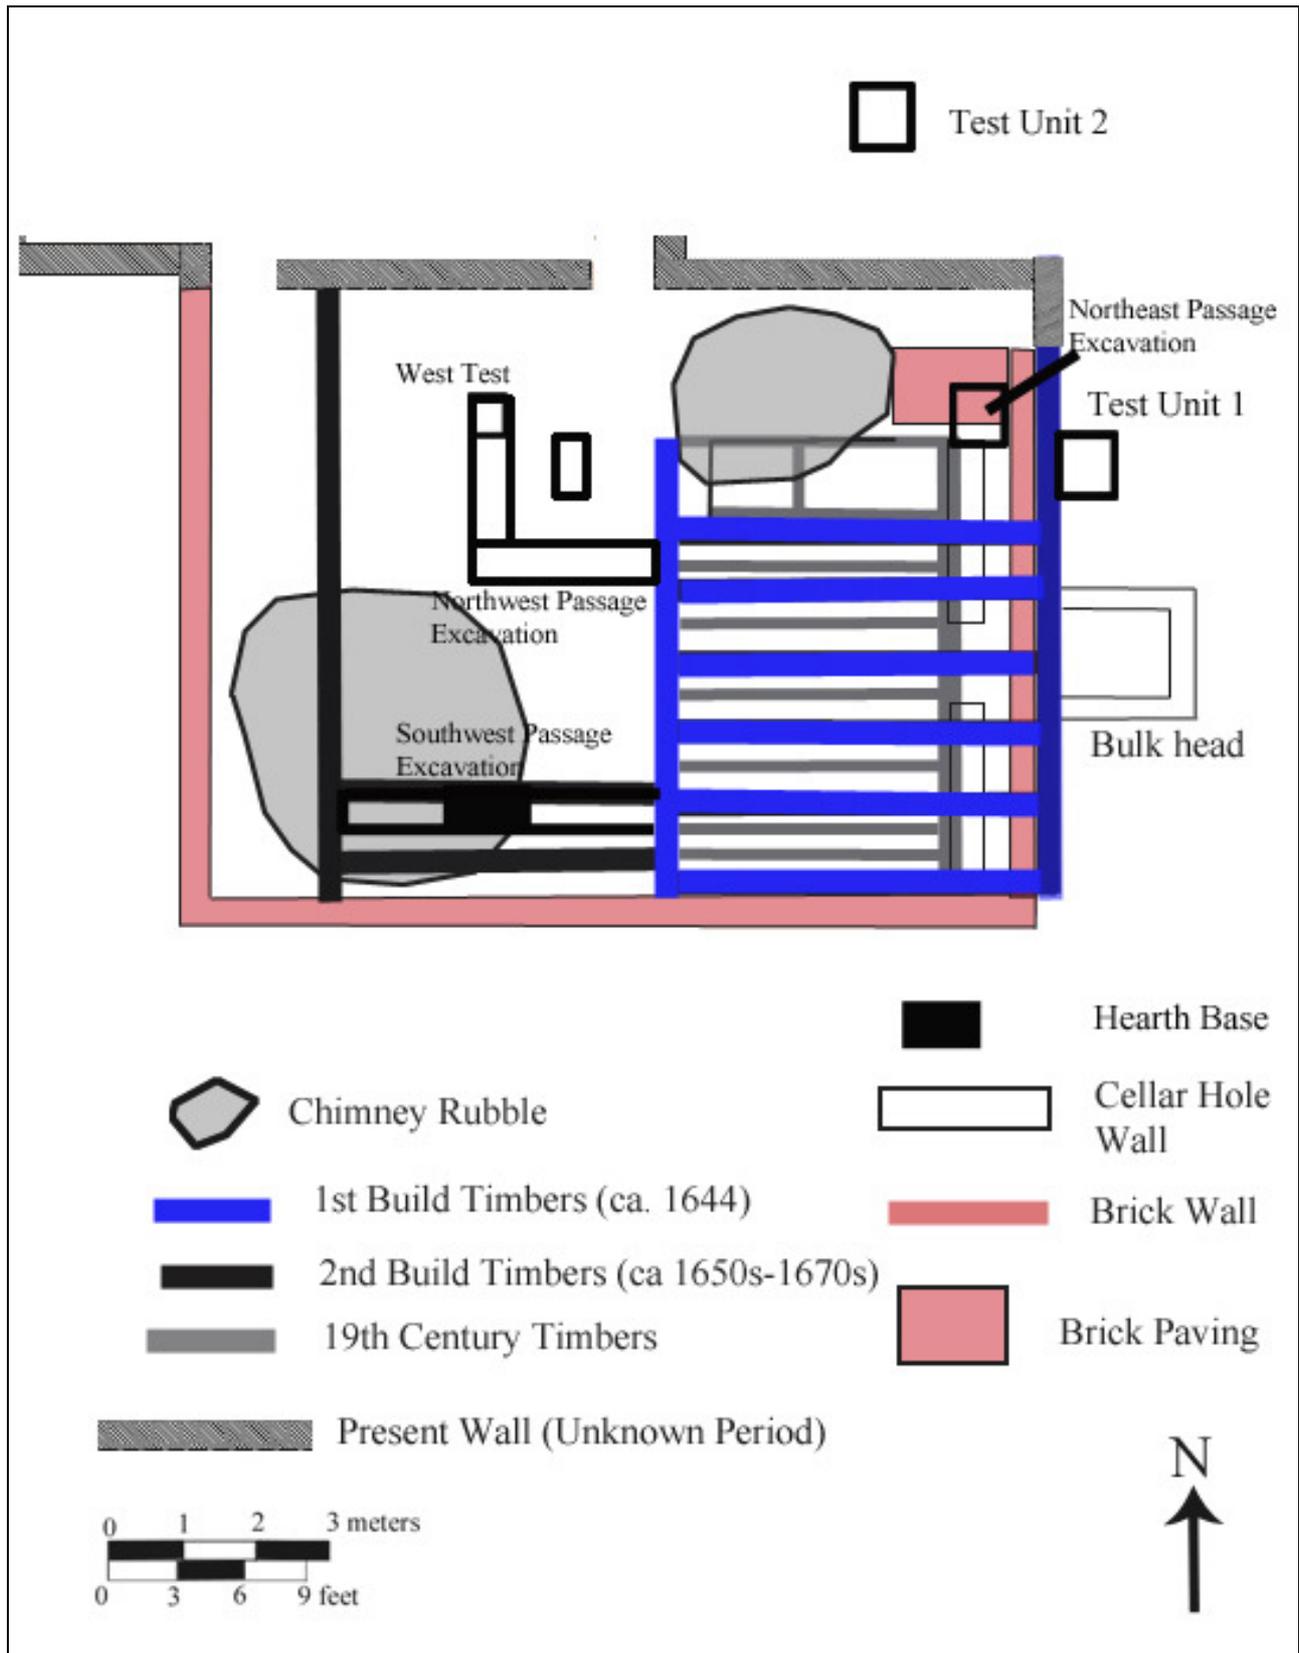
Figure 11. Excavation beneath the library

The first unit excavated beneath the house was in the crawl space excavated north of the northeastern corner of the cellar hole so that various utilities could be run beneath the building (**Figure 11**). In this area, an approximately 20-35 cm thick layer of clay and mortar was found overlaying a horizontally placed layer of bricks that measured 1.4 x 1.4 meters (4.5 x 4.5 feet). The bricks in turn rested on what appeared to be an old intact ground surface (**Figure 12**).

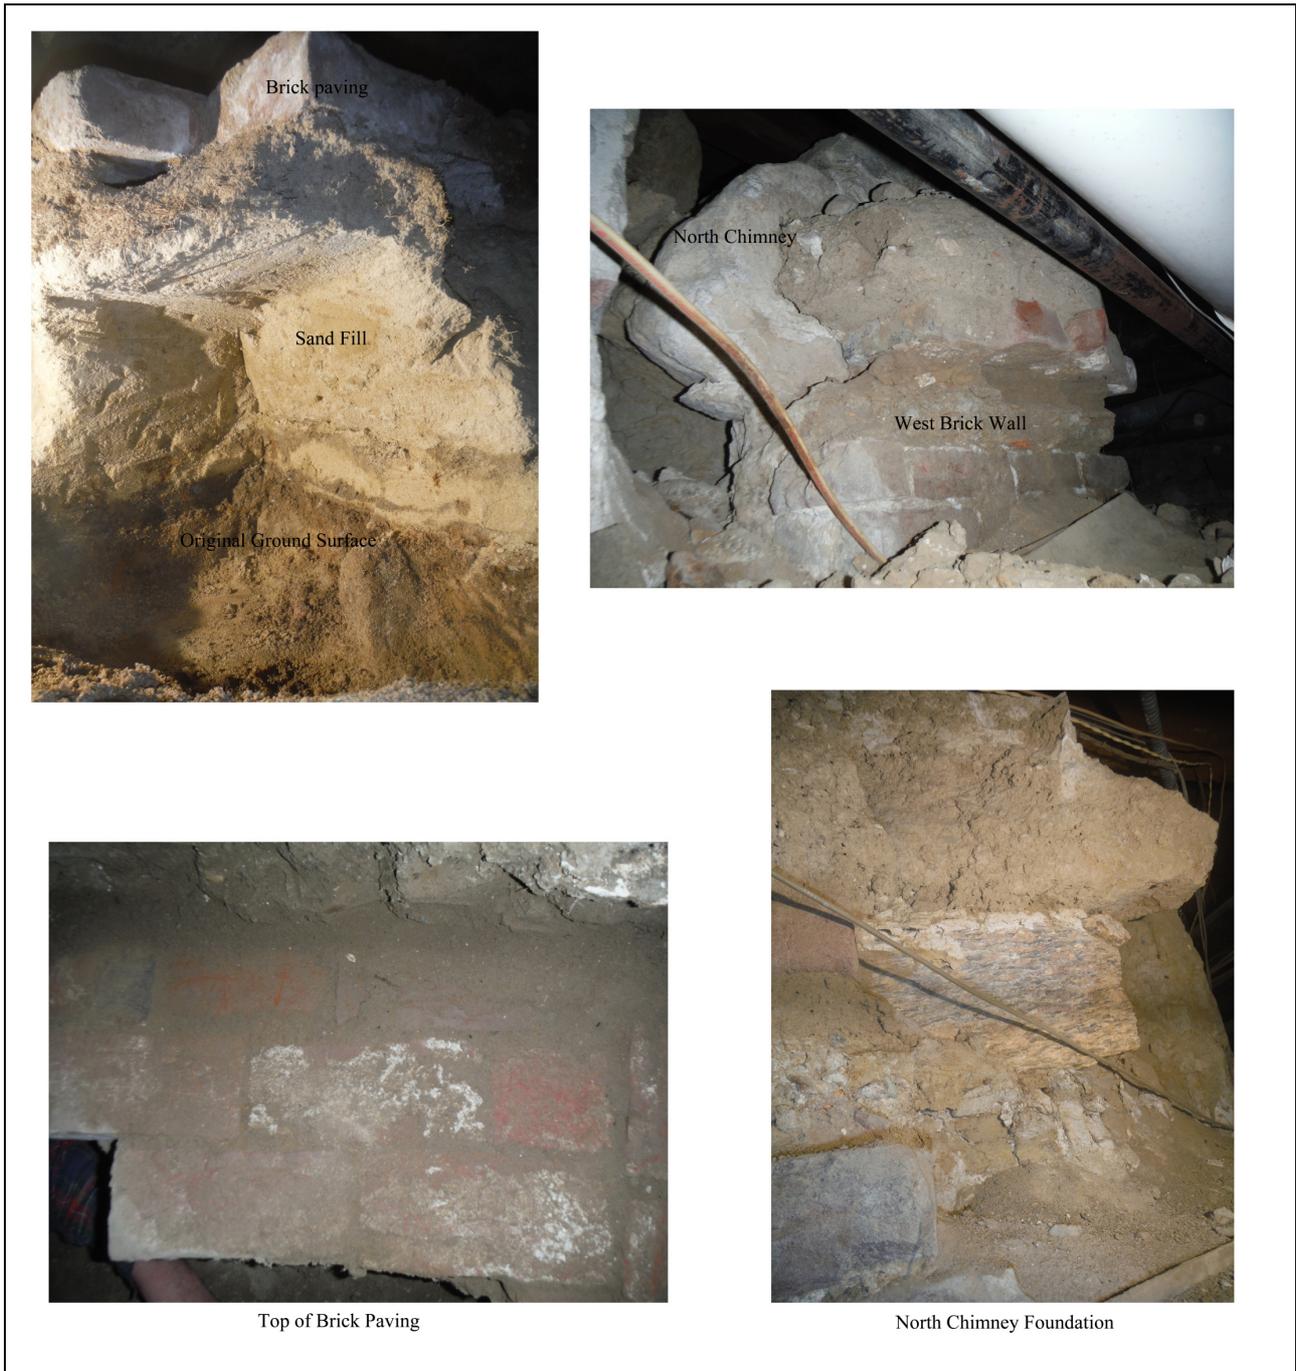
Figure 12. Stratigraphy in the northeast passage of cellar

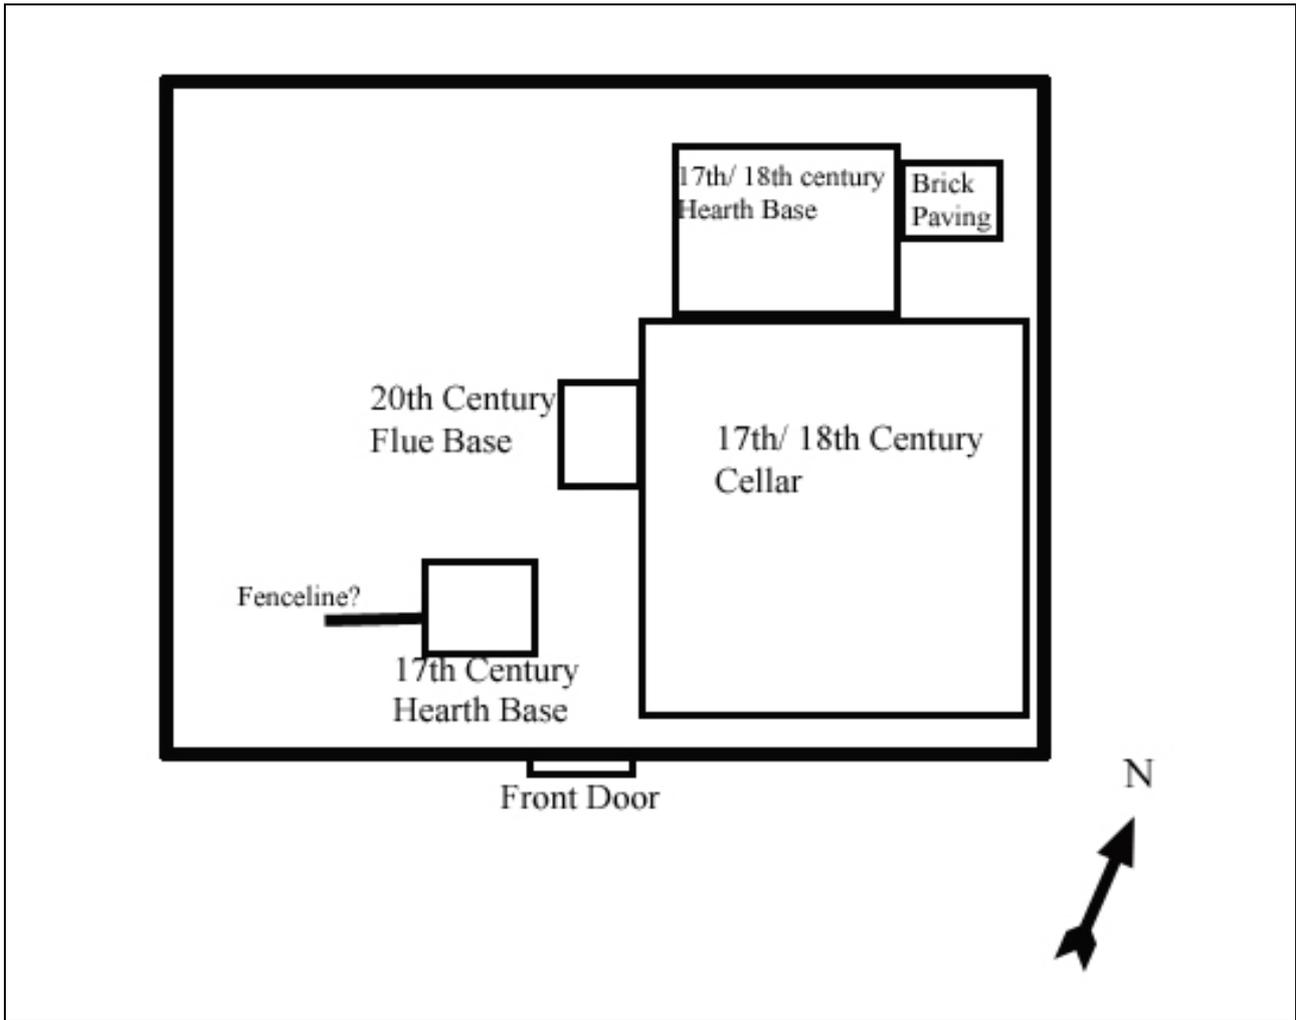
Figure 13. Location of features found beneath the Sturgis Library

Excavation of the area revealed that an intact brick foundation lay to the immediate west of the present eastern foundation and that a space of approximately 30 cm separated this brick foundation from the current eastern cellar wall (**Figure 13**). The horizontal brickwork extends from the brick foundation west to what appears to be a chimney stack base (**Figure 13**). The base is composed of split and natural granite pieces with a thick layer of clay being present on the south side. The chimney base extends into the cellar approximately 30-50 cm south. This base is believed to date to the 17<sup>th</sup> to early 18<sup>th</sup> centuries when the single cell house was expanded to a full two story salt box style. This chimney would have supported a kitchen hearth and possibly a bake oven.

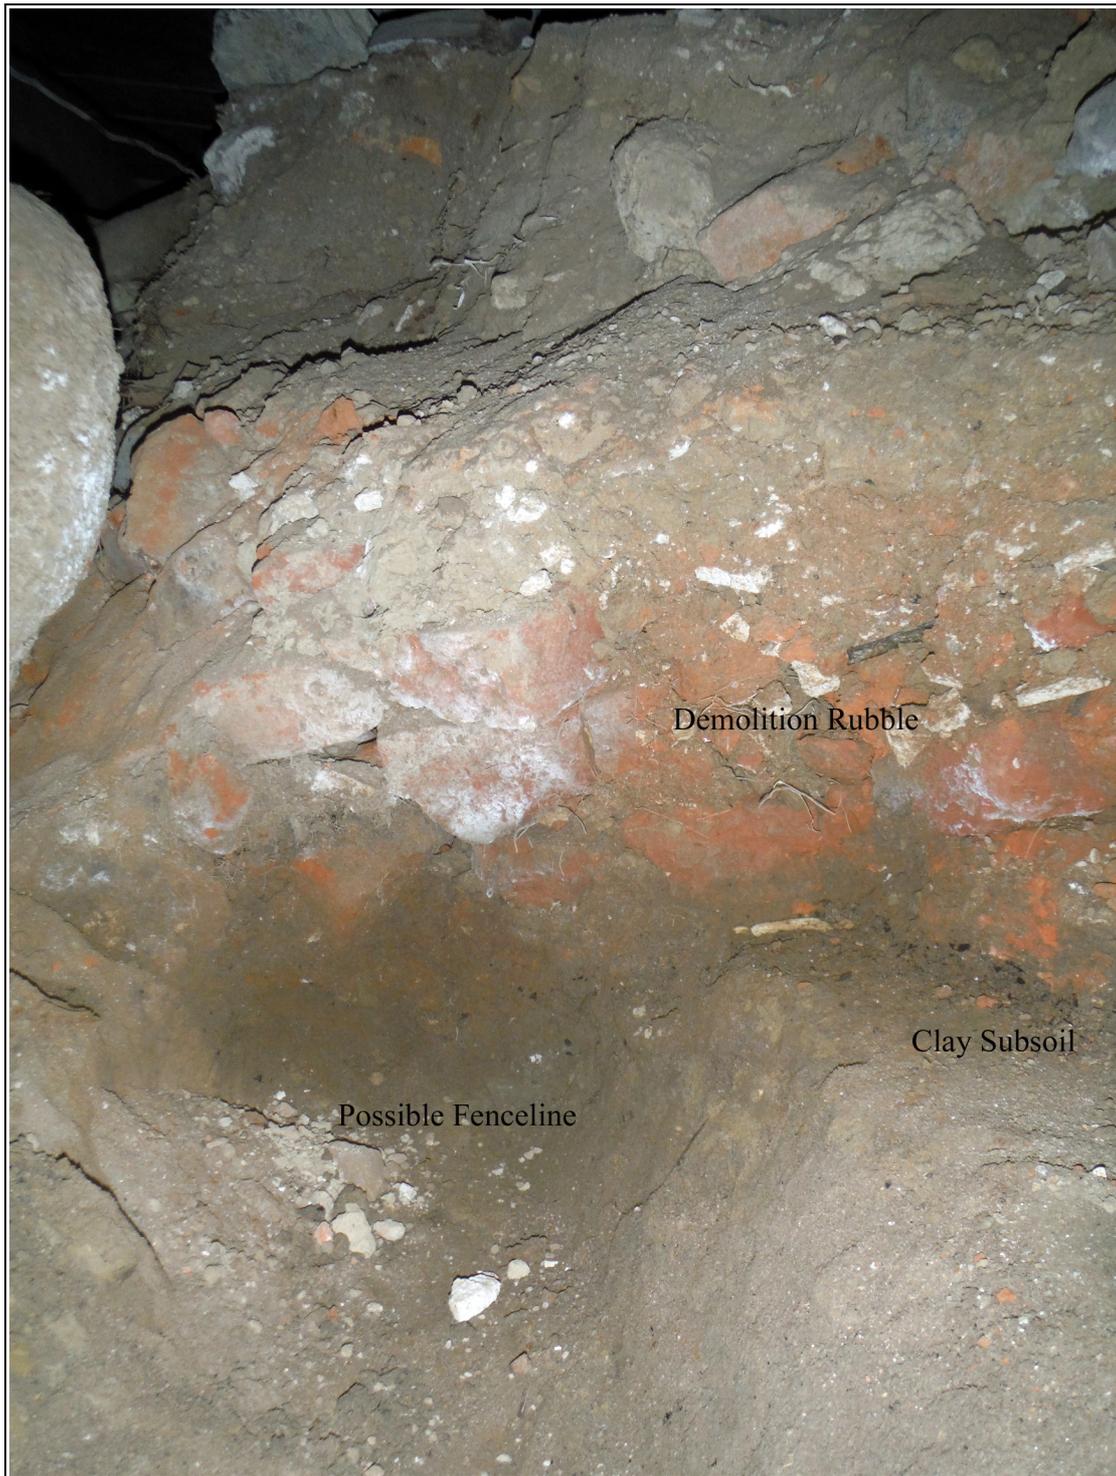
Figure 14. Possible fenceline feature in southwest passage of cellar

Excavation resumed at the extreme western edge of the southwest passage on August 11, 2014. The main discovery of this excavation was a 30 cm north to south by at least 35 cm east to west by 10 cm deep square sided trench that had been cut into the clay floor before the chimney base was erected. This was located directly west of the stone concentration and appeared to end at the stones to the east. It continued to the west under the existing demolition rubble. No brick was found in the fill indicating it was created before the heavy brick, mortar and clay rubble layer was laid down. It is possible that it represents the bottom of a slot trench fenceline that ended at the west wall of the original house. When the house was expanded the fence was removed and the trench filled, then when the central chimney was demolished the rubble piled up on top of the former fenceline (**Figure 14**). The remnants of the trench were found to start at 70 cm below the bottom of the floor joist.

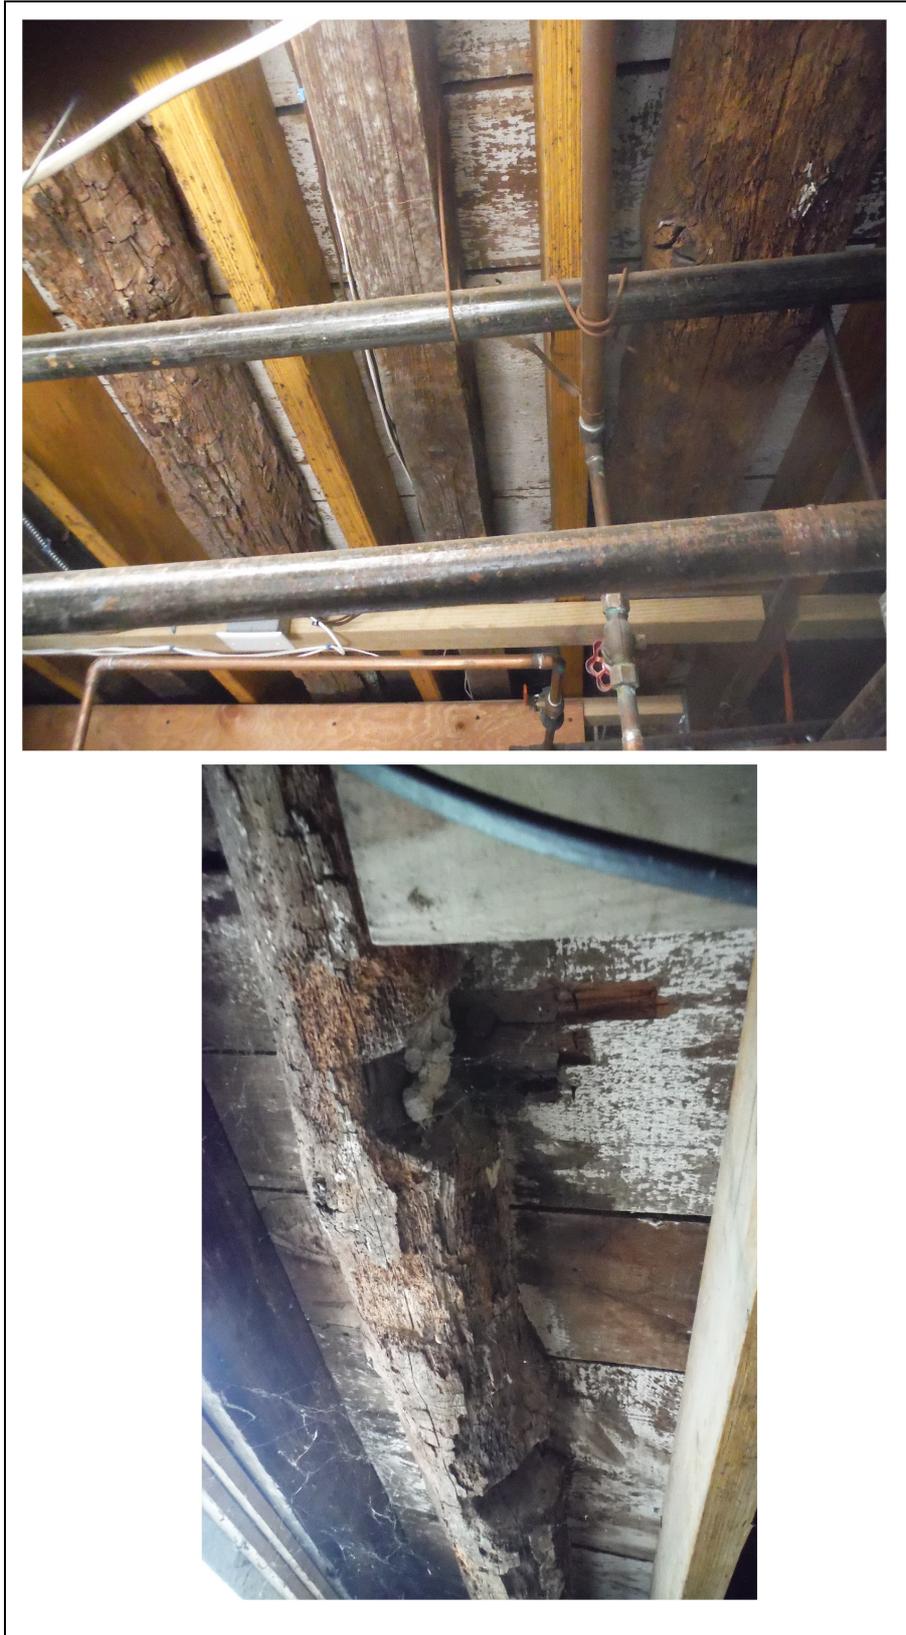
Figure 15. Joists and southern sill with notches in cellar

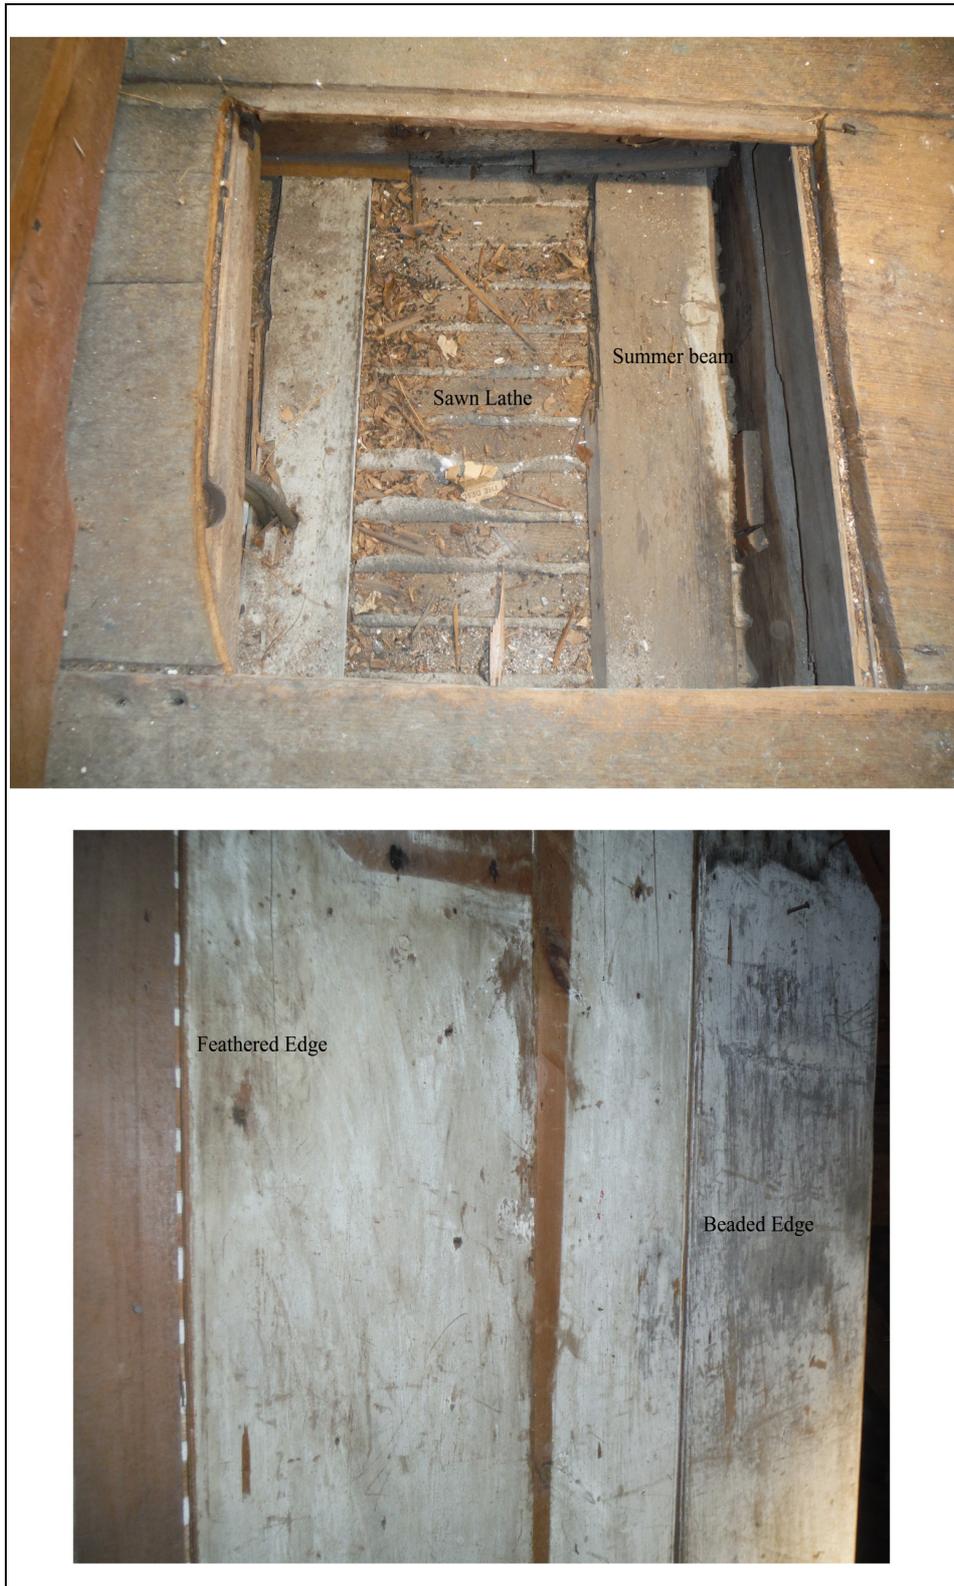
Figure 16. East gable room

A loose floorboard was removed in the northern half of the room, exposing a white oak summer beam in the middle to western portion of the room in excellent shape with hew marks still sharply visible (**Figure 16**). This beam is located in what is now the staff break room on the second floor, directly above the Lothrop room. The beam has been boxed in in the break room. Nineteenth century sawn lathe has been used to hold up the plaster ceiling in this portion of the house. One of the pieces of strapping used to support the lathe appears to be a reused piece of 17<sup>th</sup> century weatherboard or paneling. The floorboards in the room have been affixed with late 18<sup>th</sup> to early 19<sup>th</sup> century T-headed nails and light green paint is present on some of the boards, which is possible evidence of reuse. A second reused summer beam was identified along the eastern wall. This beam appears to have been reused as a tie beam along that wall. A piece of black painted 17<sup>th</sup> century floor joist has been reused here as well. A piece of what looks like a roof rafter has been reused as a portion of this tie beam as well.

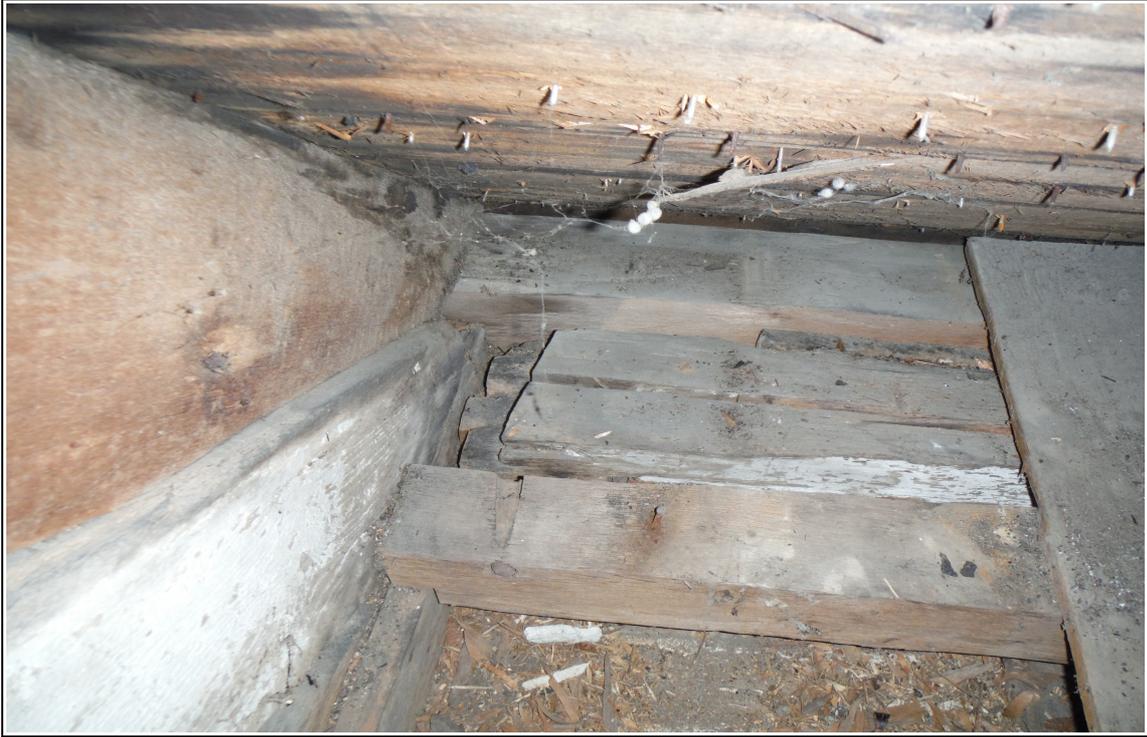
Figure 18. Front plate/ reused tie beam

The mortise for a tie beam is located at the south end of the rafter. The white oak end girt on the south side of the house appears to be the reused tie beam that originally was present on the west gable of Reverend Lothrop's house. The gable measured at least 21 feet long and the southern room as whitewashed while the northern room was not. This was a common practice. The best rooms, the rooms that people would be entertained in, would be whitewashed while the auxiliary/ support rooms at the north end of the house, would not be whitewashed. The whitewash was found to extend approximately 16-18 feet along the front plate, a dimension that matches the depth of the Lothrop room (**Figure 18**). This plate/ tie beam measures 6 x 6.5". It appears that when the house was expanded from its original form, most of the building was taken apart and reused in the new building. Vertical pine sheathing boards are present below the apex of the rafter while reused sheathing boards are placed horizontally above and to the north of it. Clapboard nail holes are present on the horizontal boards. the nail holes are spaced at an average distance of 4.25" with a range of 3-5". Cream yellow paint is present on one of the boards.

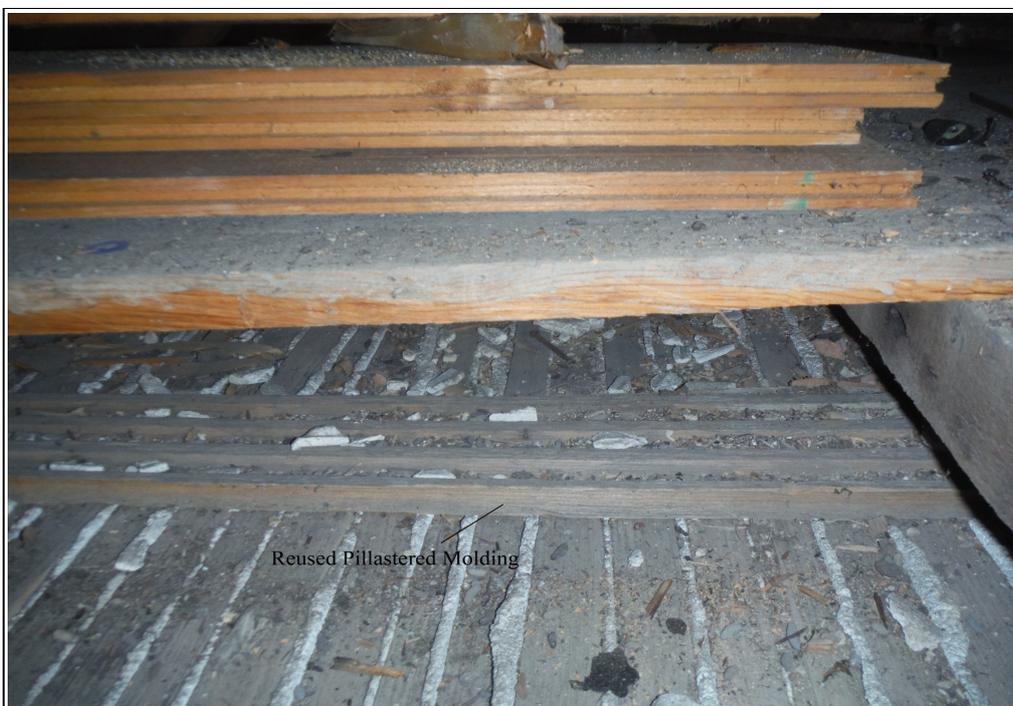
Figure 22. Reused pillastered molding

The odd scarfing that had been identified earlier was found to be the result of the reuse of roof rafters as floor joists. When boards were removed along the south wall, a very well preserved late 17<sup>th</sup> century plastered wall was found to be hidden behind the 19<sup>th</sup> century extant wall visible on the second floor. This is in the second floor's southeaster corner room, the same room that has riven lathe being used on the plaster ceiling. Nineteenth century sawn lathe is present in the room to the west of this room. The 17<sup>th</sup> century wall ends at the corner post at the southwestern end of the room. the post has not been whitewashed and still retains bark on the west side. Beneath the attic flooring a piece of very weathered possibly 17<sup>th</sup> or 18<sup>th</sup> century pillastered front door molding was found to have been reused as strapping to attached the ceiling lathe to in the southeast room (**Figure 22**).

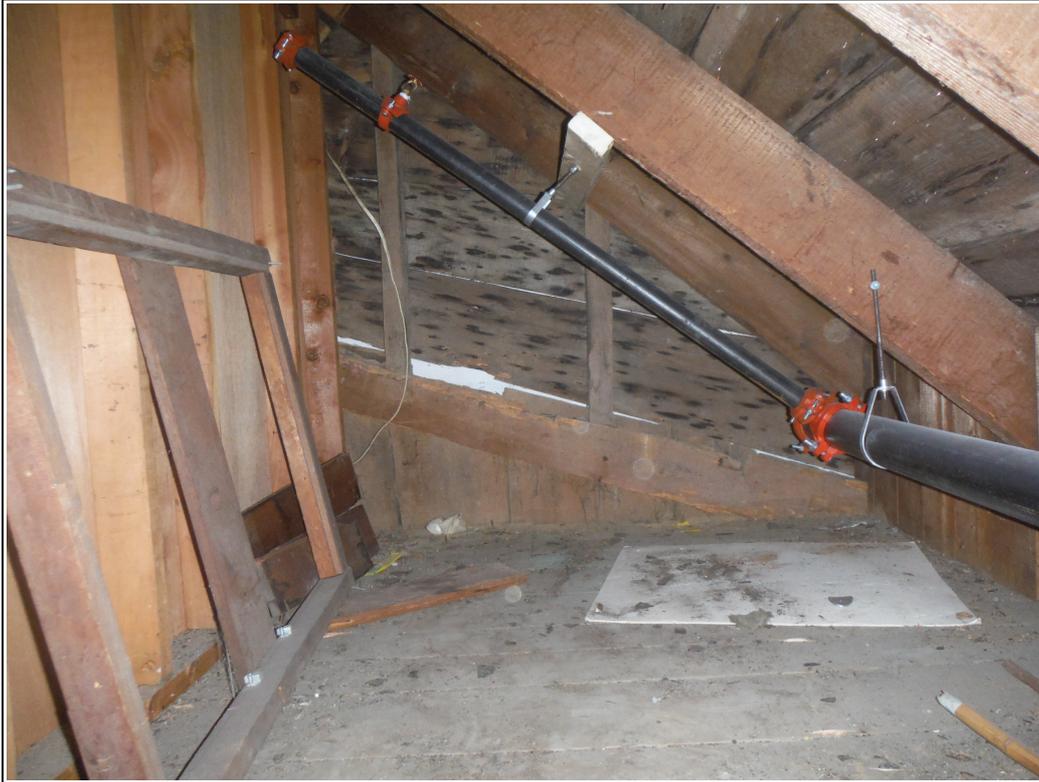
Figure 27. Salt box principle rafter

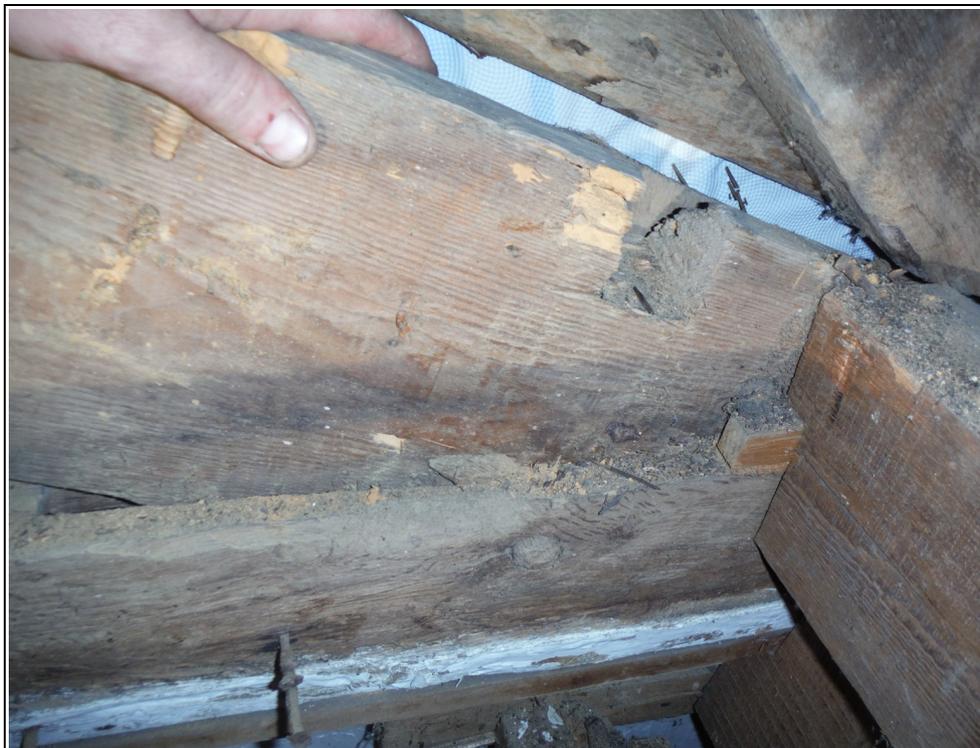
Figure 28. Joining of salt box rafter and tie beam

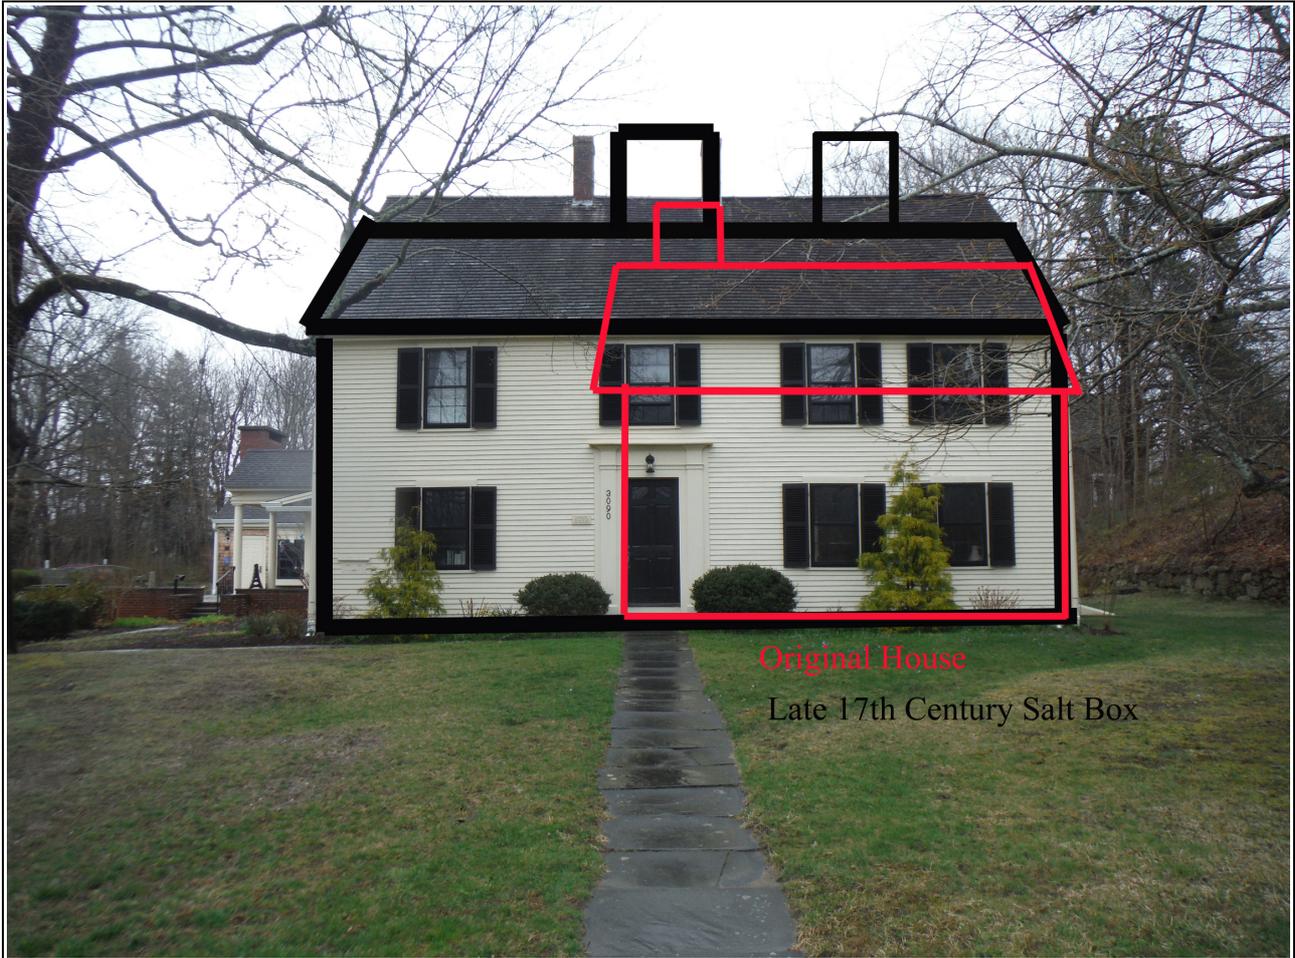
Original House  
Late 17th Century Salt Box

Figure 33. Front view of Sturgis Library showing hypothesized extent of original house

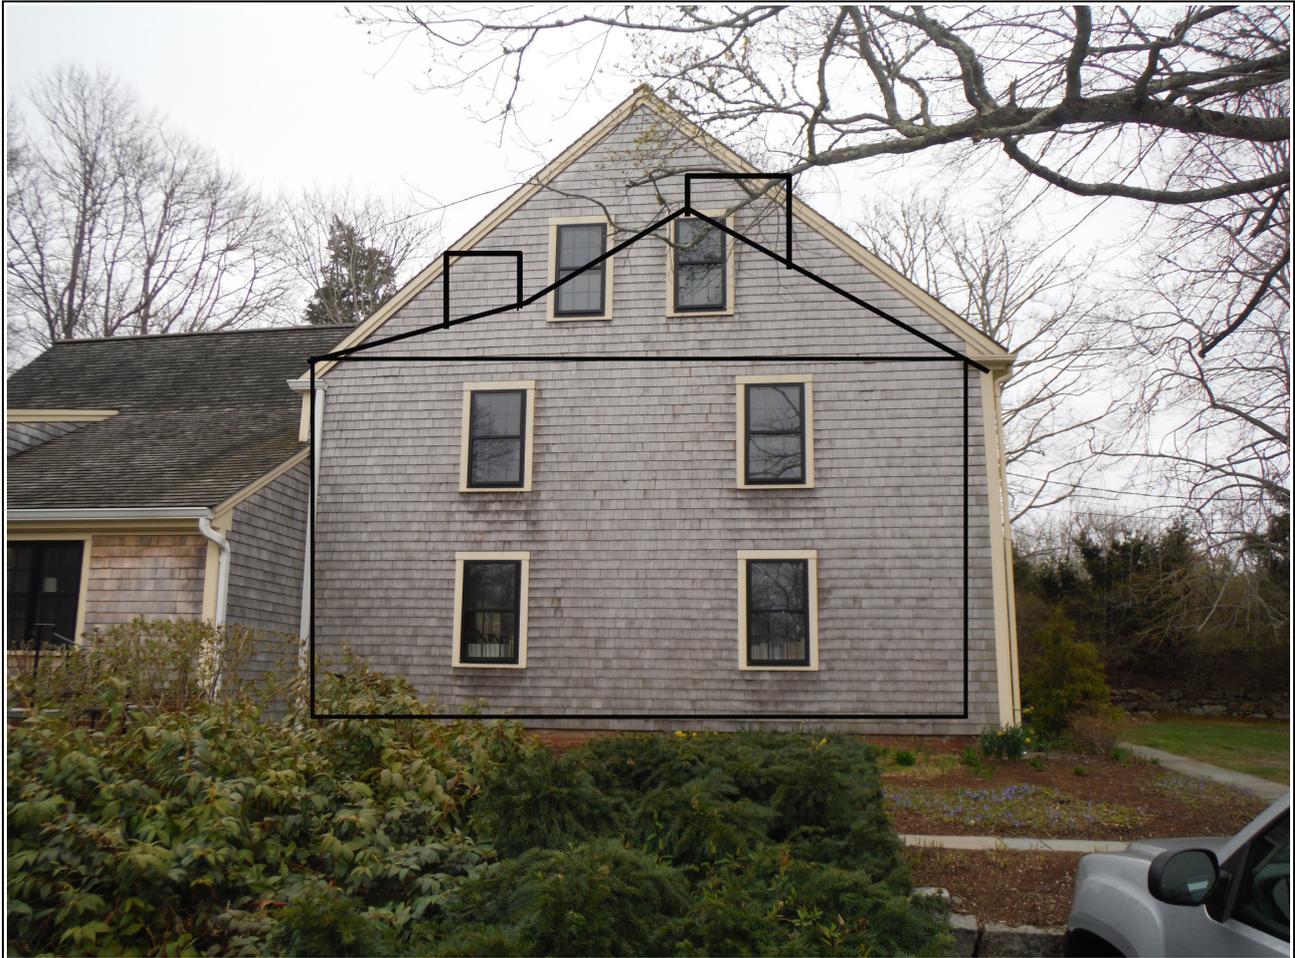
Figure 34. Western gable view of the Sturgis Library showing hypothesized salt box roof line

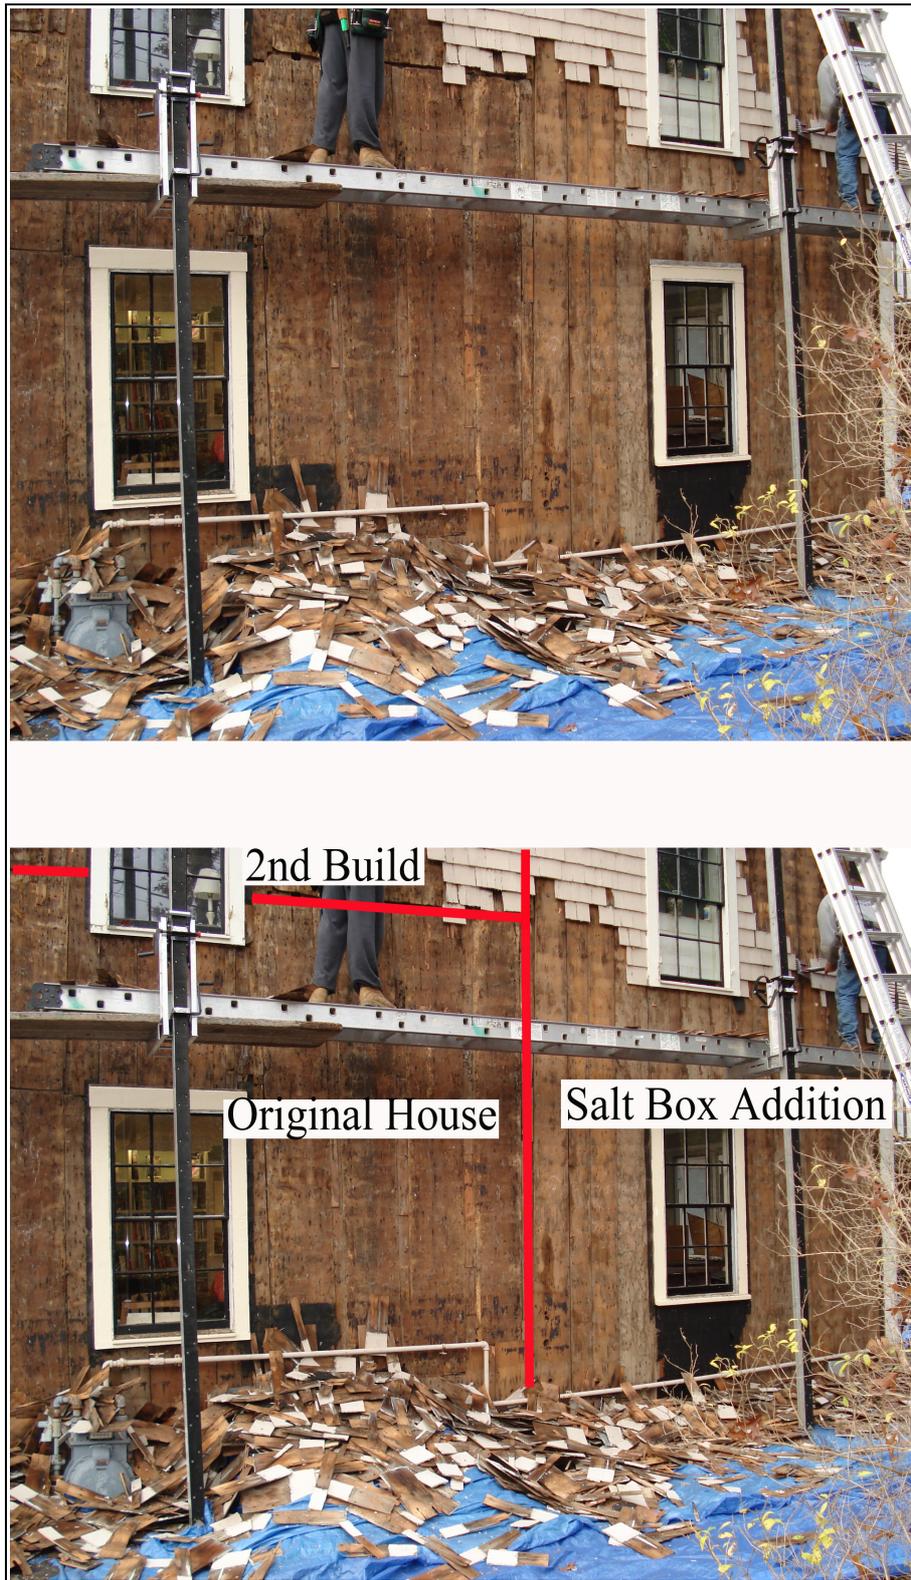
Figure 35. Various building phases visible when shingles were removed
