**Observations
on the
Reverend James Keith Parsonage
and
the 17th Century
in West Bridgewater, Massachusetts**

Craig S. Chartier
Plymouth Archaeological Rediscovery Project
July 2016

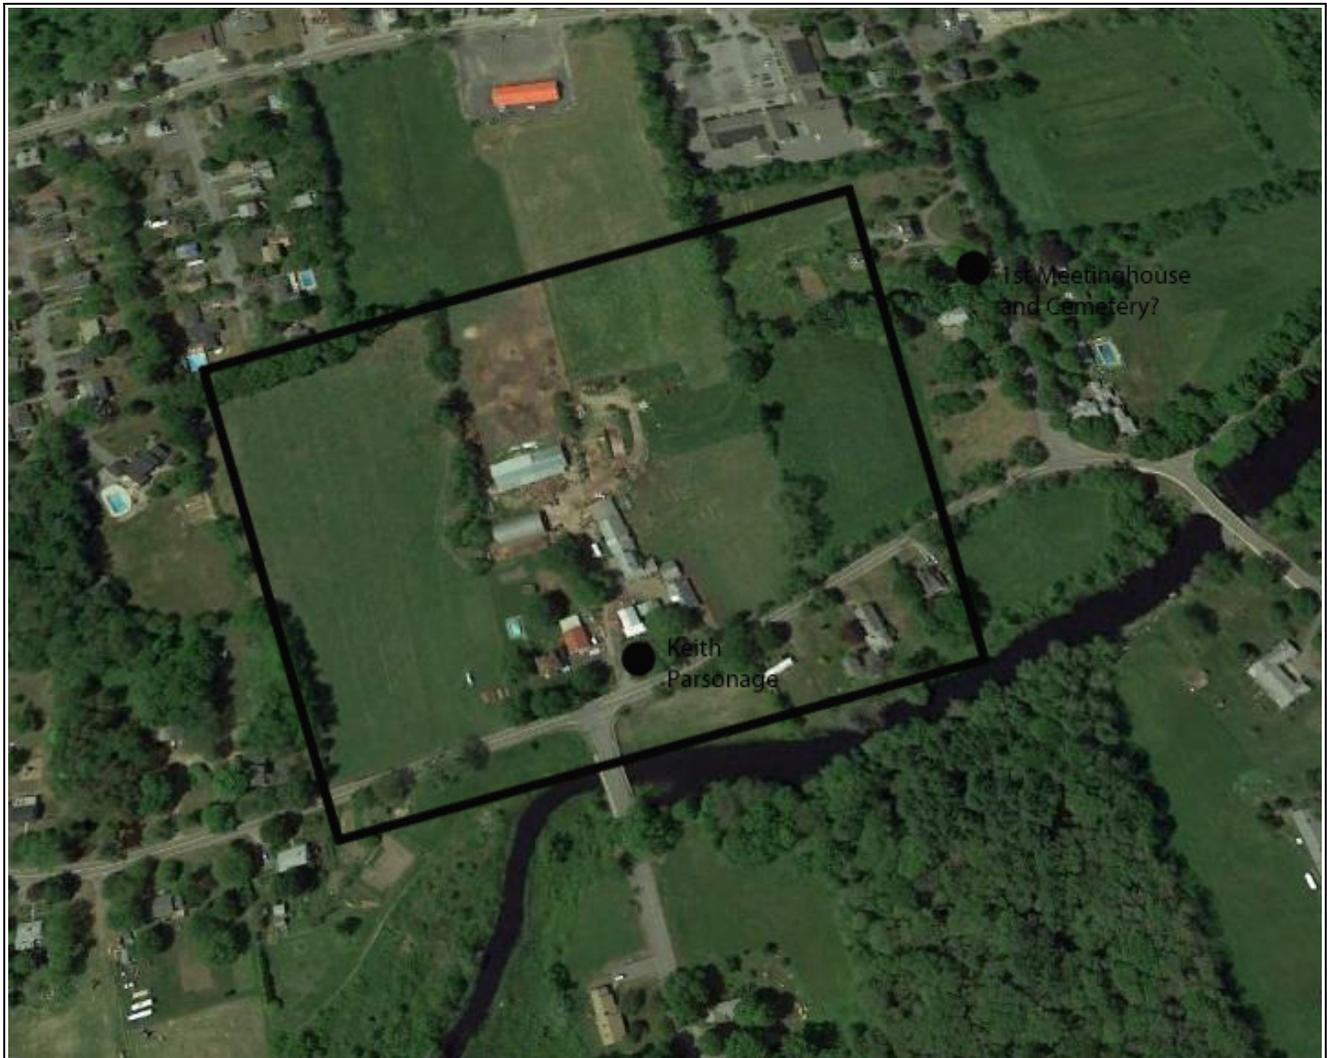
Figure 1. Possible layout of Reverend Keith's acreage.

The parsonage lot measured 12 acres in size- two of the original settler'souselots of six acres each. Acreage in the 17th century was measured in long strips half pole in breadth and three in length (83 x 492 feet). Six acres would measure 498' x 492' while 12 acres would measure 996' x 492'. We know from his will that he was also granted an additional 10 acres at some point, making his total 22 acres. This additional 10 acres was probably to the north of his first grant, as the original lots in the town were laid out parallel to the Town River. Looking at a modern map, his 22 acres, if his house was in the center, may have lain approximately where the adjacent farm with the possible location of the first burial ground and meetinghouse being just east of it (**Figure 1**).

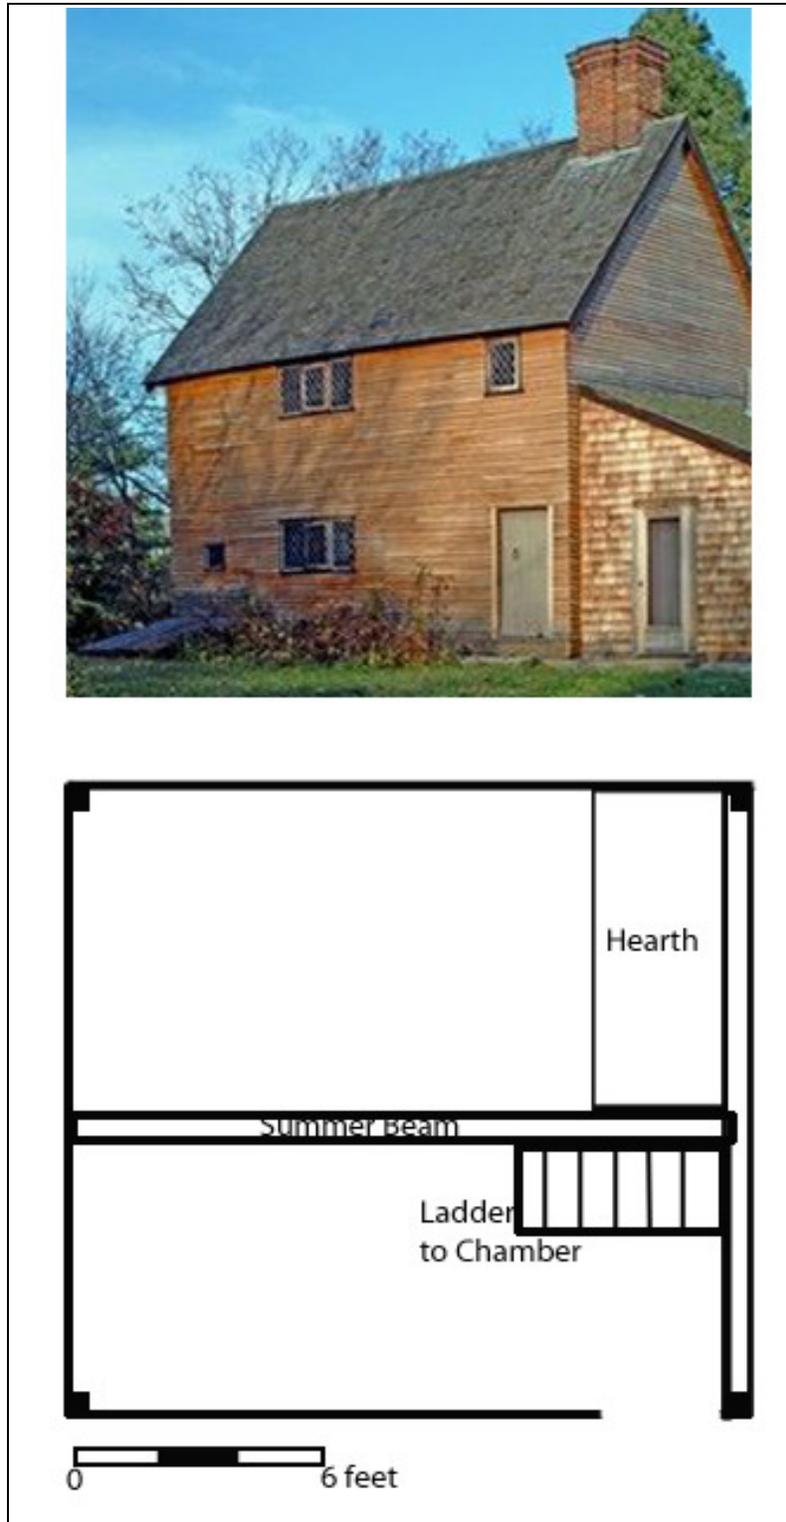
Keith's original house appears to have been a simple, two-story structure measuring 16' east to west by 17' north to south (**Figure 2**). It would have looked similar to the Browne House in Watertown, Massachusetts. The front door was on the south side, facing the river, and the second story was probably accessed by means of a ladder, possibly located inside the front door. The hearth was probably along the east wall, north of the summer beam, and the whole first floor would have been used as a traditional hall- a multipurpose room where daily activities and sleeping took place. The chamber, the second floor, would have been used for storage and for sleeping and was probably originally unfinished. The building may have had a lean to extension on the north side, but this is pure speculation and is not recorded anywhere.

Figure 2. Conjectural layout of the original Keith house based on the architectural elements visible in the present house (bottom) and a south side entrance view of the Browne House in Watertown, Ma.

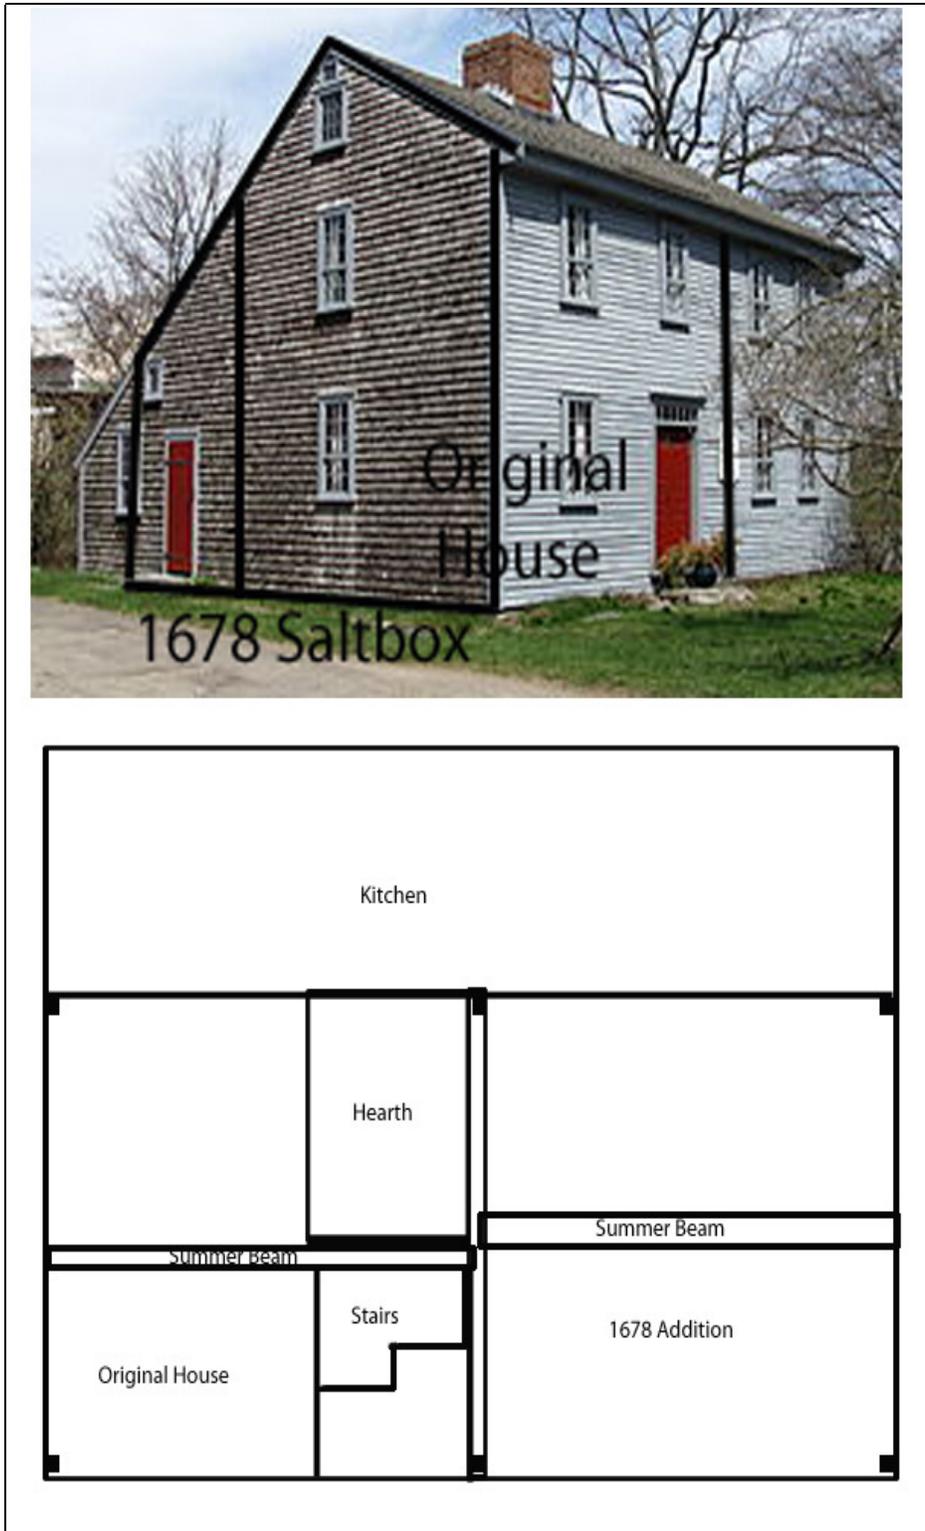
Latham states that in 1678 the house was enlarged by means of an 18' x 34' addition to the east side of the original house, creating a classic New England saltbox style house- two stories high on the south side with a one story ell on the north side and a long, sloping rear roof. This enlargement was recorded in the town records: “The towne being mett together the twentieth of Desember 1677, Did accor & Agree to give frely to Mr. Keith twenty and foure pounds to be paid at his house, the one half to be paid in Indian corne, and the other half in bords and Clabboards, by the last of Aprill Insuing the Date hearof, and the said twenty four pounds to be raised by way of rate upon the Inhabitants of the towne, which was given to Mr. Keith towards the building of him A convenient Roome or dwelling house, the boards at 5s a hundred and clabboards shaven at 5s per hundred.” (Puffer 1889: 11 from the original town records page 74). The new addition was probably built in the spring of 1678. The conversion of the square, single-cell house to a salt box was accomplished through the construction of an eastern ground floor room with a chamber above it, and a lean to on the rear. A lean to that is 18' wide would have been very uncommon in the period, especially on a house that only measured 17' wide to begin with. It is more probable that the lean to, which are traditionally 1 story high at the rear, would have measured 8-10' wide and 32' long, which is the length of the present building (**Figure 3**).

Figure 3. Layout of the house after the 1678 addition.

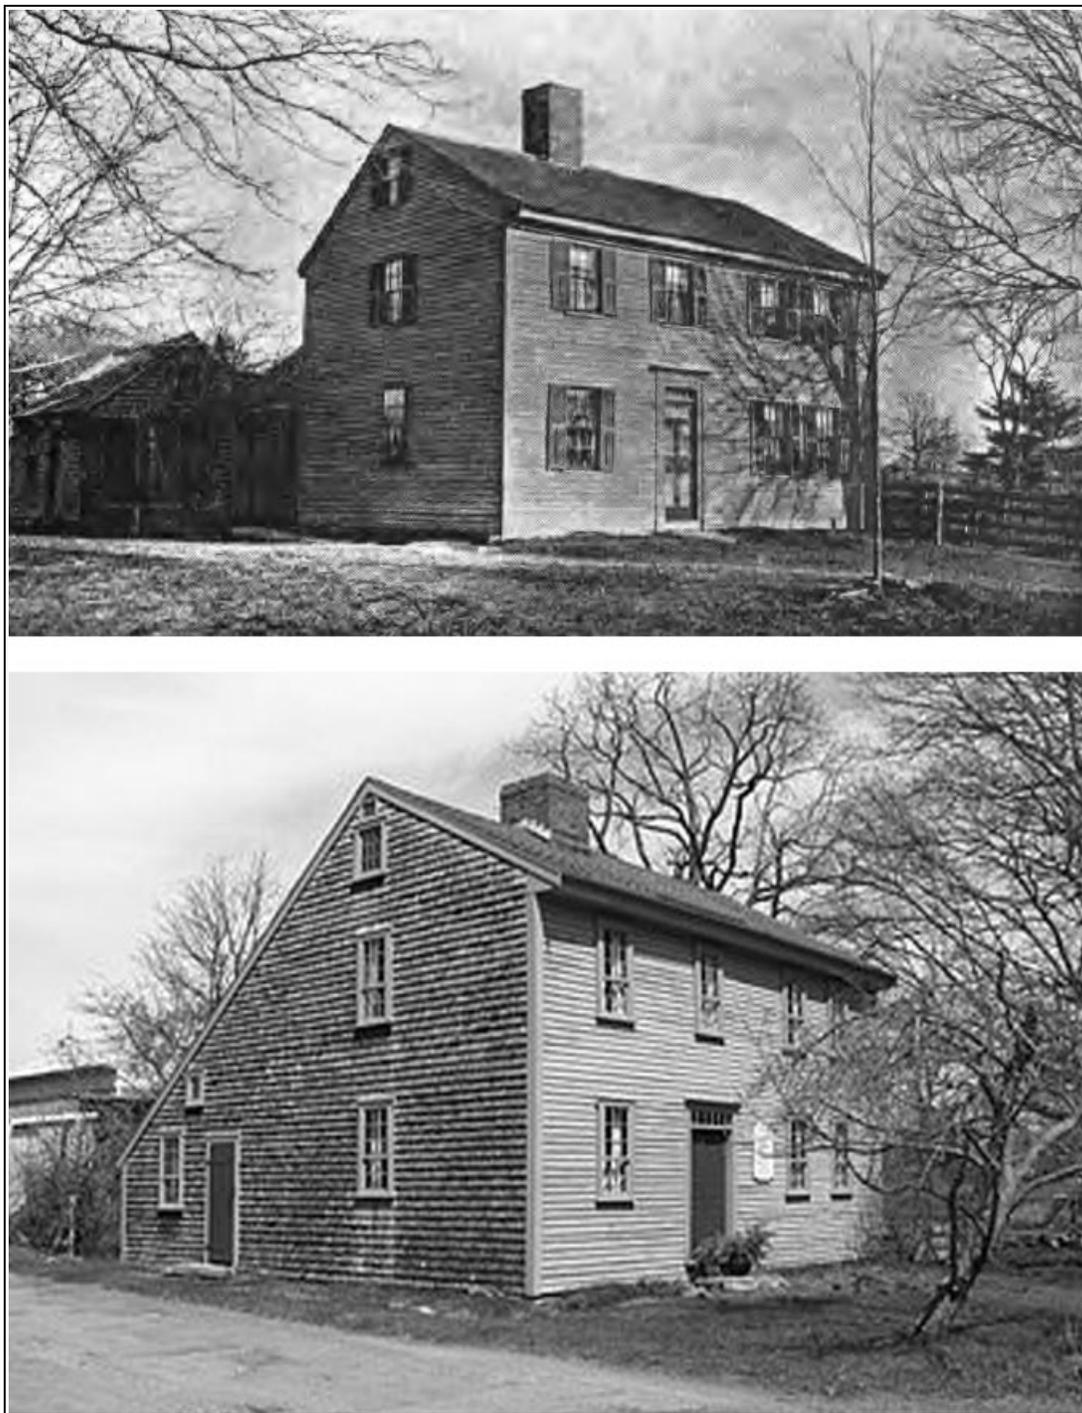
The next major construction was recorded by Latham as having occurred in 1837 when Thomas Pratt, cut 14' off of the north side of the house, completely removing the north ell and kitchen, so that the south and north sides of the house were now the same height but leaving the south roof 13 1/2' long and the north one only 12' long. Pratt also removed much of the old chimney and fireplaces, replacing them with much smaller versions. The bricks that were removed were said to have been larger than 19th century bricks and were laid in clay. Pratt also removed the shingles from the house and replaced them with clapboards. Pratt's "renovations" created a house that measured 32' east to west by 20' deep with a porch annexed to the back side. The windows were left in their original places, but instead of diamond shaped panes and casements, they had square panes and were double hung. The front door was probably replaced at this time with a simple 19th century paneled door (**Figure 4**).

Figure 4. Comparison of the house today (bottom) and as it looked after Pratt's 1837 renovation (top).

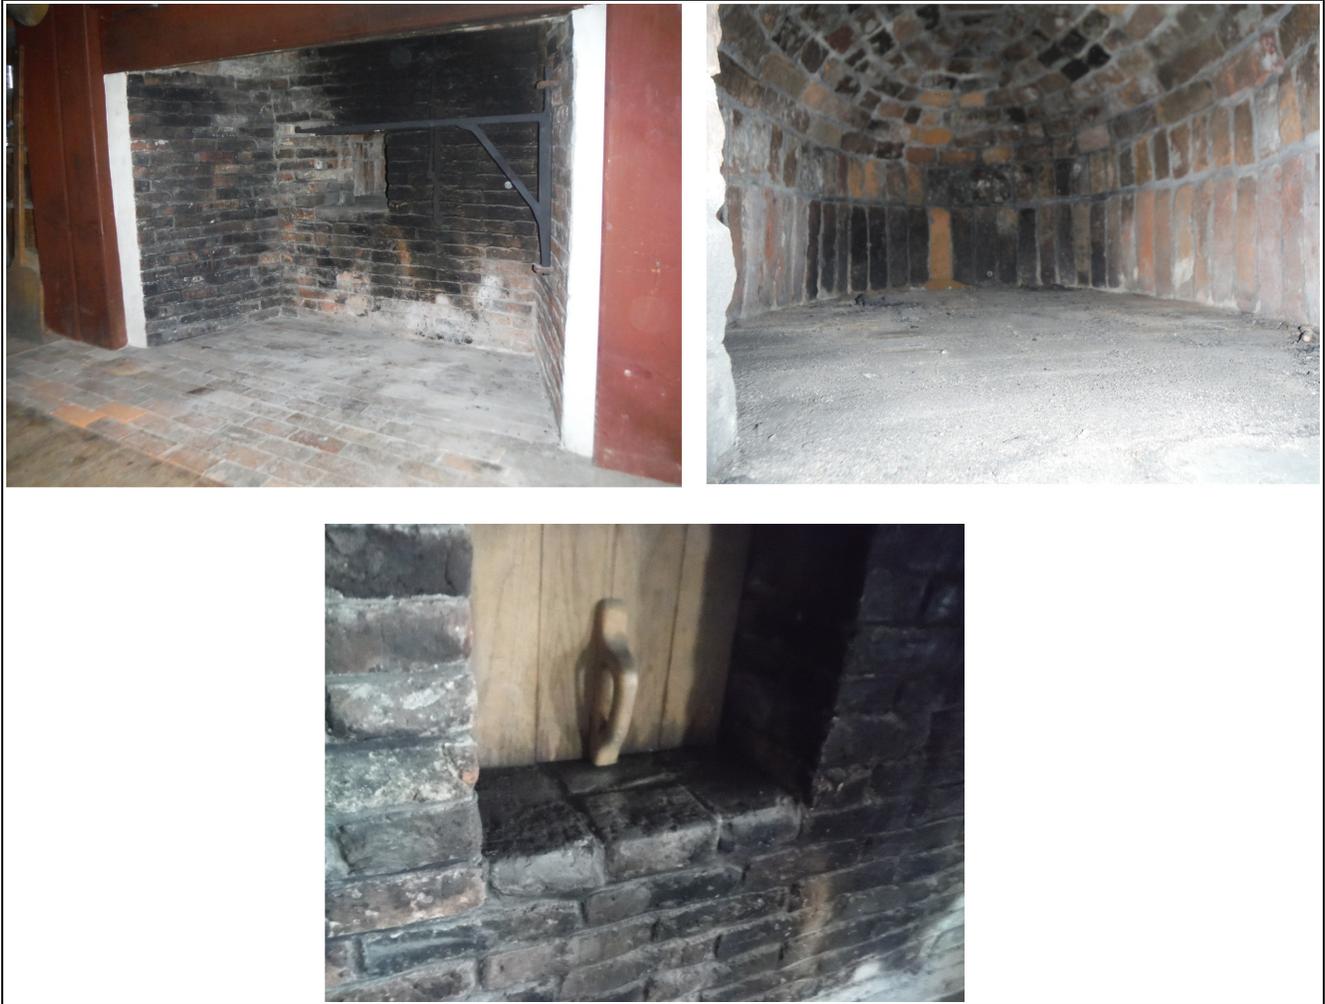
Figure 8. Kitchen hearth and bake oven. (Top left: general view of hearth and oven; Top right: inside the bake oven; Bottom: bricks on front of oven showing possible use wear from door and possibly oven peel)

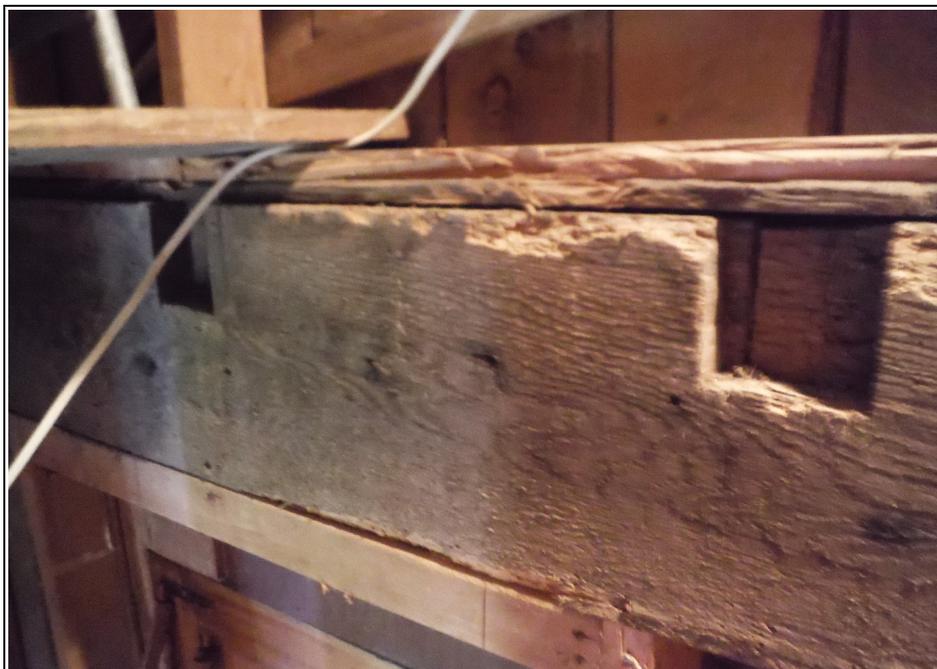
Figure 8. Back stair joists showing the stairs were added in the 1970s.

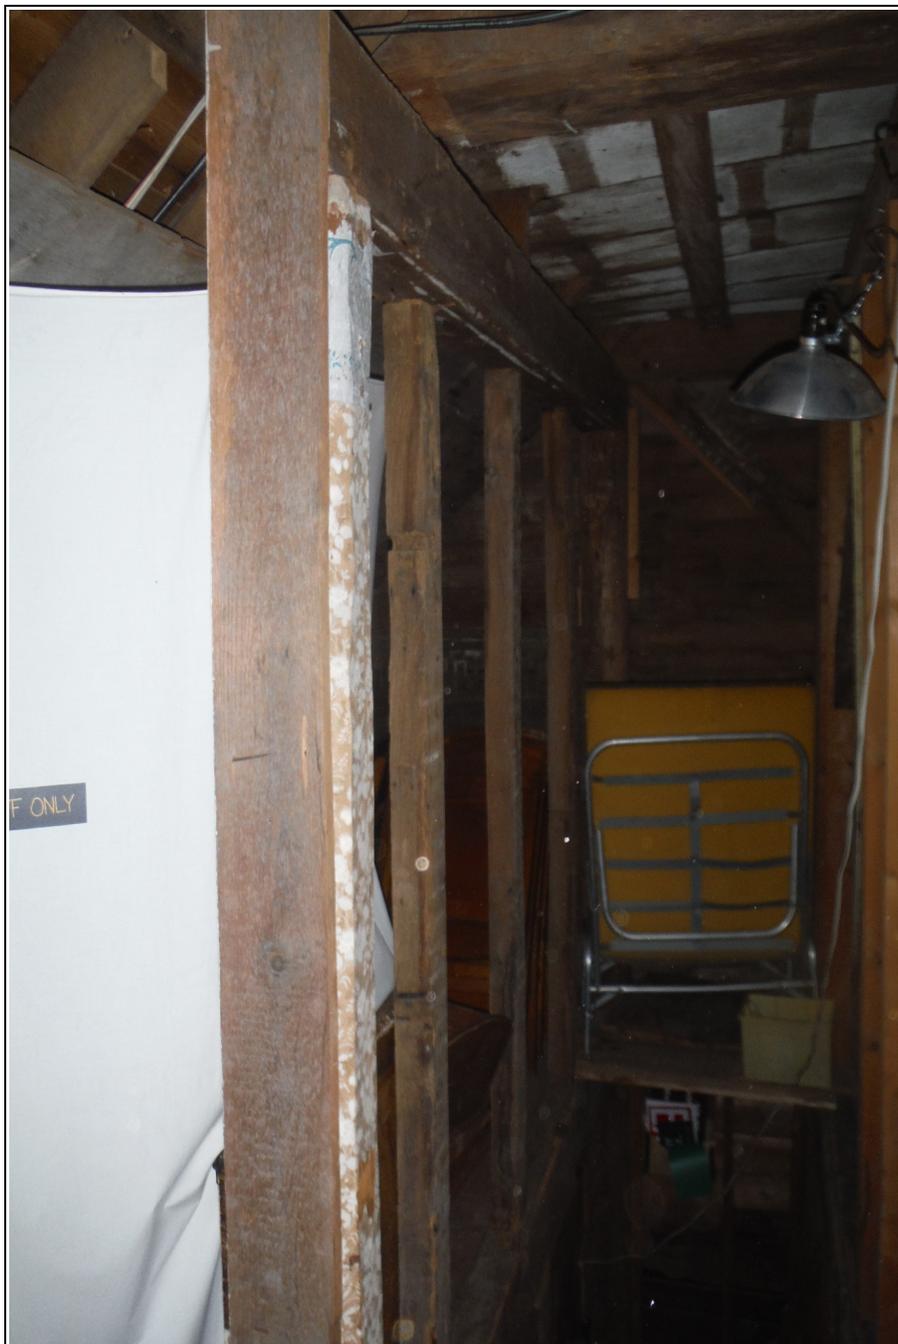
Figure 9. The north wall of the house (left side of picture) at the top of the back stairs that was added by Pratt in 1837.

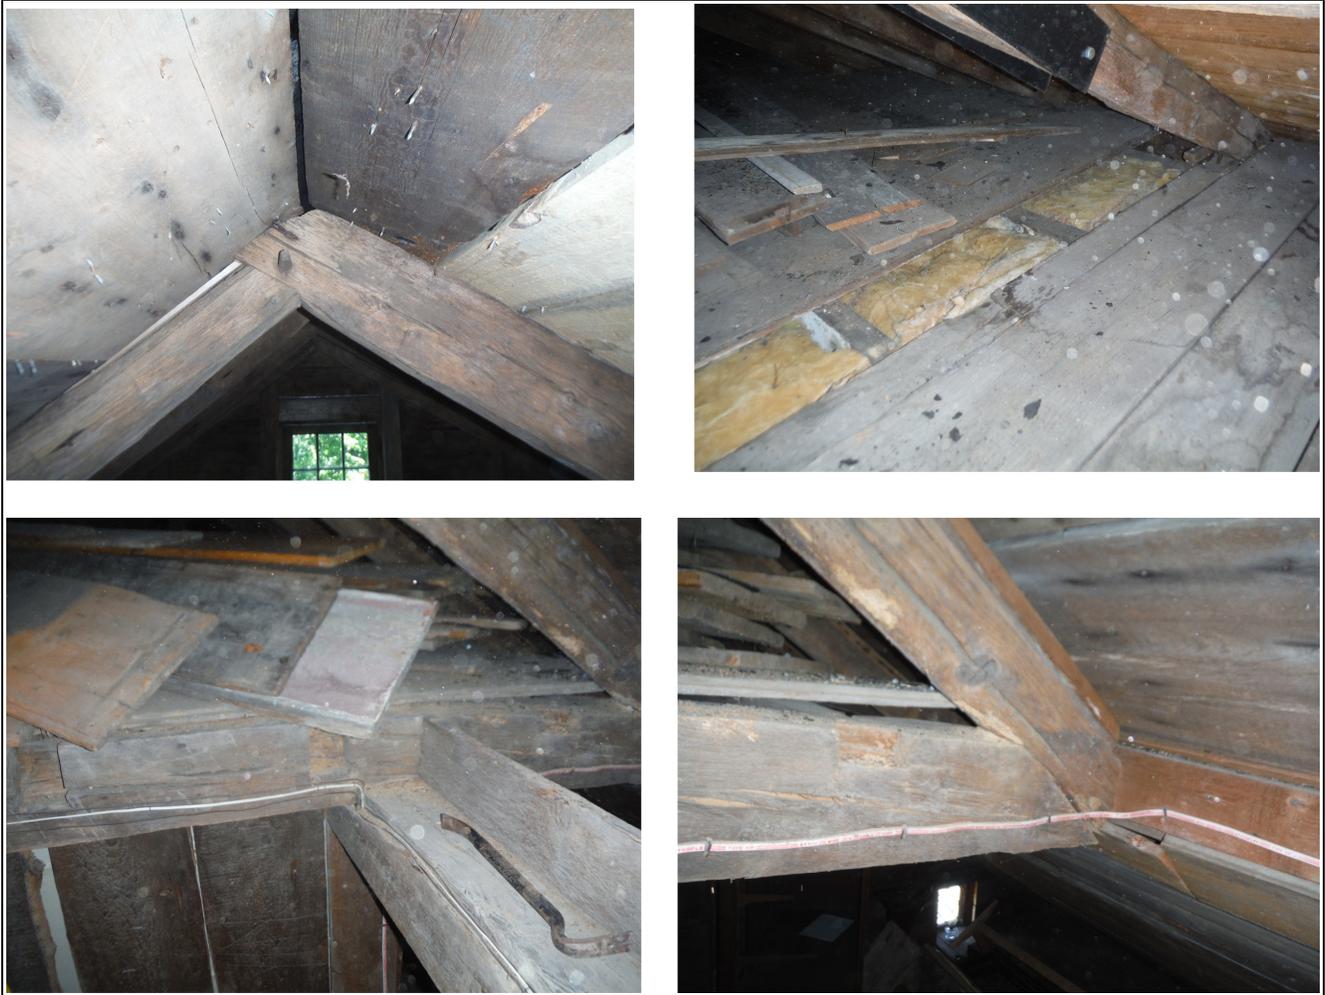
The investigation then proceeded to the attic. It was determined that the boards on the roof of the building had been replaced at least since the Society acquired the house, probably in the 1970s. The rafters are original to the 1678 expansion of the house, in is called a principle and common rafter system. Basically, this means that there are some larger, principle rafters and between them are interspersed smaller, common rafters. All the rafters were found to have been numbered in pairs on the ground by the builders prior to hauling them up and erecting them. In this way, the paired rafters could be correctly fitted on the ground first, and then hauled individually up to the roof and rejoined with their mates. The principle rafters were numbered I to III and the common rafters were numbered I to VIII. Numbering was sequential west to east and all pairs remained together. This indicates that the framing has not been removed and reshuffled since it was erected in 1678. The tops of the rafter are joined with what is called brindled joints, very consistent with the 17th century (**Figure 10**).

Figure 10. Architectural features in the attic. (Top left: apex of 1678 rafters; Top right: whitewashed joists beneath the attic floor; Bottom left: joist pockets on stairwell to attic; Bottom right: joist pocket and roofline at cantilever).

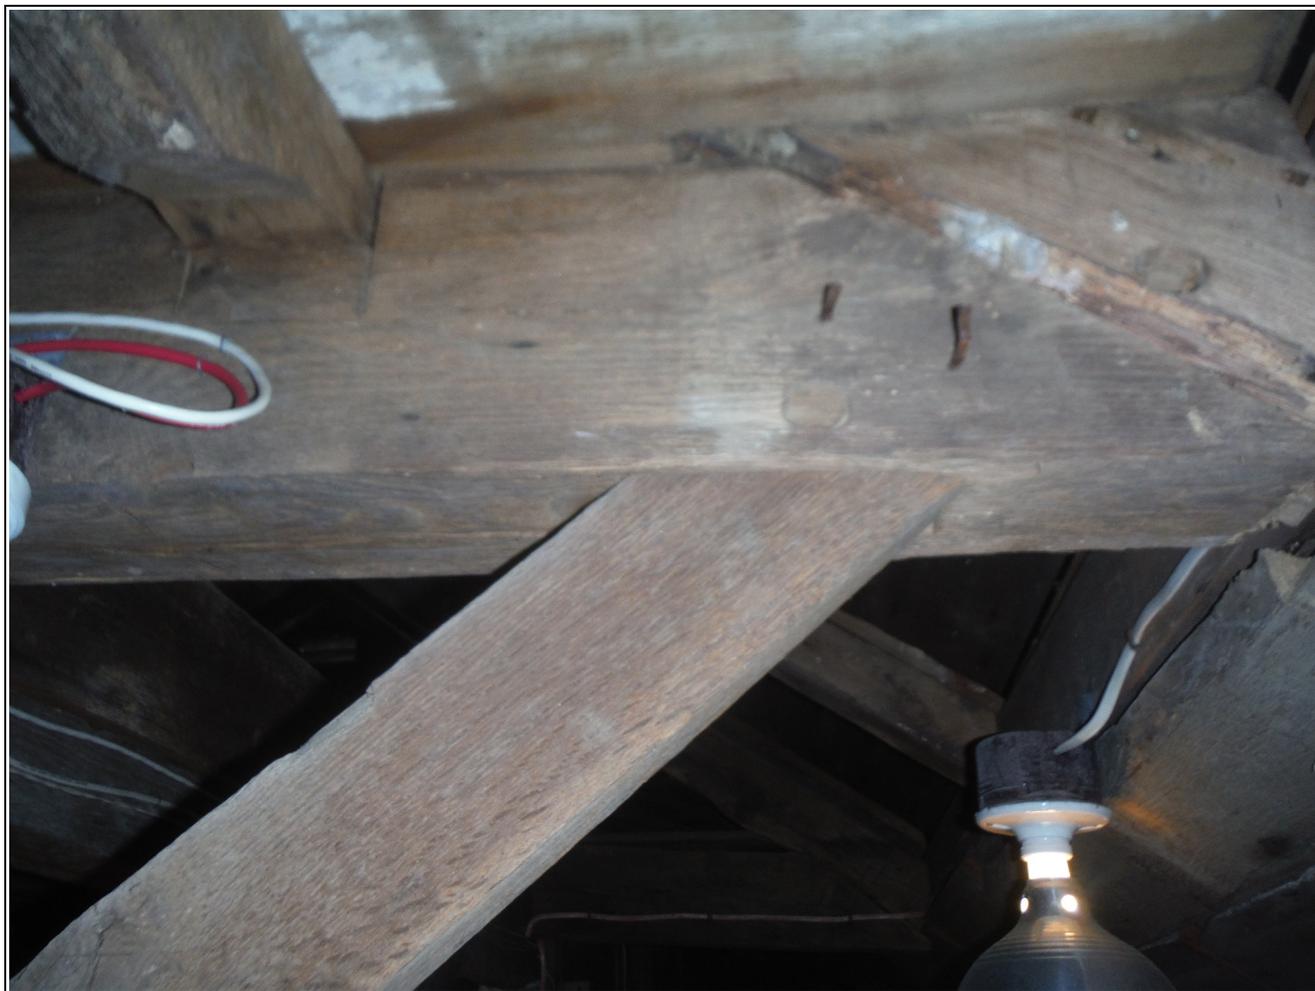
Figure 11. Cantilever visible in the second floor.

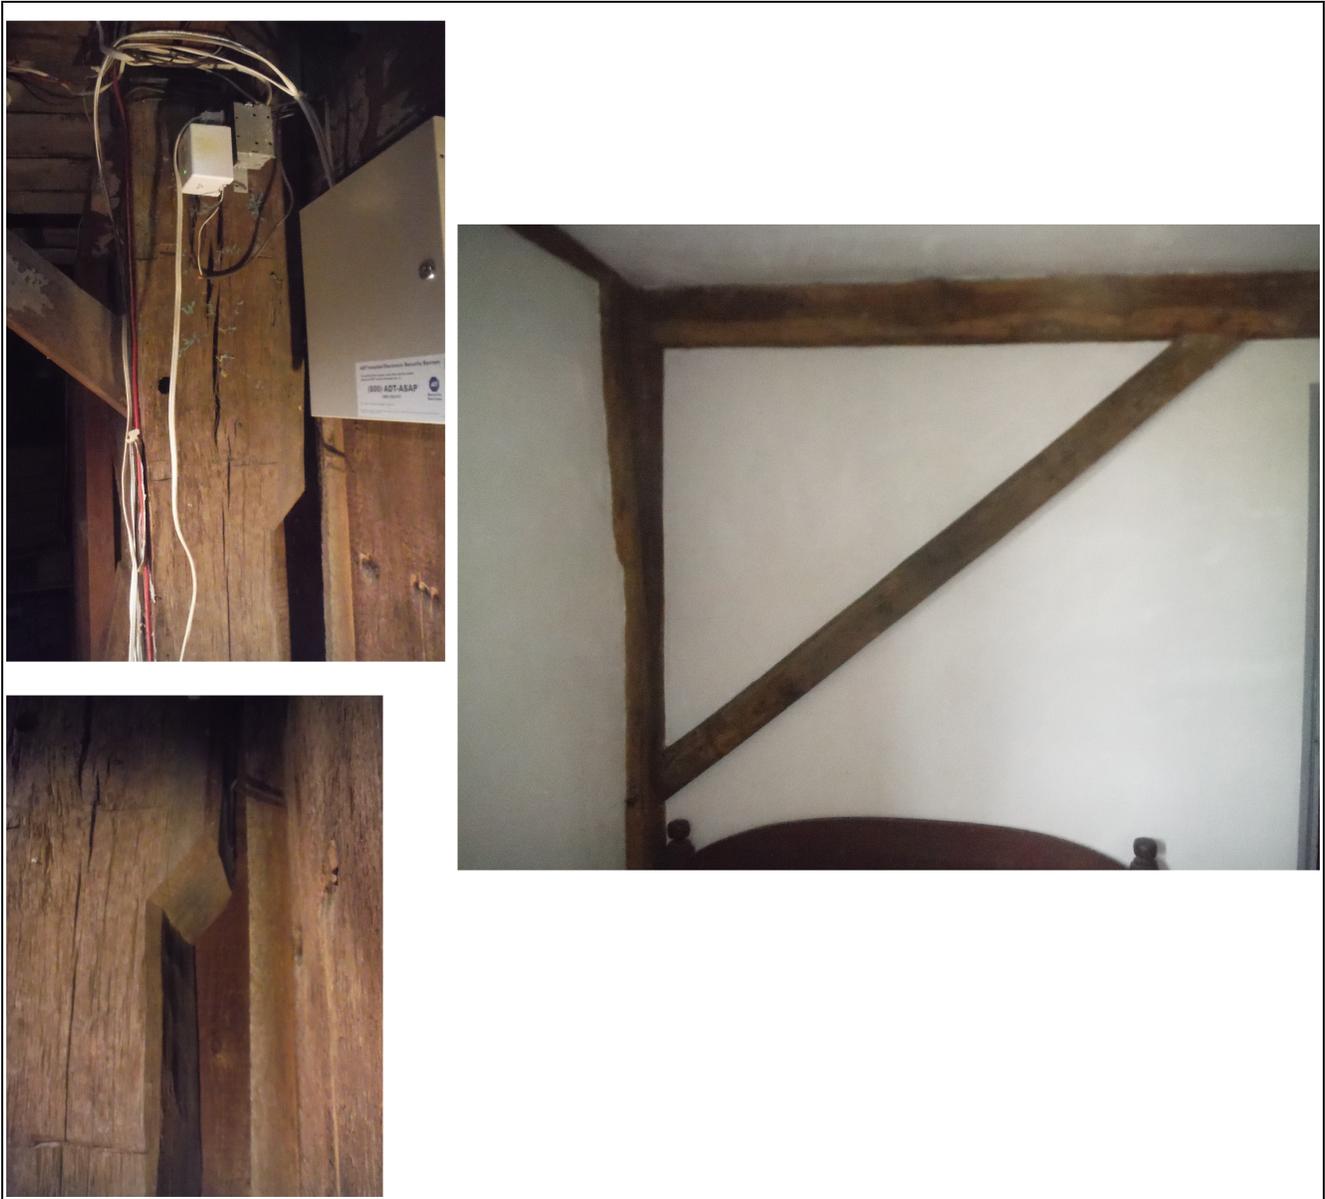
give rigidity to the frame (**Figure 12**). The use of rising versus falling braces, ones that go down instead of up, is indicative of an West Country building tradition versus an East Anglian one and, again is classic 17th century. The edges of the posts are chamfered, basically the sharp corner has been removed with a chisel or plane, and this was purely aesthetic. The rising braces have been removed from the southwest corner post, presumably in the 1970s, but at least one and possibly both are present in the attic. These should probably be replaced, as they are important structural elements.

Figure 12. Corner post with gunstock visible on second floor north side (Top left: north center post of the house; Right: gunstock post and rising brace in the northwest room; Bottom right: detail of chamfering on gunstock post).

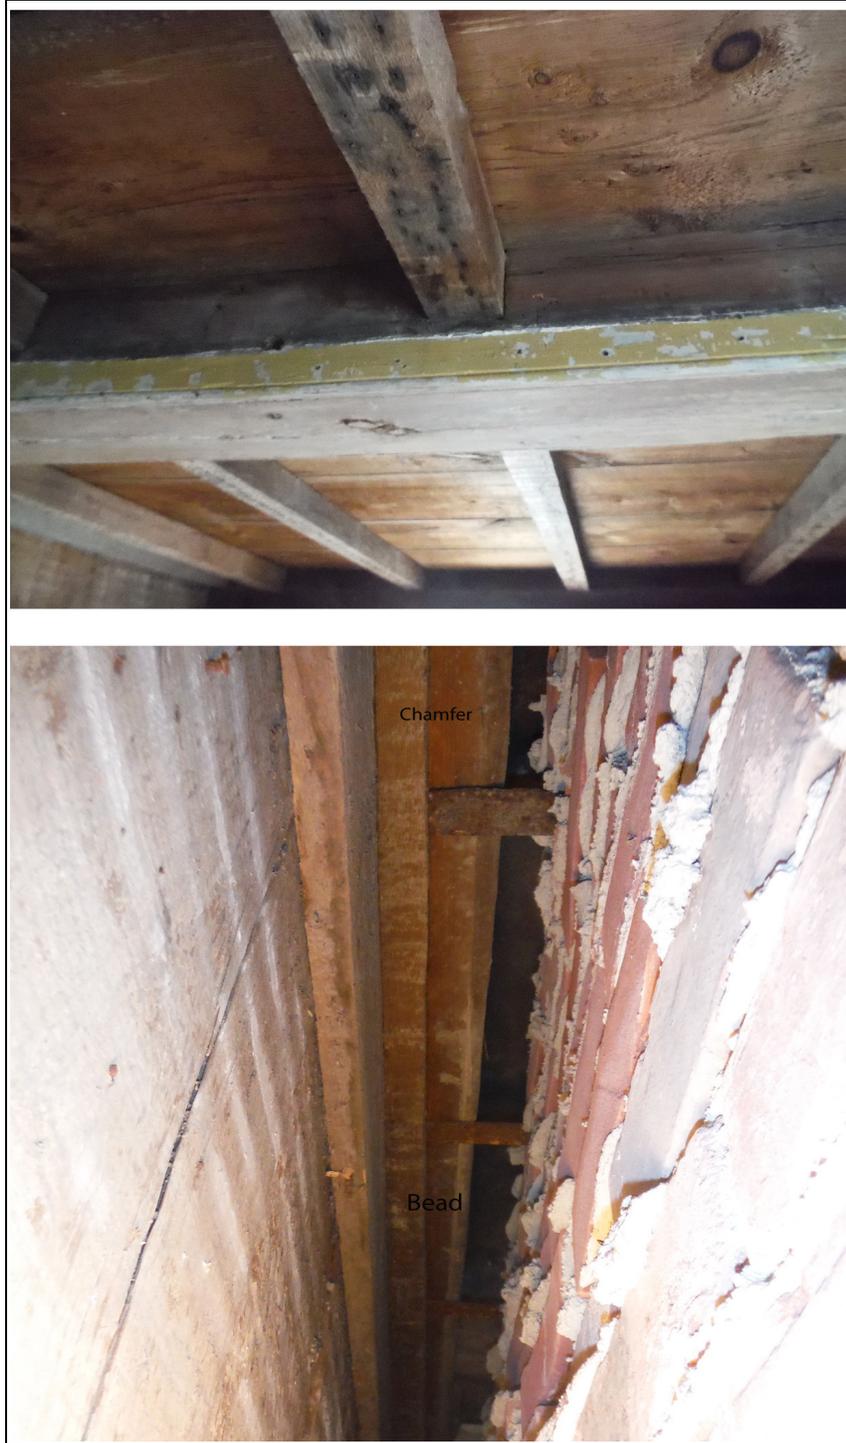
Figure 13. Summer beam in the southwest room (Top: view of summer beam with quirked beading in the room; Bottom: view from inside the southeast room closet showing chamfering and beading behind staircase).

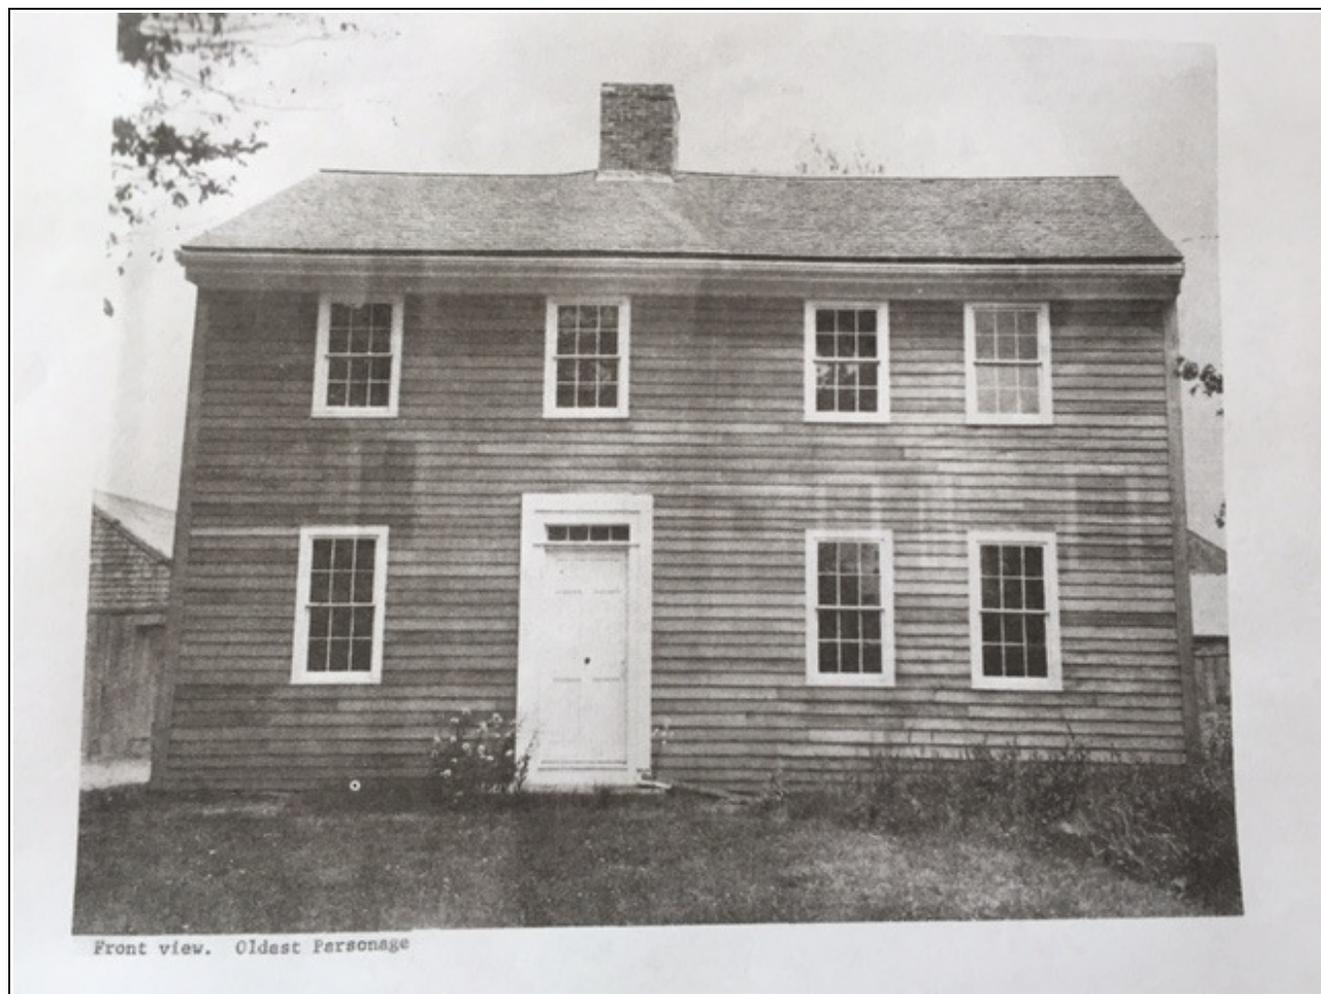
The front door of the house appears to have been replaced in the 1970s. A 1961 photograph of the front of the house (**Figure 14**), shows a simple, single door, while the present doors are 19th century double doors. It is unknown why the renovators in the 1970s decided to replace what was probably a ca. 1837 door with a later style of door. The glass above the door was probably replaced at the same time, and the bullseye pane on display inside the house probably came from this 19th century transom over the door. Seventeenth century doors would have been simple and practical batten board affairs.

Figure 14. Photograph of the house showing the front door.

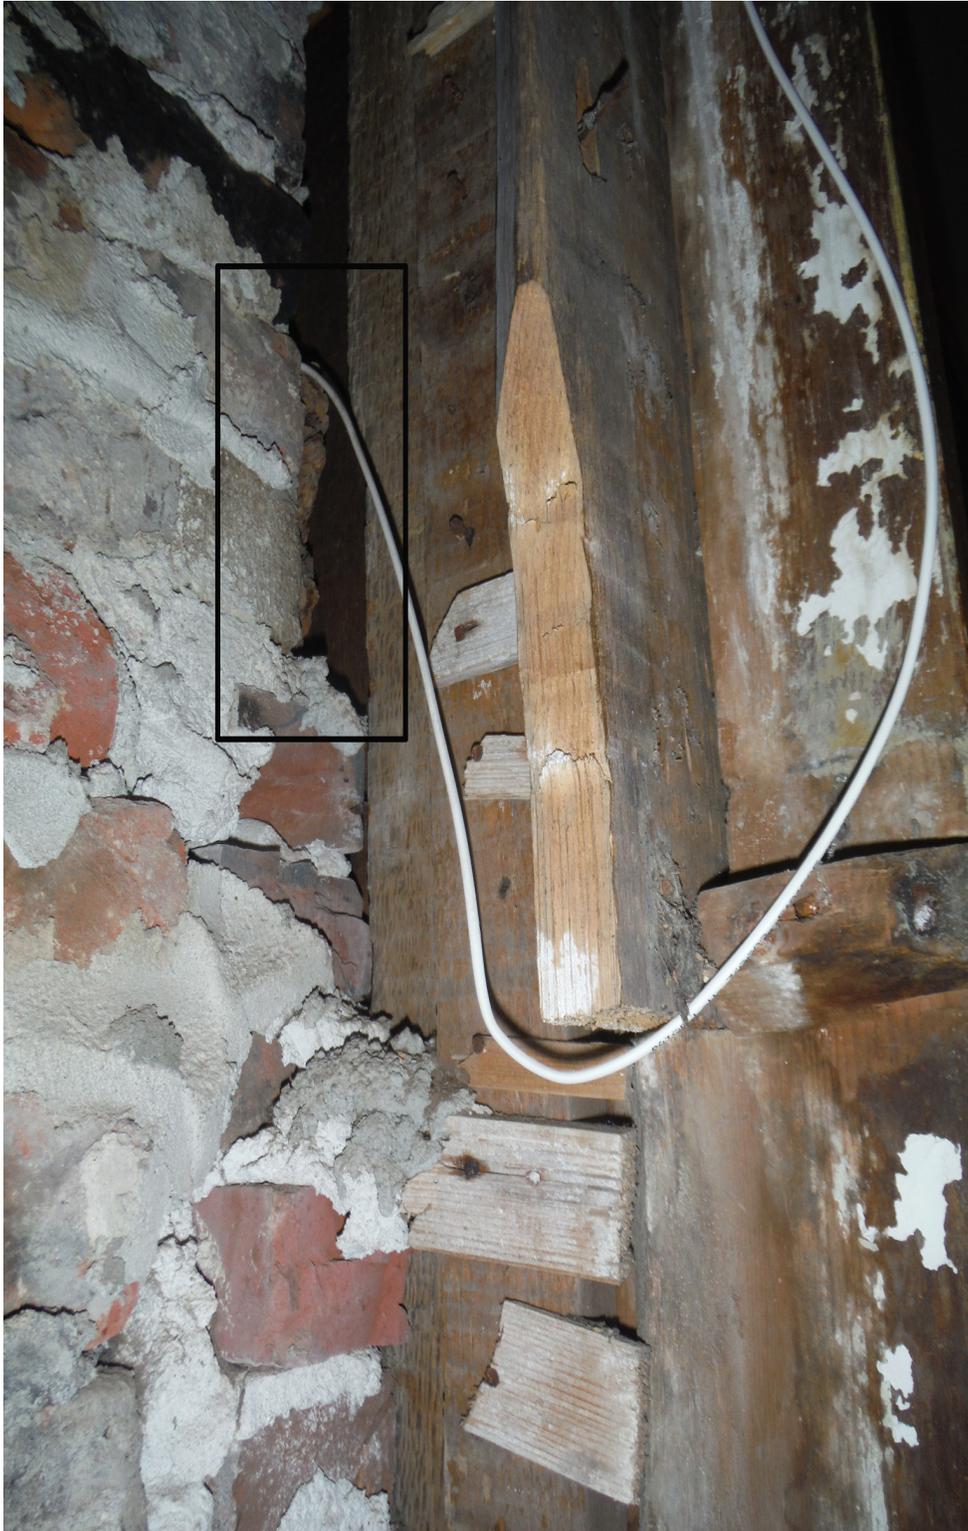
Figure 15. A view inside the southeast room closet showing the old brick, 19th century lathe, and the old board or lintel (within the black rectangle).

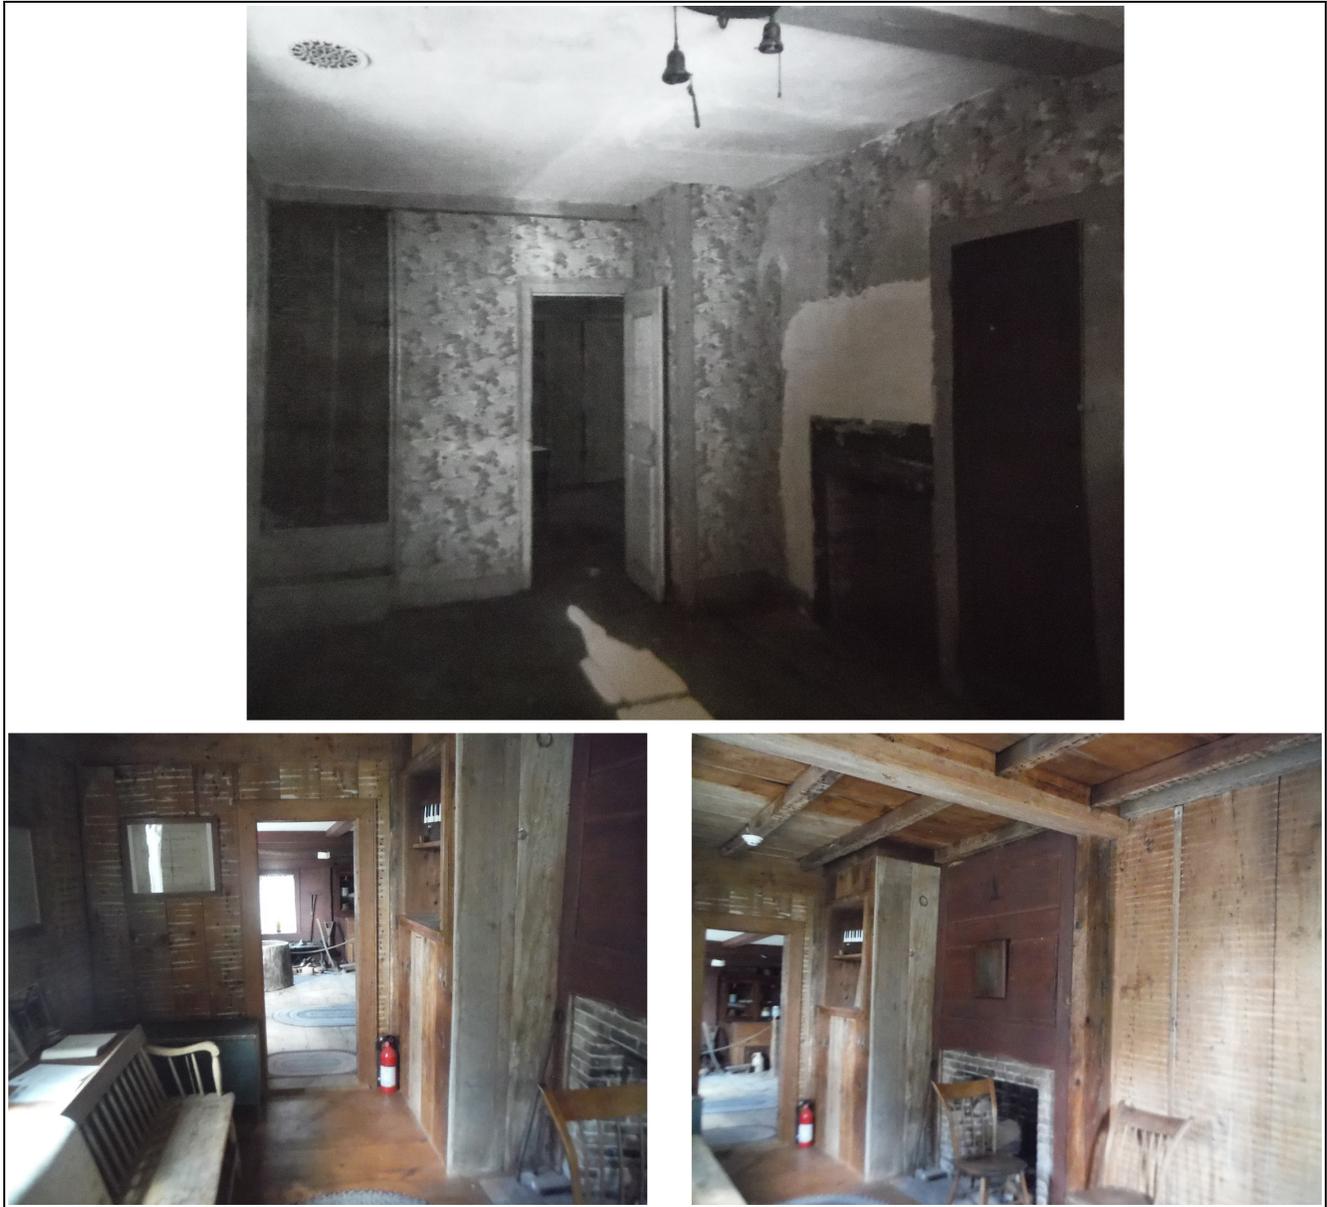
The 1970s renovation attempted to reverse some of the changes made to the house by the Pratts, but in some ways, resulted in a less accurate reconstruction. The oldest room of the house was “rusticated” in an attempt to make it look more old-timey, and 18th century style paneling was added throughout the house. Modern 2x4s and plasterboard were used to replace crumbling walls and floors. The 1678 chimney was truncated to a height of approximately 5' and replaced with modern brick, wire, flashing, and cement, the rear lean to was rebuilt, probably in a form larger than it was before, and rear stairs were added.

Figure 16. The southwest room of the house (Top: before the 1970s restoration; Bottom: as it appears today).

I would suggest that the Society think about removing some, of the elements added in the 1970s. It seems, based on the photographs I have seen, that most of them were added in order to make the oldest part of the house look "pioneer" and "rustic" (**Figure 16**) and to continue and expand upon the 18th century paneling that appears to have been present in at least a portion of the east half of the house. The west/ original room could be stripped down to the bare plank and timber framing all

around (walls and floor) and then the evidence of what was originally there could be examined and subsequently replaced. This replacement could be done over time, not all at once, and the room could be rendered back to an accurate semblance of what it may have looked like in the 17th century. Evidence that could be found include original window positions and sizes, wall finishing (whitewashing and/ or plastering), hearth location and arrangement, and original stair location. Archaeology could also be done under the floor, an area that should bear evidence of the very first construction and occupation at the site as well as subsequent renovations. This renovations would reveal whether the original hearth was stone or wattle and daub, whether the replacement hearth built in the 1660s was completely brick or a combination of brick and stone, and possibly even what the original windows looked like.
