**Report on the
2017 Archaeological Testing
in the West Closet at the
Reverend James Keith Parsonage
in West Bridgewater, Massachusetts**

Craig S. Chartier
Plymouth Archaeological Rediscovery Project
January 2017

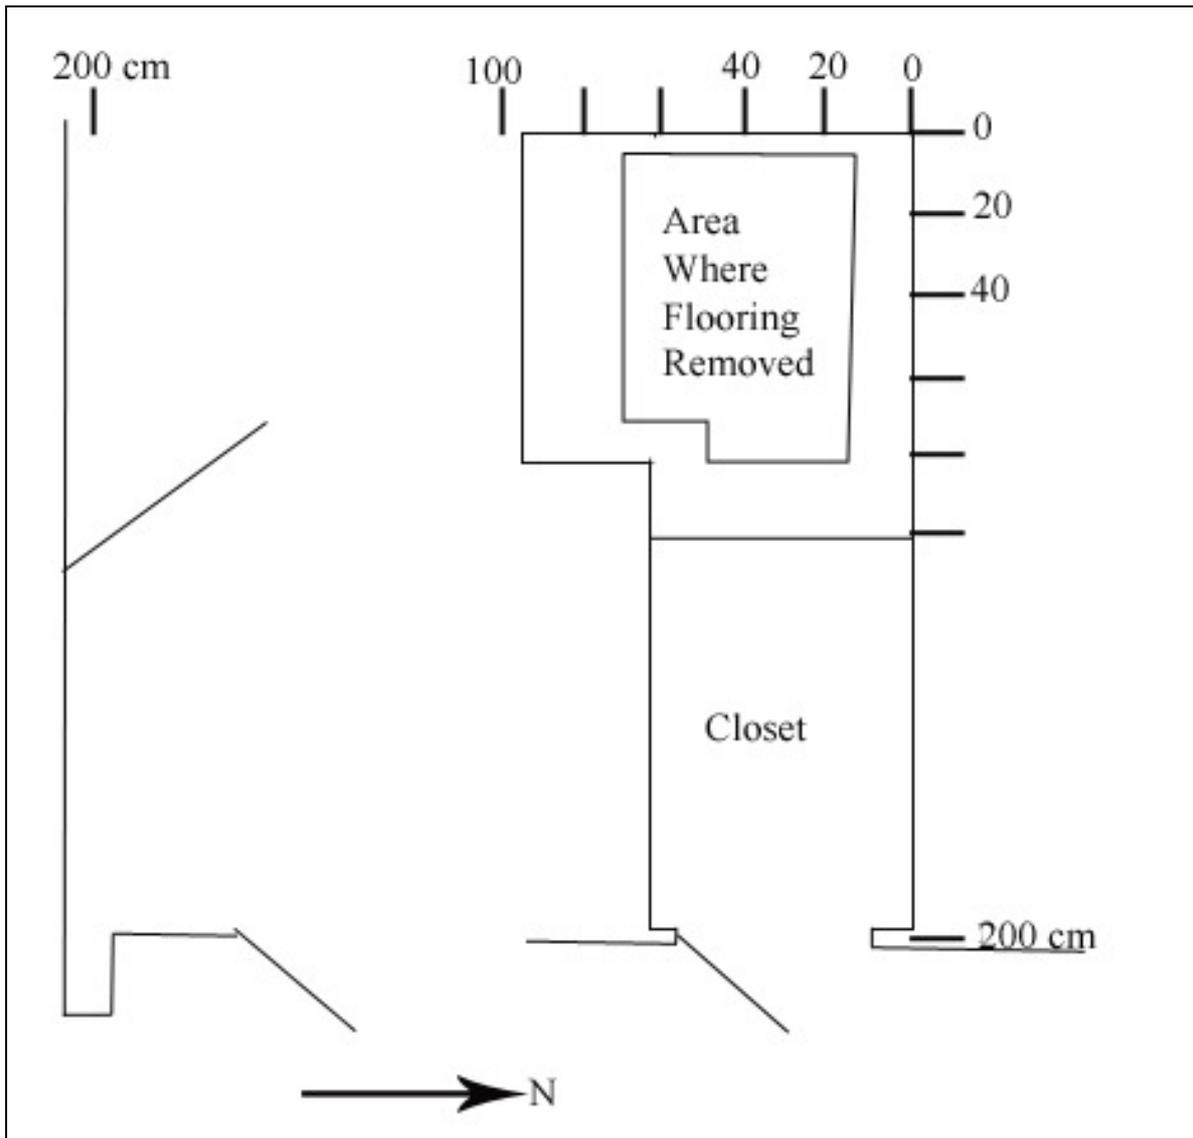
Figure 1. Location of excavation area in the east room closet

PARP was invited back in January of 2017 to investigate the potential of conducting archaeological testing beneath the ground floor of the house and to further examine the degree to which past renovations had removed 17th century architectural elements from the house. Visual inspections were carried out behind the built-in shelves and the wall heating units on the west and south walls of the west room. One test pit was excavated under the floor east room closet located beneath of the front staircase (**Figure 1**).

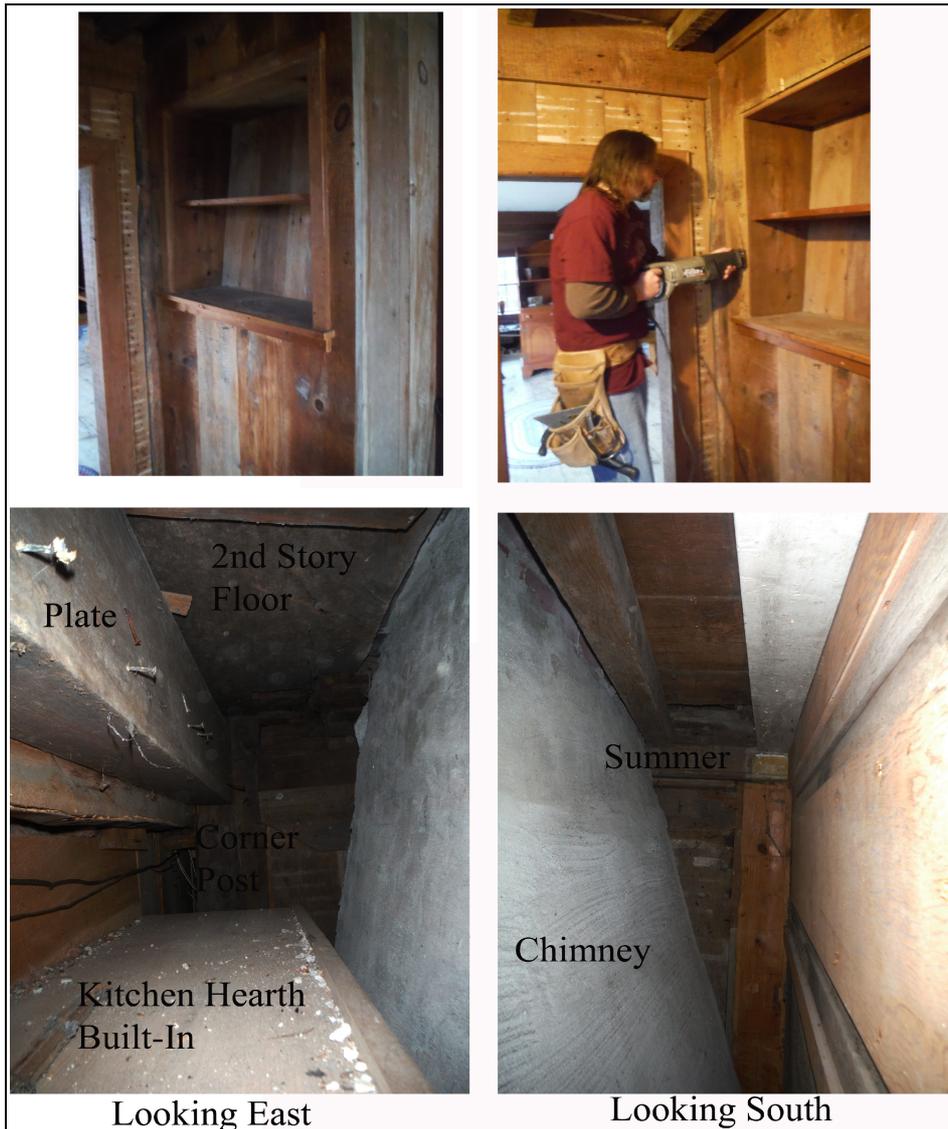
Figure 2. Investigation in the west room built-in

The removal of the wall unit in the west room, a feature that appears to have been installed during 1970 renovation, allowed us to look at the framing timbers behind the kitchen and west room hearths(**Figure 2**). The majority of the element found appeared to date to the 1970s renovations. The only original pieces found were the second story north plate, the northeast corner post of the original house and the summer beam of the west room. Yellow paint was observed on the north plate and the summer beam, indicating that, prior to the 1970s, the northwest corner of the room was approximately 6" larger (to the east). No evidence of whitewashing or plastering on the summer beam or the north plate was found, meaning that the original room was not whitewashed or plastered and may have had paneling on the interior, or was merely exposed wood. The lintle beam over the hearth was also visible in the built-in, but it appears to be a reused old timber reused as a lintle in the 1970s (**Figure 3**).

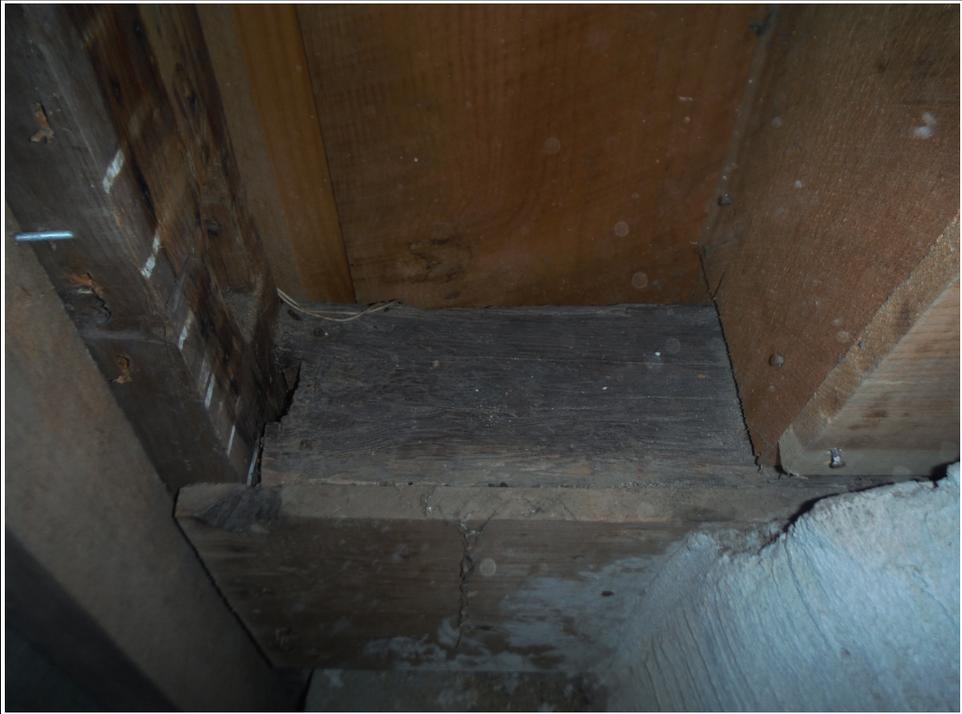
Figure 3. Kitchen hearth “lintle” showing how it is a reused beam and not original

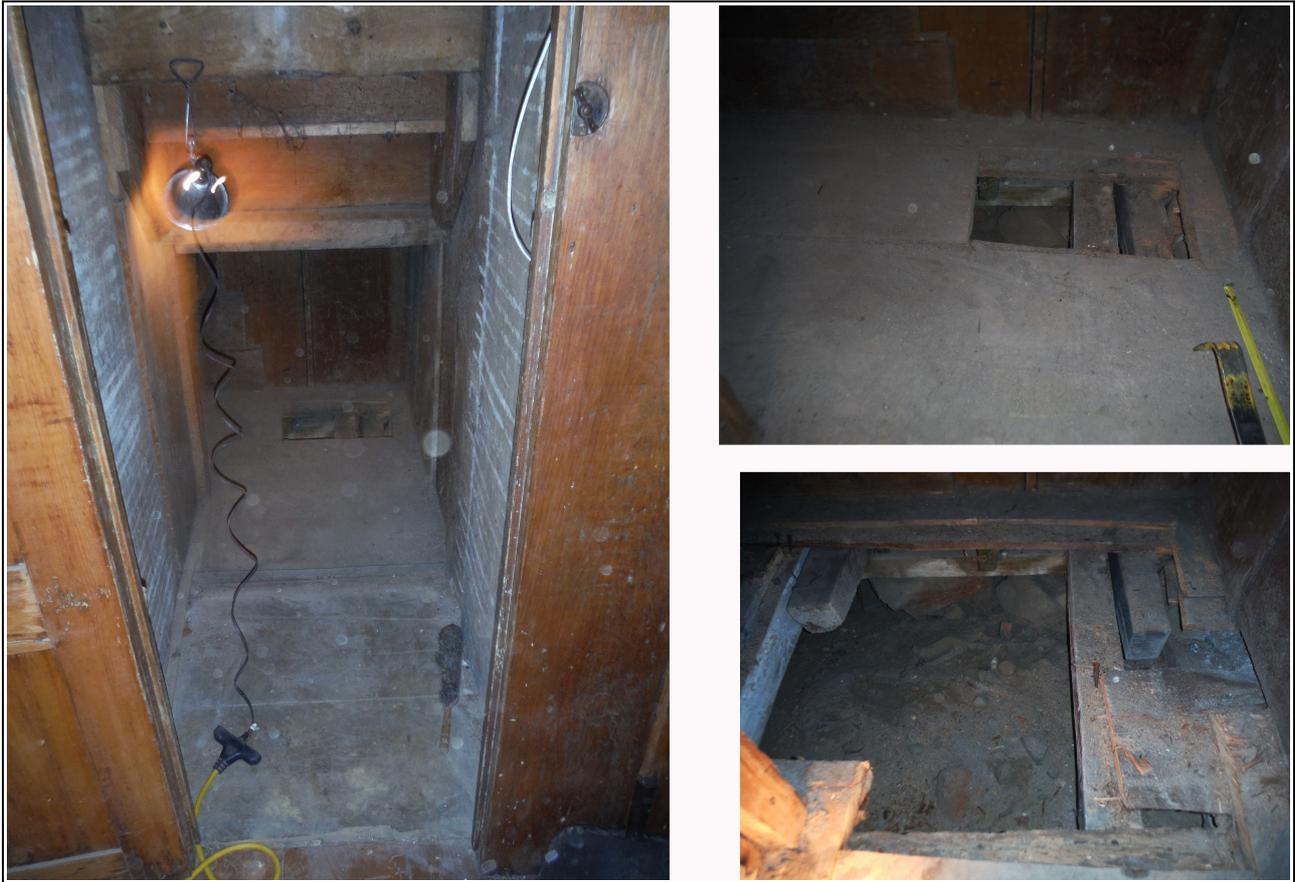
Figure 4. Location of excavation unit in east closet

Traces of 19th century wall plaster lathe shadows are visible within the east closet. The west wall of the closet, which consisted of three boards that appear to have been nailed in place since the 19th century, were carefully removed and it was determined that an area of the floor approximately 60 cm square, could be removed to see what evidence remained of the original ground surface below the building (**Figure 4**). This area would have been located just south of the original hearth in the original house. One interesting finding was a piece of original 17th century floor joist that was reused in the 19th century as part of the staircase (**Figure 5**). This joist bears three vertical lines meant to identify its place in the construction of the building.

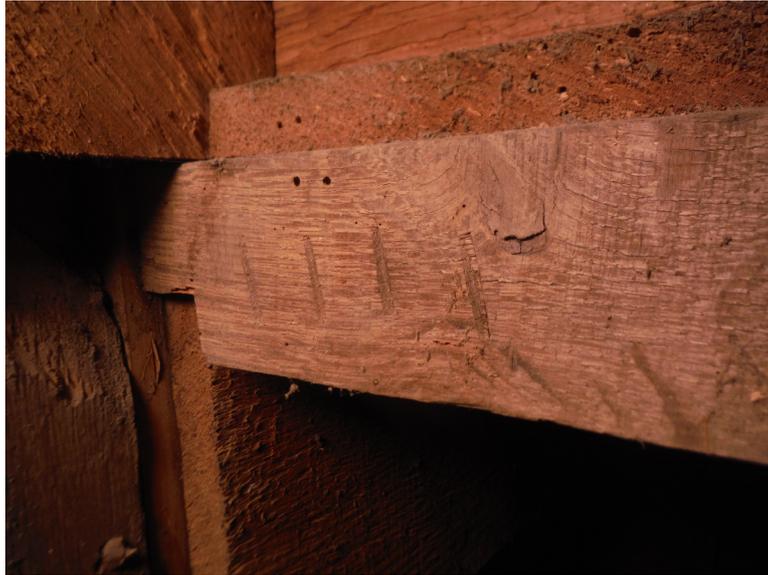
Figure 5. Housewright mark in east closet

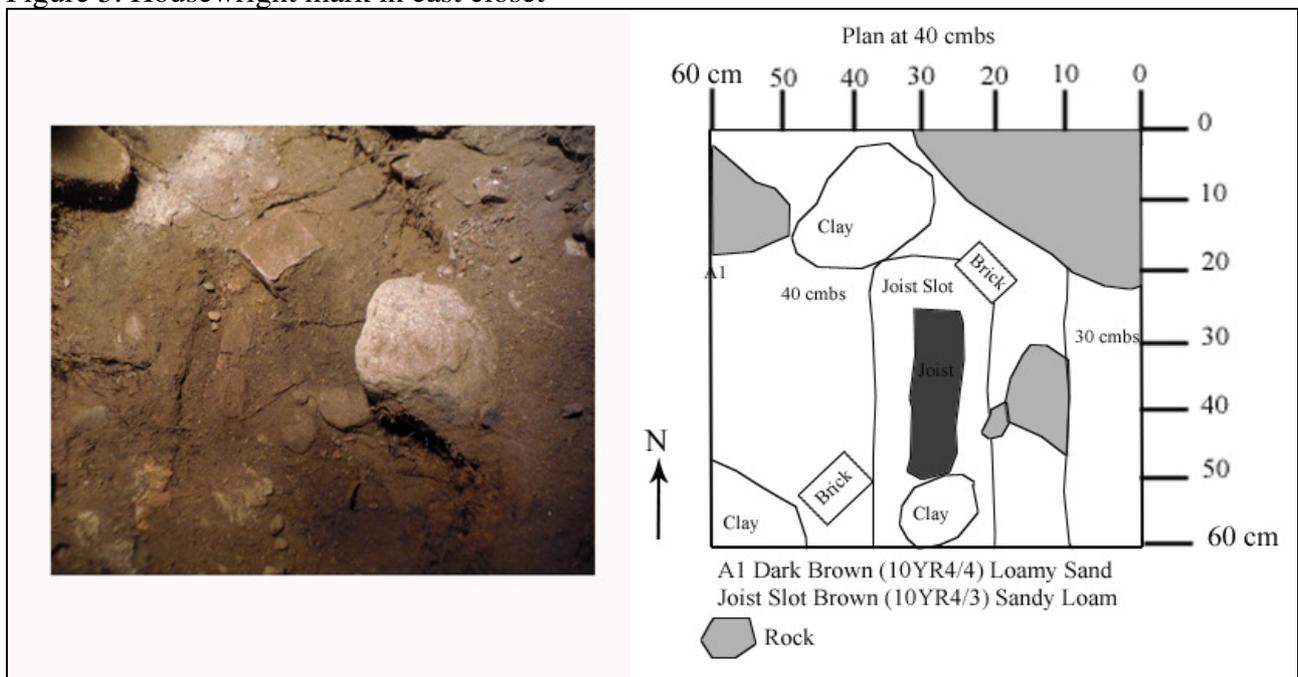
Figure 6. Plan of the excavation at 60 cmbs

Two layers of floorboards were encountered and removed and numerous floor joists and sistered joists, all apparently dating to the 1830s Pratt renovation period, were found. The ground surface below the floor consisted of loose soil with many pieces of brick and mortar. This loose fill (identified as Fill Layer 2) was removed to a depth of 40 cmbs, below which a second fill layer (Fill Layer 1) was found (**Figure 6**). This layer contained many cobbles and much gravel and fewer artifacts. Fill Layers 1 and 2 dated to the 19th century and may represent excavat from the digging of the cellar (which was believed to date from the 17th century but which may date to the 1837 Pratt renovation) and the possible rising of the entire house approximately 19” above the original ground surface.

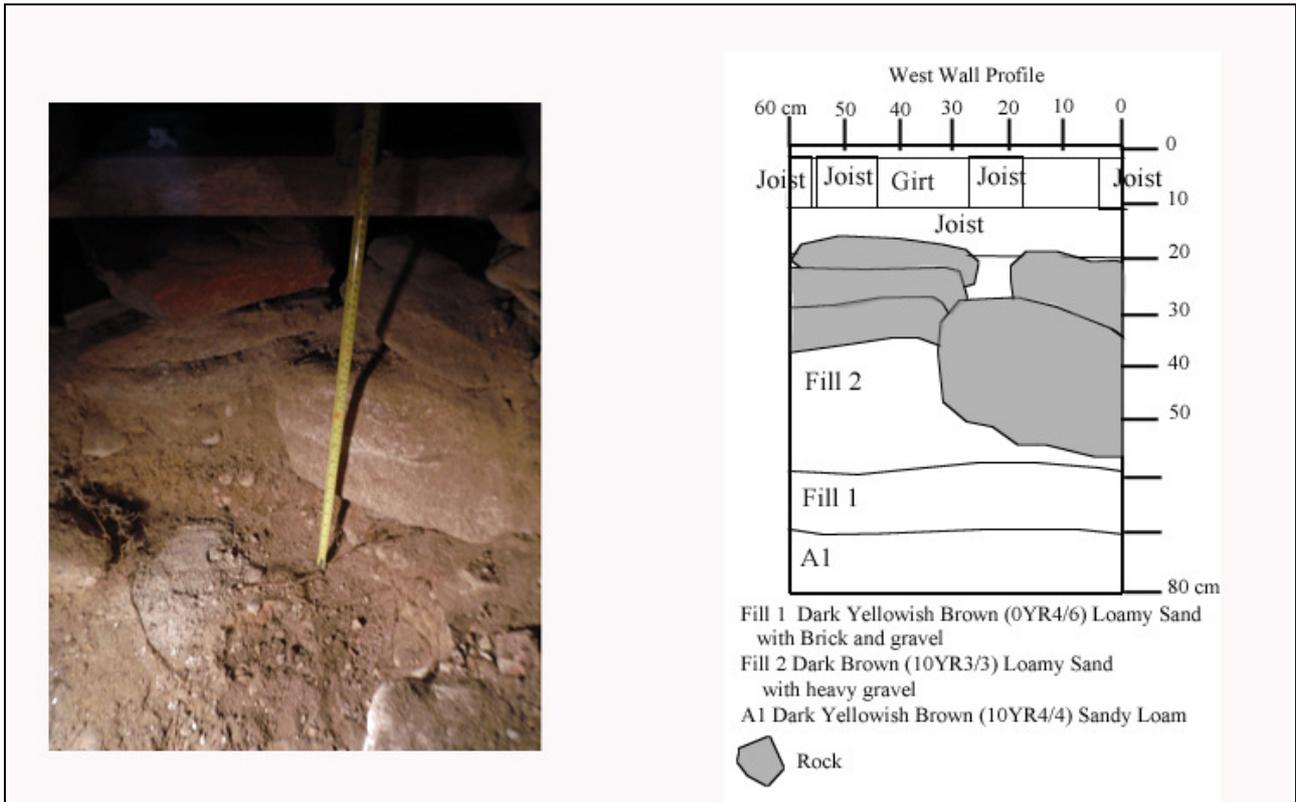
Figure 7. Profile of the excavation in the east closet

Below Fill Layer 1, the original ground surface dating from the 17th century was found (**Figure 7**). The surface of this layer had lumps of clay, which are believed to represent clay mortar used in the 17th century chimney (probably the 1678 chimney versus the 1660s chimney), and 17th century brick fragments. Probably the most significant finding from this excavation was the discovery of one of the original floor joists, probably from the 1660s house, still remaining within a joist trench. The use of joists and sills that were buried in the ground to a point where they were almost level with the ground surface, appears characteristic of many early period buildings that PARP has found in Plymouth Colony and that others have found in Maine at the site of Popham's 1607 Colony. The discovery of this joist, which measures 5 x 5 cm (2 x 2”) within a trench measuring 15 cm (6”) wide indicates that th original joist was probably close to 6” in diameter, but that when th house was raised, the joist had rotted to a degree that it was just left in place when the building was raised and new joists were added. The identification of a buried joist opens the possibility that the original 1660s house was earthfast and that the corner posts were originally buried in the ground. It is recommended that test pits be excavated outside the locations of the original corner posts to see if any evidence of postholes or the rotted lower sections of the posts can be found.

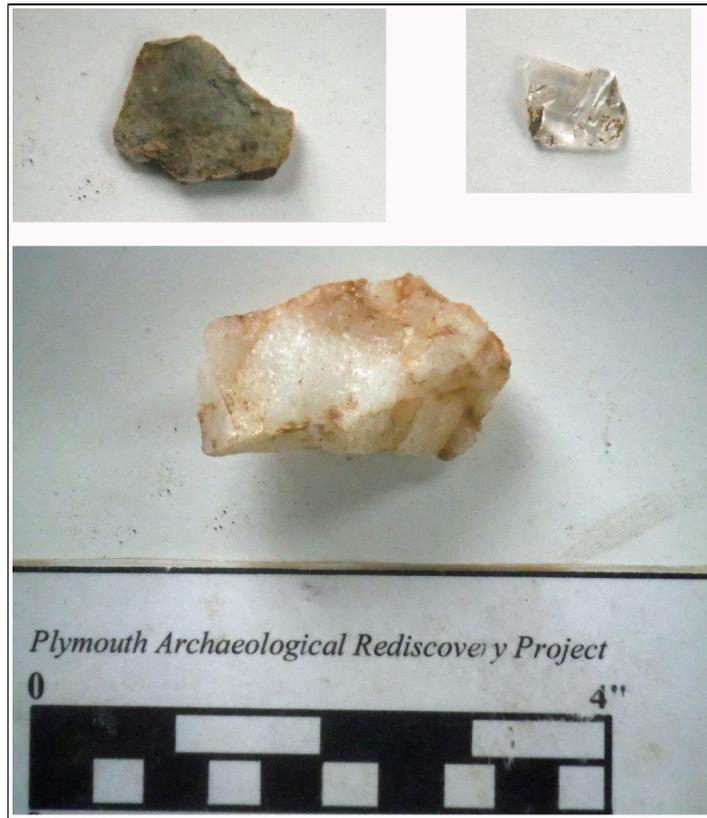
Figure 8. Lithics (Top Left to Right: Rhyolite flake, glass possible flake)

Prehistoric material was abundant, taking the form of 22 pieces of quartz debitage (flakes, flake fragments, shatter, and a core) and one rhyolite flake. Finding these artifacts offered support to the findings from the test pits excavated in the south yard where a moderate amount of Native material hints at some degree of occupation in the prehistoric period. One clear glass “flake” was recovered from the 0-10 cm level. Whether this is a real “flake”, intentionally created, or is more probably just a fortuitous flake created by a clear vessel being accidentally broken, is not known, but the later is suspected.

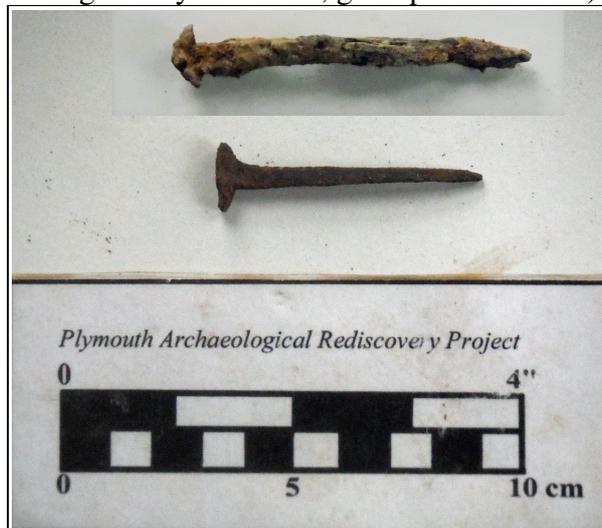
Figure 9. Wrought nails (Bottom- T-head flooring nail)

wrought flooring nails and a piece of a redware pan were found. The artifact assemblage from 0-20 cm appeared to date from the 19th century, from the Pratt renovation period (ca. 1837) while the remainder of the soil to 60 cmbs is believed to date from the 1660s to 1670s.

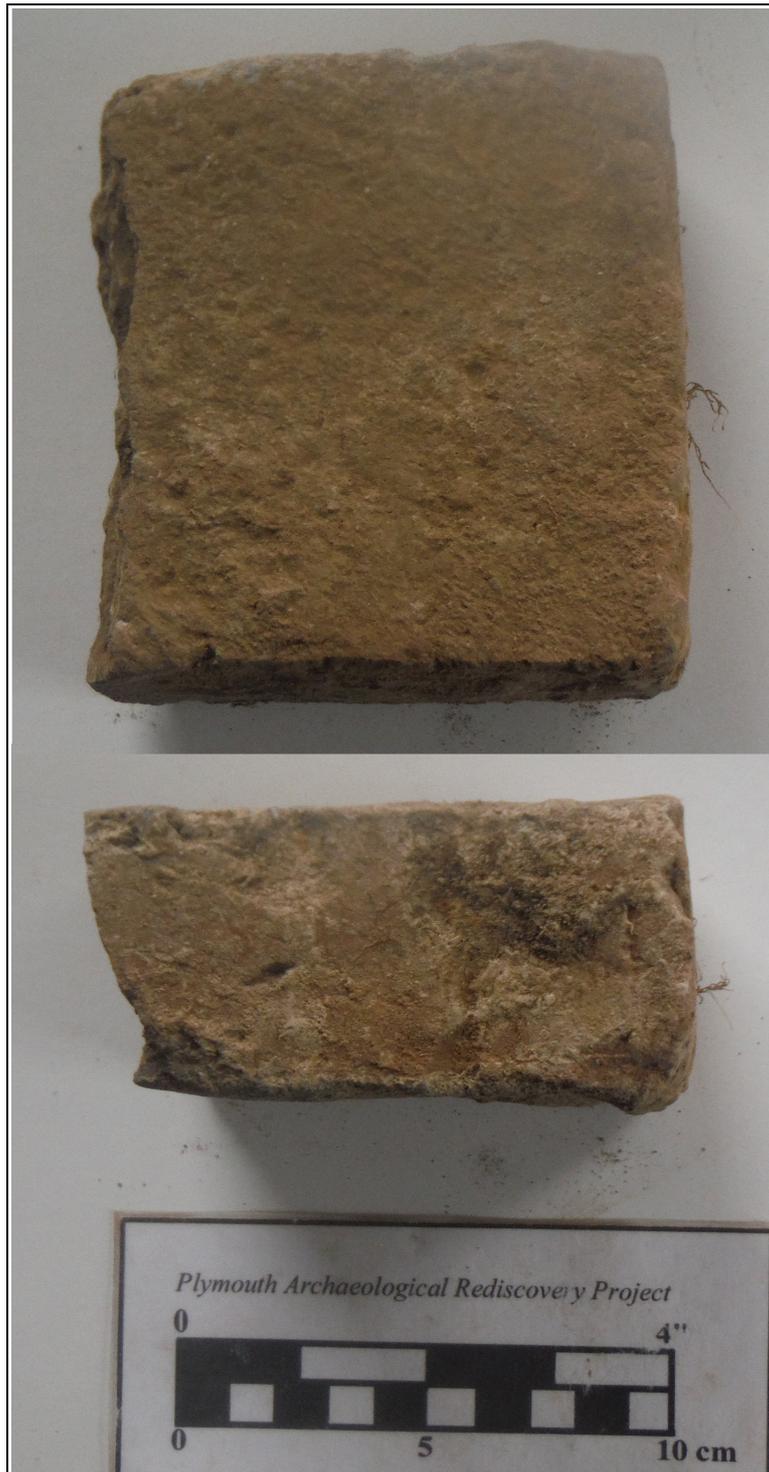
Figure 10. 17th century brick (Top: overhead view; Bottom: side view)

Seventeenth century material took the form of brick fragments, hand-wrought nails, and at least one pipe stem. Nineteenth century material consisted of creamware and pearlware vessel fragments,

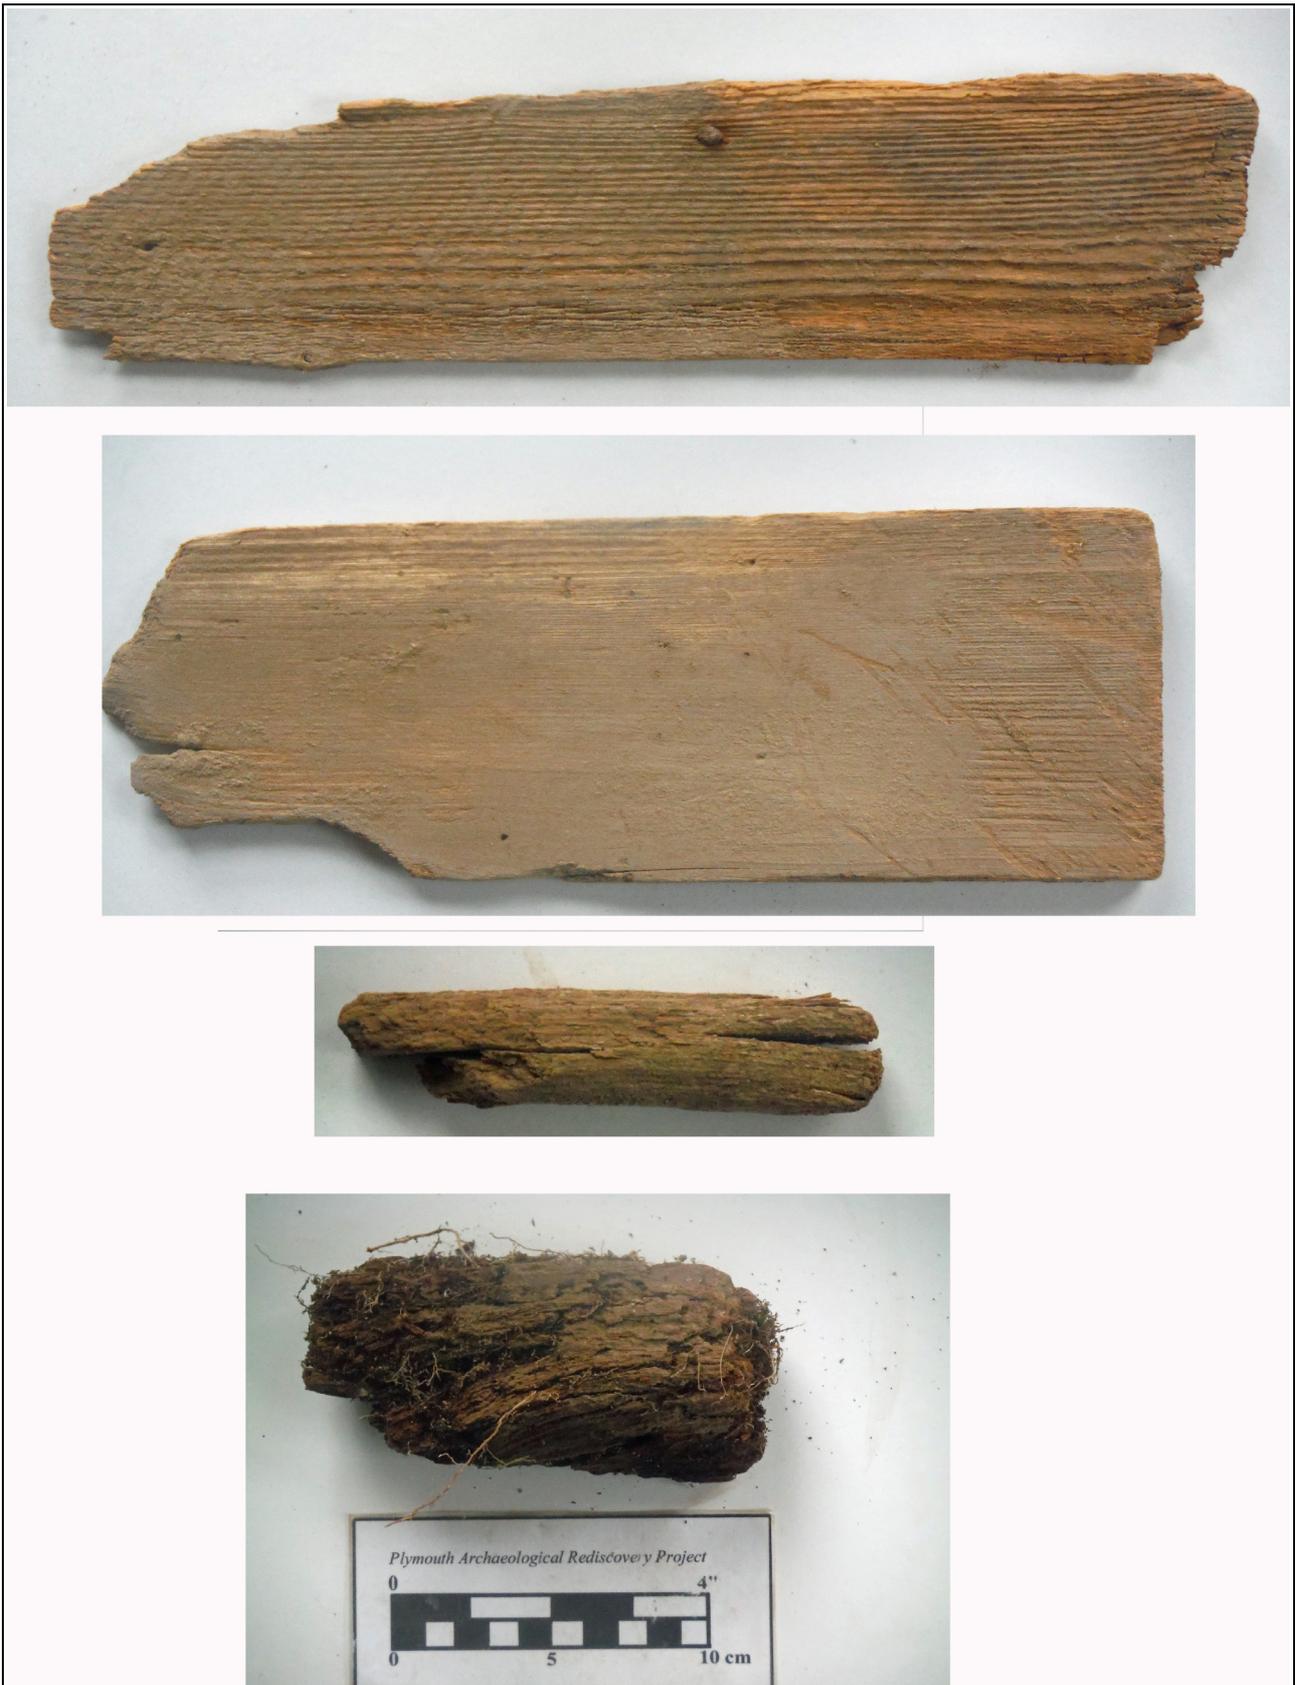
Figure 11. Architectural wood (Top to Bottom: Shingle, shingle, trunnel, joist fragment)

machine-cut nails, window glass, fragments of wine bottle, a 2-hole brass button, a tobacco pipe stem, and a molded glass bottle bearing a floral design. Two complete wooden shingles were found on the surface of the unit. Latham reported that Pratt removed the shingles on the house and replaced them with clapboards. The recovered shingles appear to be 19th century in style and are consistent with the Pratt period.

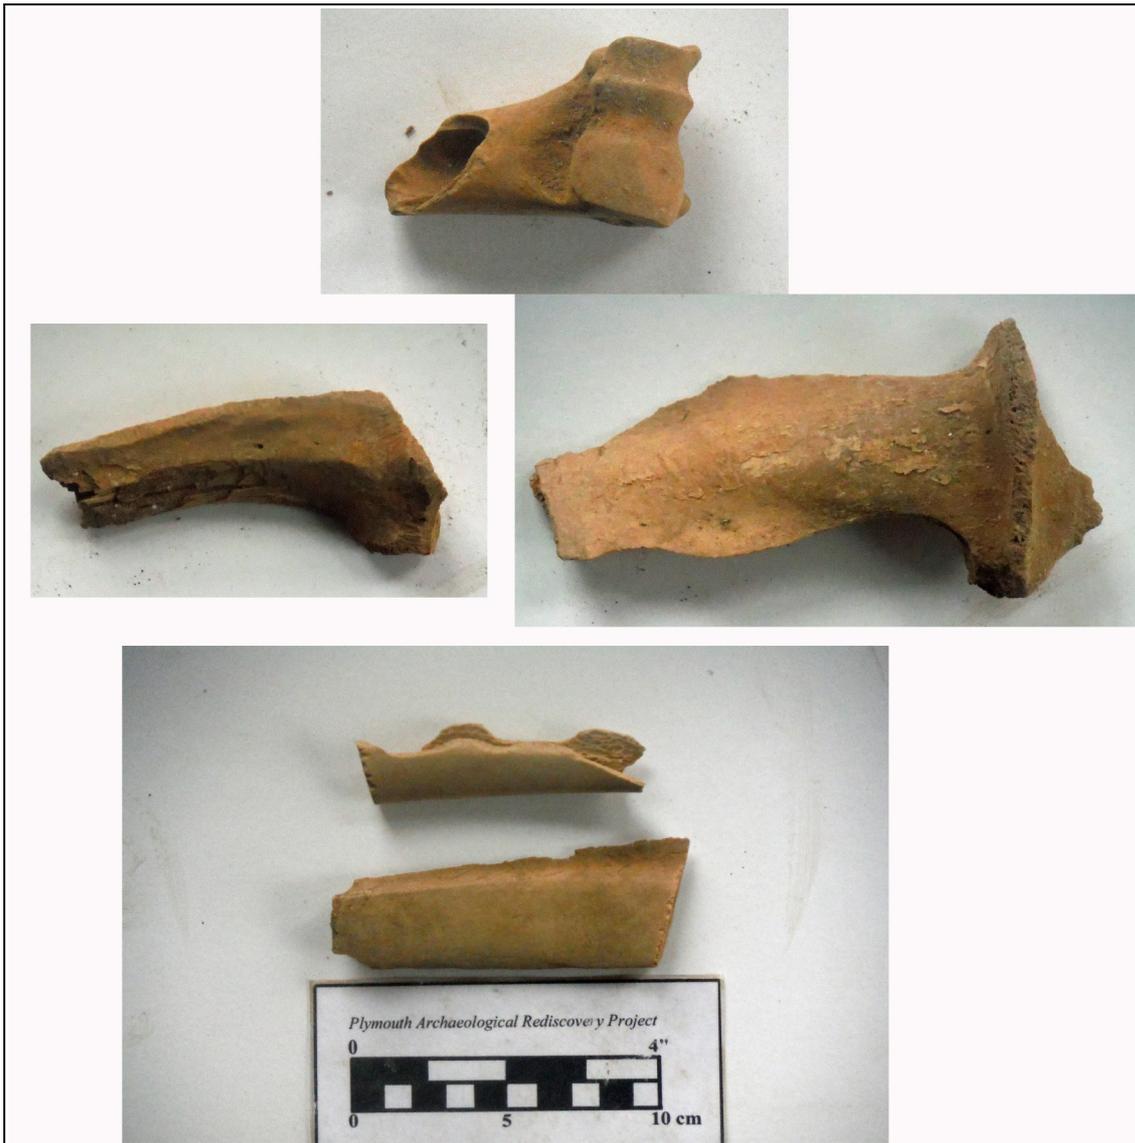
Figure 12. Faunal remains (Top: sheep humerus; Middle Left to Right: chopped and rodent gnawed cattle rib, chopped cattle lumbar vertebra fragment; Bottom: sawn cattle ribs)

The faunal remains, which took the form of bones from domestic animals that were consumed by the inhabitants (cattle, sheep, swine, and chickens), are believed to date to the 19th century based on their stratigraphic position. These may have been the remains of meals eaten by the men working on the house ca. 1837, they may be bones dragged under the house for consumption by the rats (whose bones were also found) or they may have arrived under the floor as a result of a combination of processes. The seed and nut fragments are believed to have been brought under the house by rodents.

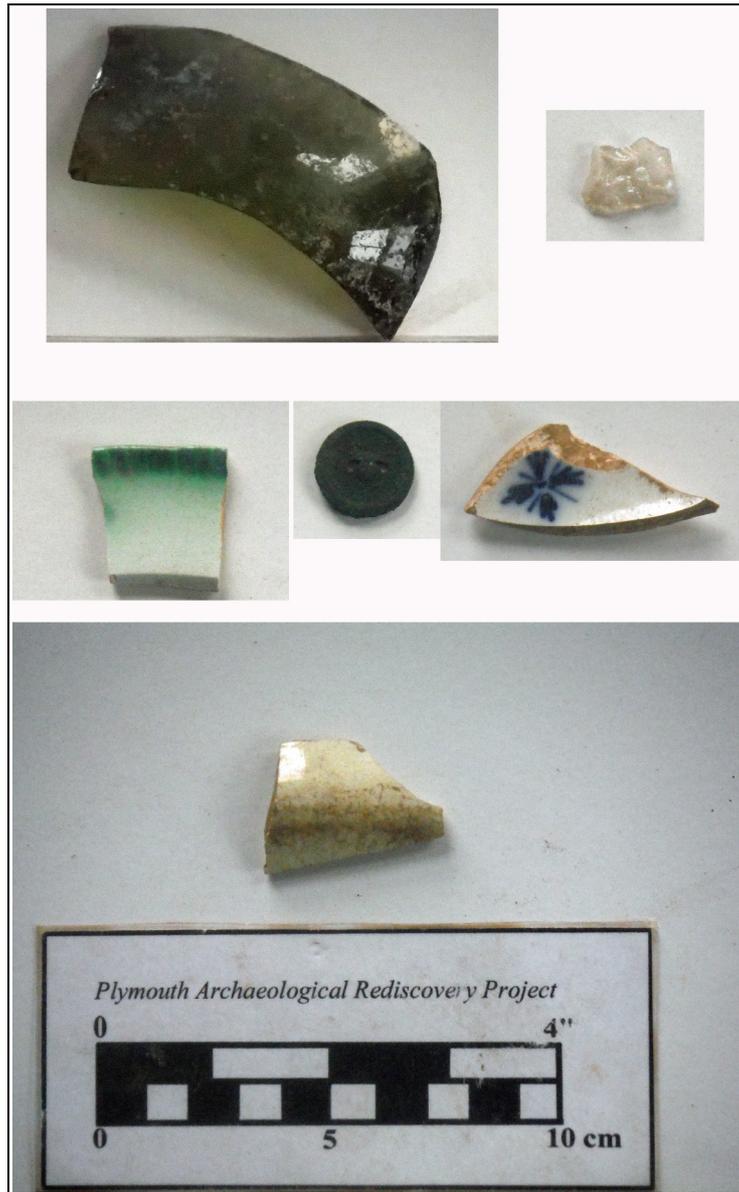
Figure 13. Glass, button, and ceramics (Top Left to Right: wine bottle, molded bottle; Middle Left to Right: green edged pearlware plate, brass 2-hole button, hand painted pearlware vessel; Bottom: creamware plate with base wear)
